820 Esquimalt Road, 833-837 Old Esquimalt Road—Esquimalt, BC

Construction Impact Assessment & Tree Management Plan

April 06, 2022

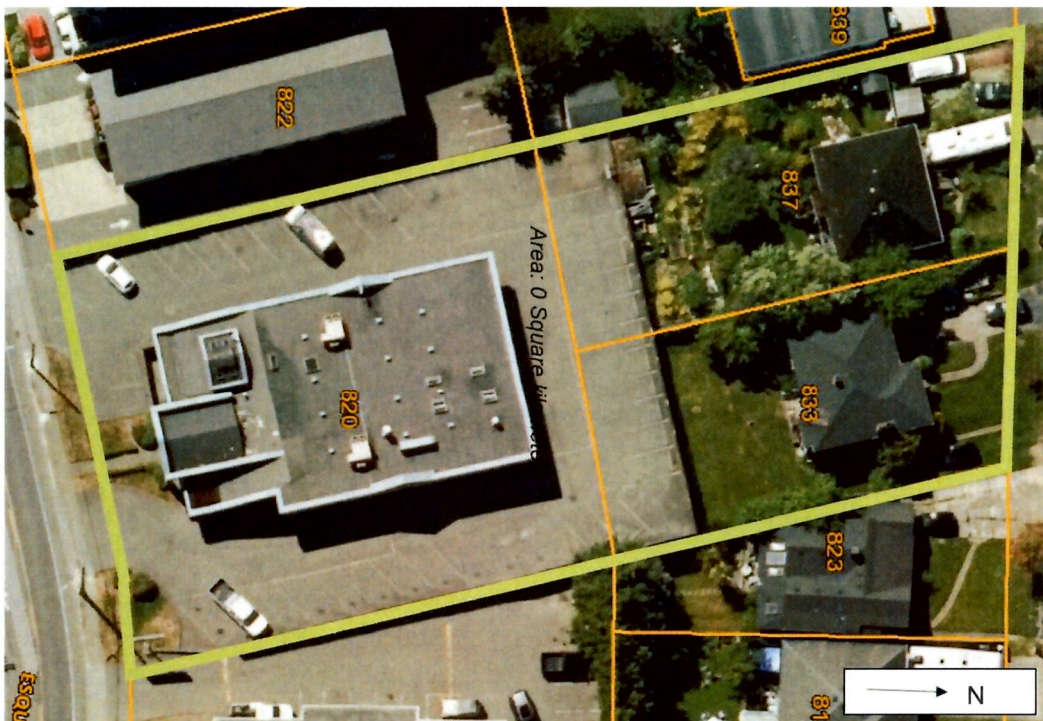
The onsite tree resources were largely non-native (*Table 1*) and situated within the property lines of 837 Old Esquimalt Road and 833 Old Esquimalt Road (*Figure 1; Appendix A*). The 820 Esquimalt Road lot was elevated at the northern end and generally covered with asphalt and other structures that precluded tree growth. Two municipal trees (M1 & M2) were documented along Old Esquimalt Road (*Table 1; Appendix A*), with M2 situated immediately adjacent to the proposed development. Two offsite, private trees (OS1 & OS2) were documented adjacent to the east and west property lines of the 820 Esquimalt Road lot (*Table 1; Appendix A*). These offsite trees had a point of germination two meters below the pre-existing grade of the parking lot positioned at the north-end of 820 Esquimalt Road. The critical root zones of these offsite trees may be impacted depending on the extent of excavation along the east and west property lines.

Figure 1: Site context air photo: The approximate boundary of the subject site is outlined in Green.

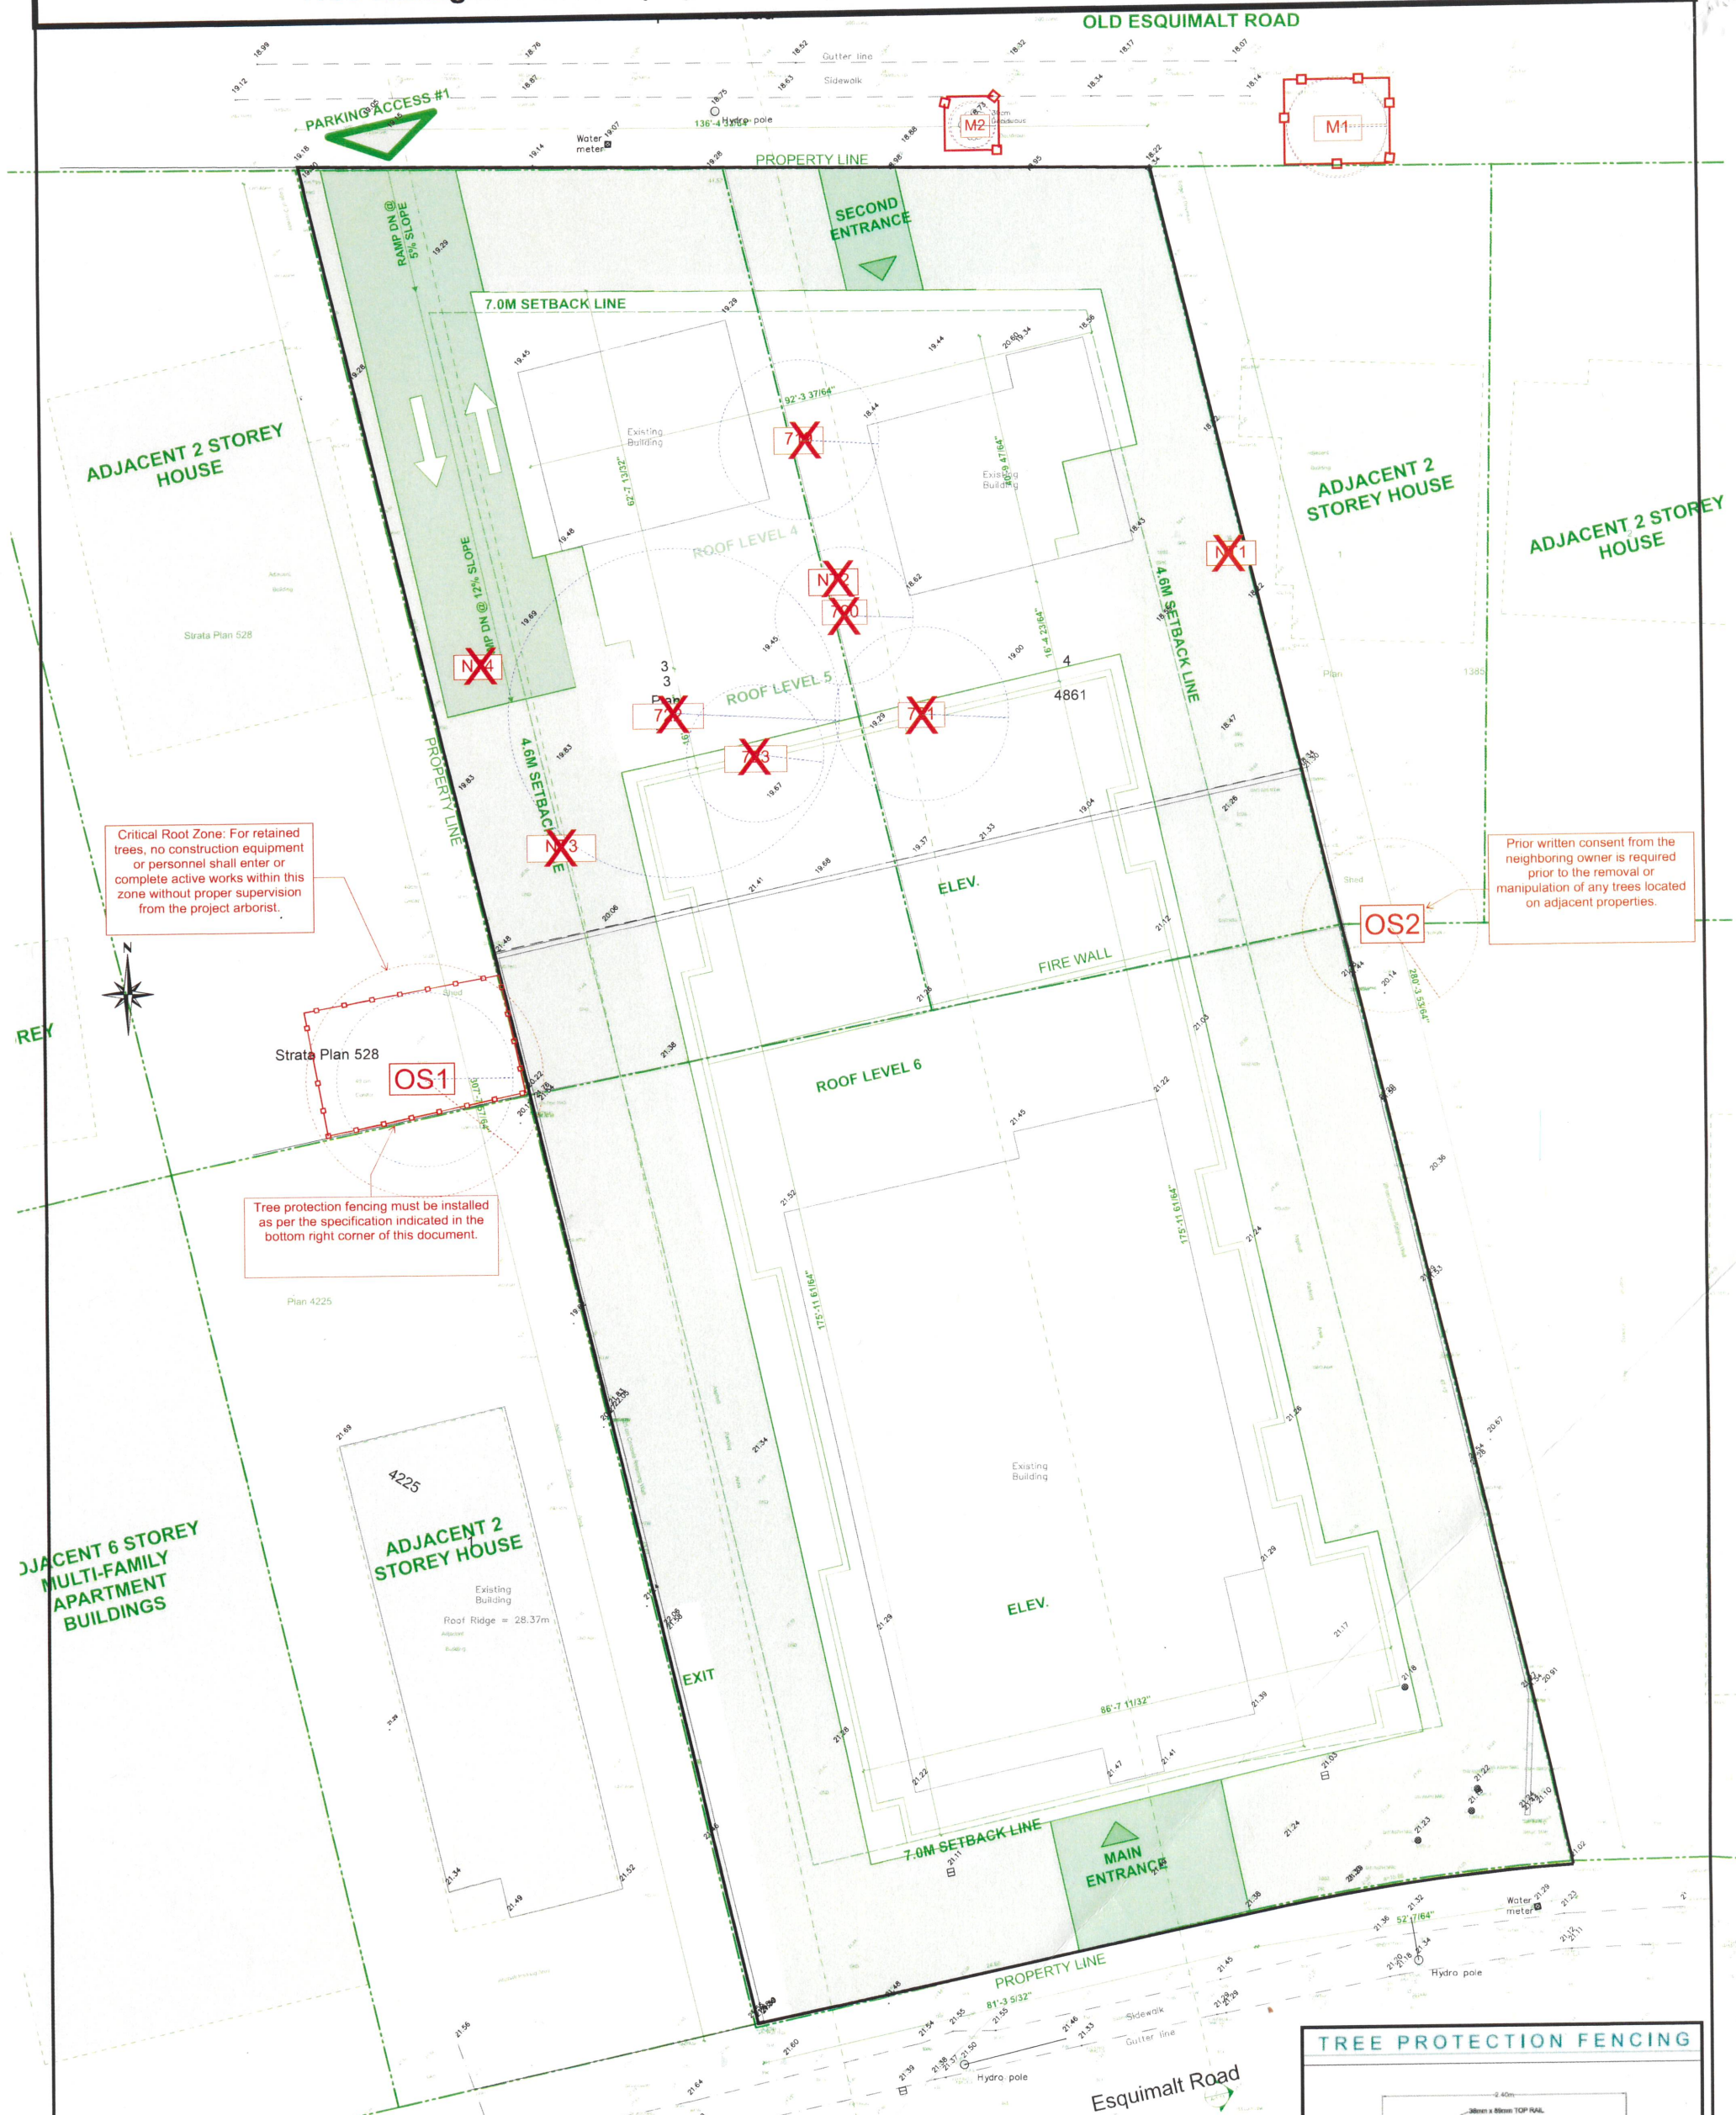
Tree Management Plan (T1) - 820 Esquimalt Road, 833-837 Old Esquimalt Road

Due to the proximity to the proposed development and its health and structure, the retention status of M2 is “to be determined (TBD)” based on the proposed positioning of onsite works and construction practices. Currently, M2 is scheduled to be retained and protected until the proposed development is approved and such information can be confirmed.

Due to the proximity to the proposed development and their health and structure, the retention statuses of OS1 & OS2 are “to be determined (TBD)” based on the proposed positioning of onsite works and construction practices.

- 719, 720, 721, 722, 723,

- NT1, NT2, NT3, NT4

Tree Protection Barrier: The areas, surrounding the trees to be retained (M1, M2, OS1, and OS2) should be isolated from the construction activity by erecting protective barrier fencing (see [Appendix A](#) for municipal barrier specifications). Where possible, the fencing should be erected at the perimeter of the critical root zone. The barrier fencing to be erected must be a minimum of 4 feet in height, of solid frame construction that is attached to wooden or metal posts. A solid board or rail must run between the posts at the top and the bottom of the fencing. This solid frame can then be covered with flexible snow fencing. The fencing must be erected prior to the start of any construction activity on site (i.e., demolition, excavation, construction), and remain in place through completion of the project. Signs should be posted around the protection zone to declare it off limits to all construction related activity. The project arborist must be consulted before this fencing is removed or moved for any purpose.
