## Capital Tree Service Inc.

Arborist Report

903 Admirals Rd,

\*Revised November 3, 2025\*

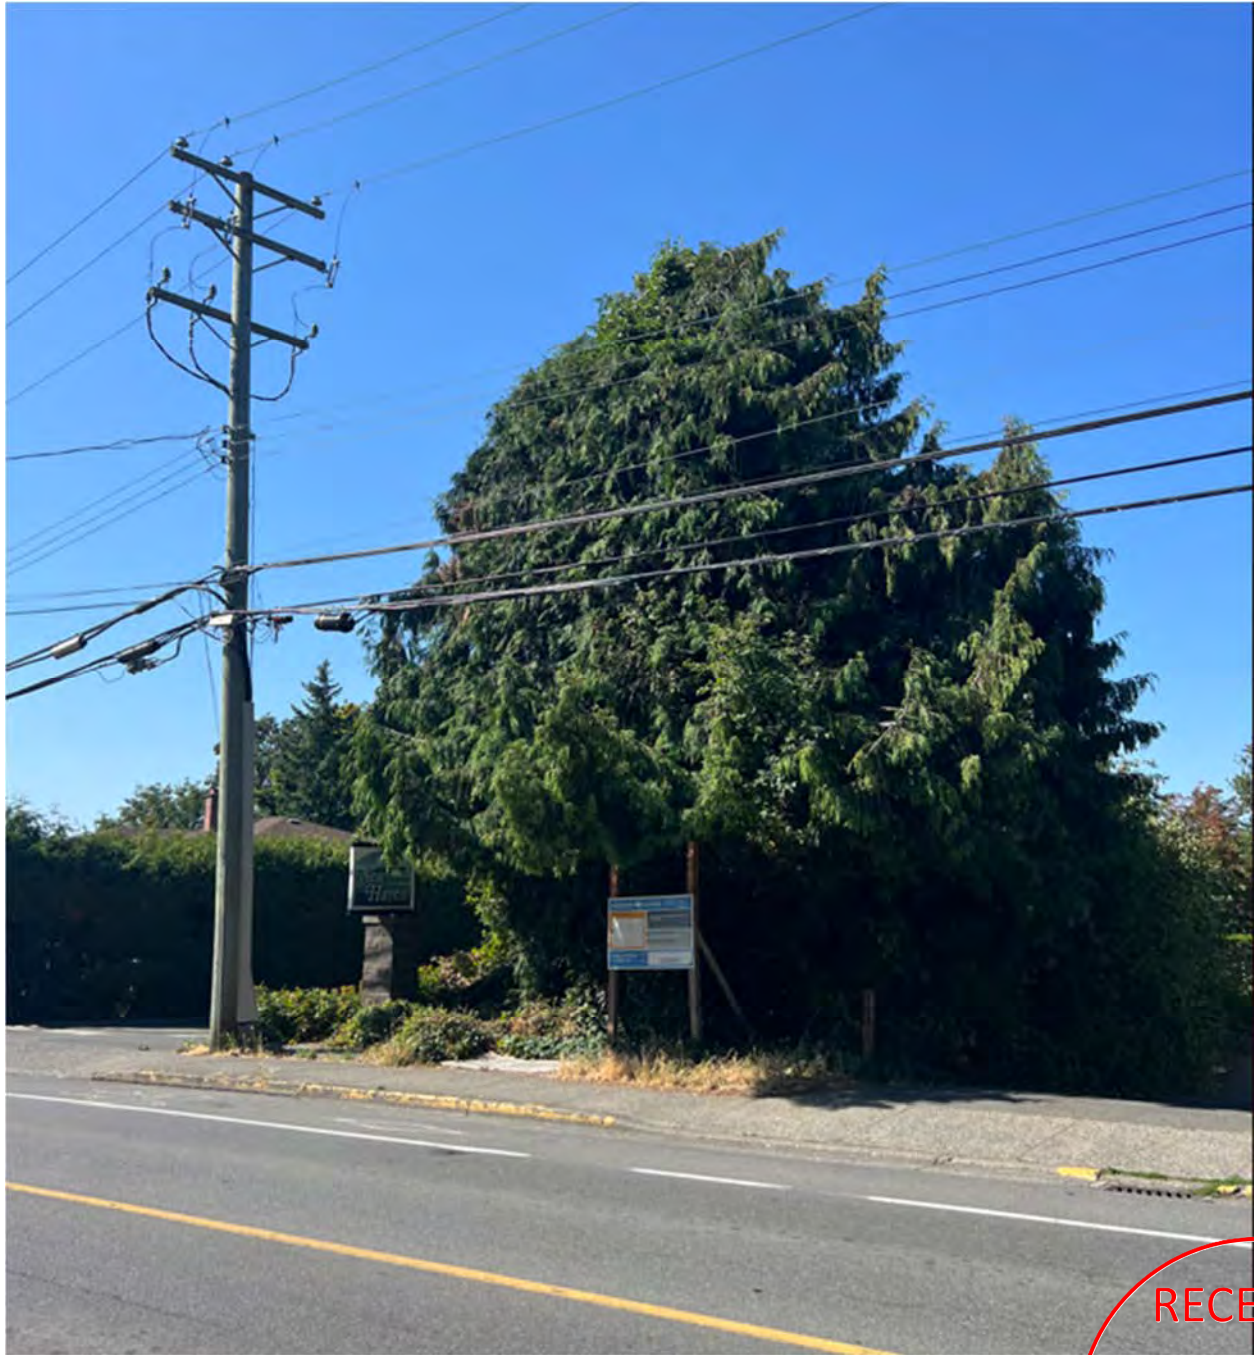
Figure 3. Streetview of 903 Admirals. Tree #61 above development sign.

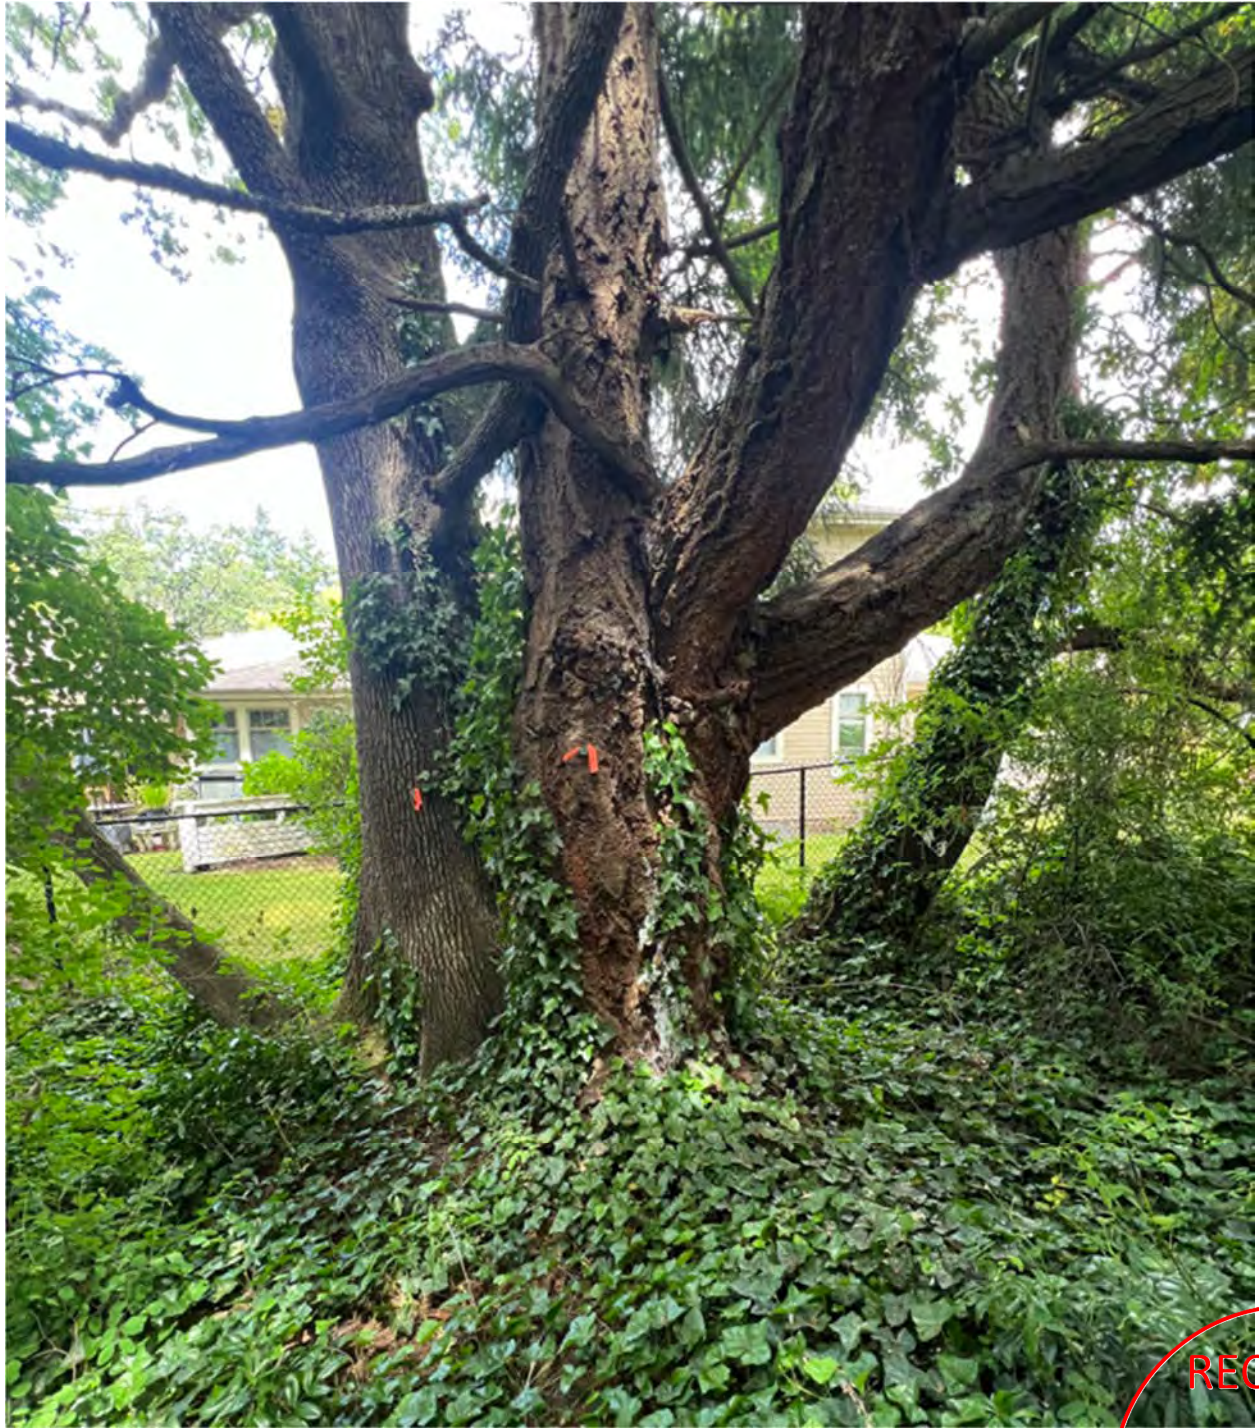
Tree #24, a mature Garry oak in the north-east corner will be retained. The careful removal of nearby tree #23, a Douglas fir with myriad structural deficiencies will be required as several branches from the Oak have intertwined and fused with the Douglas fir. Once the Douglas fir is removed, pruning on the Oak to reduce the canopy to eliminate conflicts with the new building can occur. Deadwood removal and any other maintenance/health pruning may also be done at this time. The remaining stump from tree #23 shall remain in place as it likely has intertwined roots with tree #24. A slight design change may be required shifting the patio from the proposed unit from the north to the east side of the unit- this may be assessed after preliminary site preparation including removal of all other surrounding trees.

**Figure 4. View of Northeast corner of property. Trees 24, 23, 25 in frame.**

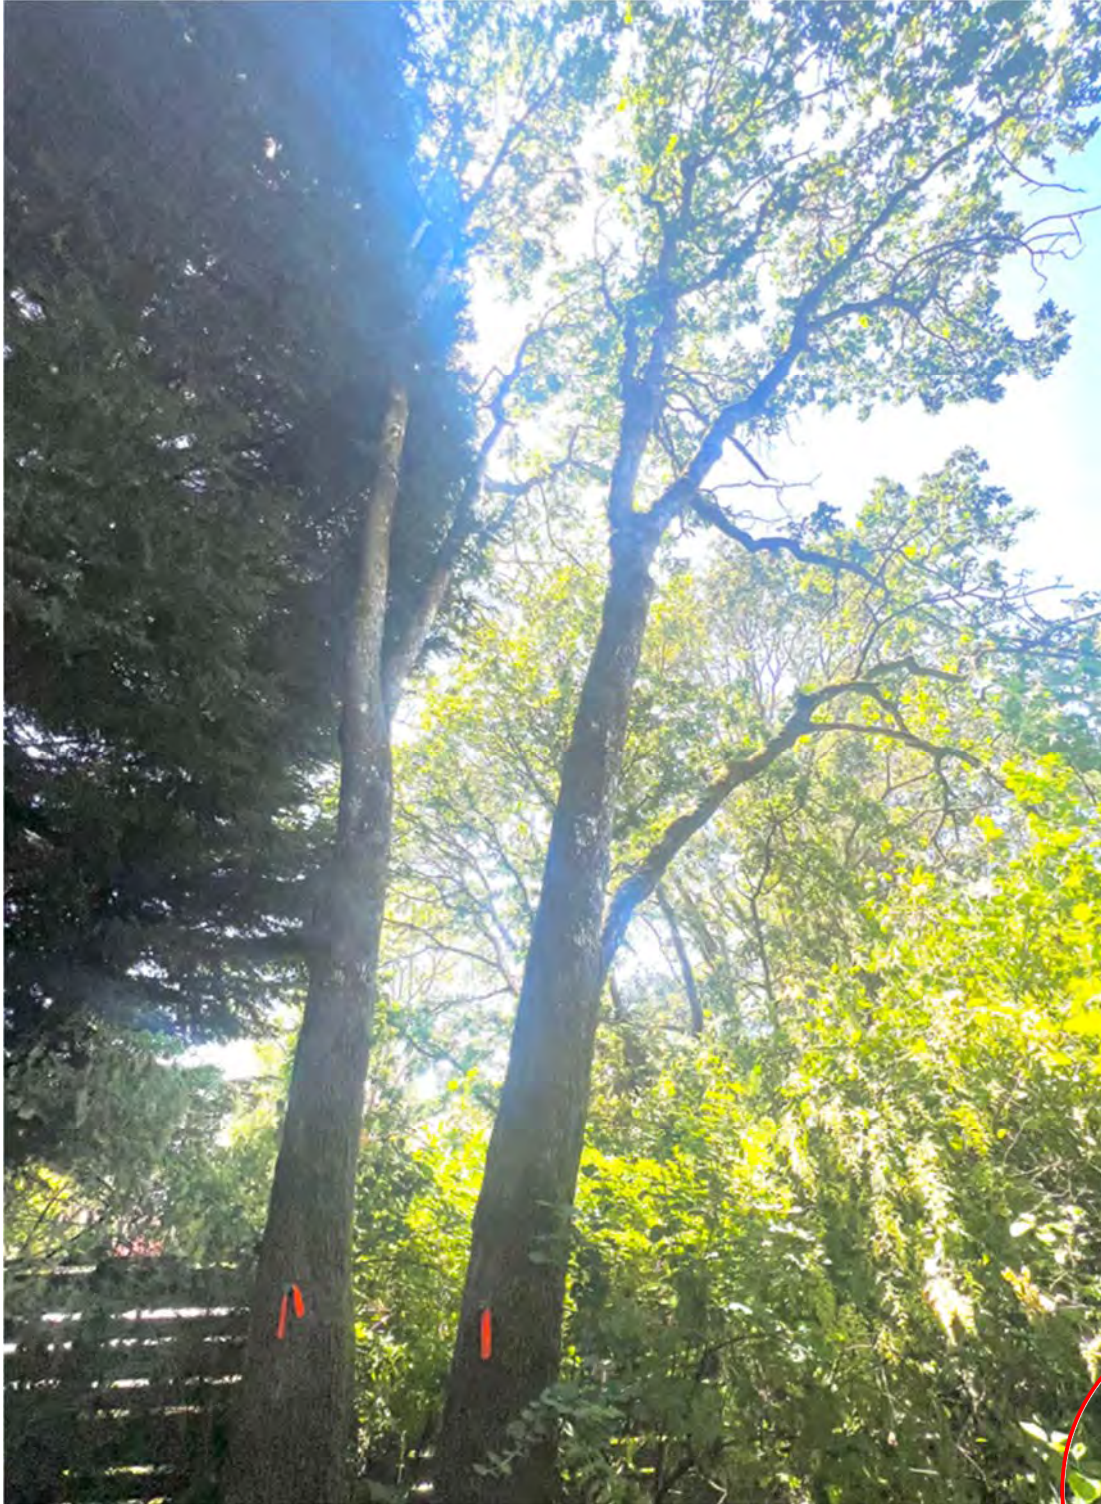
Figure 5. Tree 43/44

Tree #43/44, a mature two-stem Garry oak will be retained. Additional assessment after the removal of surrounding trees and preliminary site preparation has occurred may confirm if a cable installation is necessary to address the co-dominant structure. The patio design has been

42	Garry oak	19	2	5	F/P	Yes	Remove	Phototropic lean. Uneven canopy. Poor live crown ratio. 5cm+ Deadwood.
43/44	Garry oak	35	4	5	F/P	Yes	Retain	Co-dominant stem with #44. Poor live crown ratio. Narrow angles of attachment in canopy. 5cm+ Deadwood. Raised canopy. Uneven canopy. Possible decay at Co-dominant union.
		37	4	5	F/P			Co-dominant stem with #43. Poor live crown ratio. Narrow angles of attachment in canopy. 5cm+ Deadwood. Raised canopy. Uneven canopy. Possible decay at Co-dominant union.
45	Lawson cypress	72	9	9	F/P	Yes	Remove	Multi-dominant top. Narrow angles of attachment in canopy. Uneven canopy due to neighboring trees. Good foliar colour.
46	Lawson cypress	74	9	9	F/P	Yes	Remove	Multi-dominant top. Narrow angles of attachment in canopy. Uneven canopy due to neighboring trees. Good foliar colour.
47	Lawson cypress	35	4	6	F/P	Yes	Remove	Multi-dominant top. Narrow angles of attachment in canopy. Uneven canopy due to neighboring trees. Good foliar colour.

altered to allow for the retention of this tree. Patio installation of this patio, all other patios, and hardscaping within the PRZs of retained trees is to adhere to the following procedure.

1. Remove top layer of organics with a mini excavator under arborist supervision.
2. Lay down a layer of geogrid (Combigrid 30/30).
3. Lay down base material for final surface.
4. Install final surfacing material.

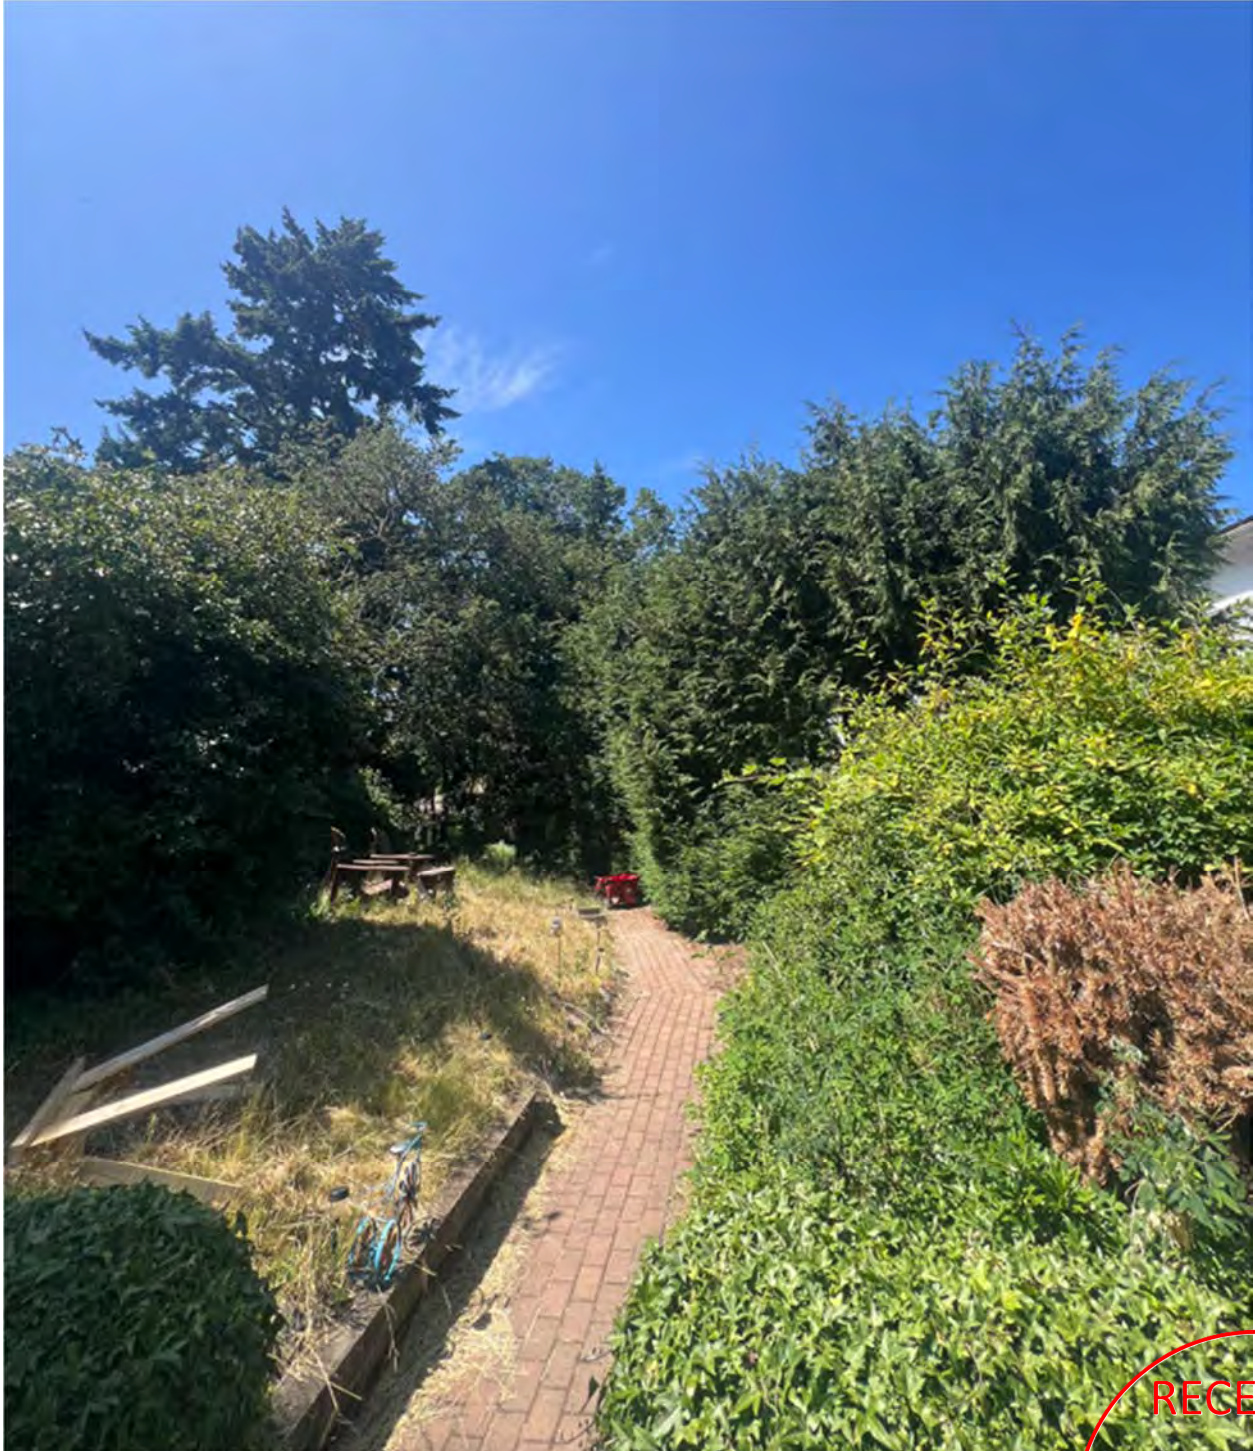
Figure 6. View from driveway looking north.

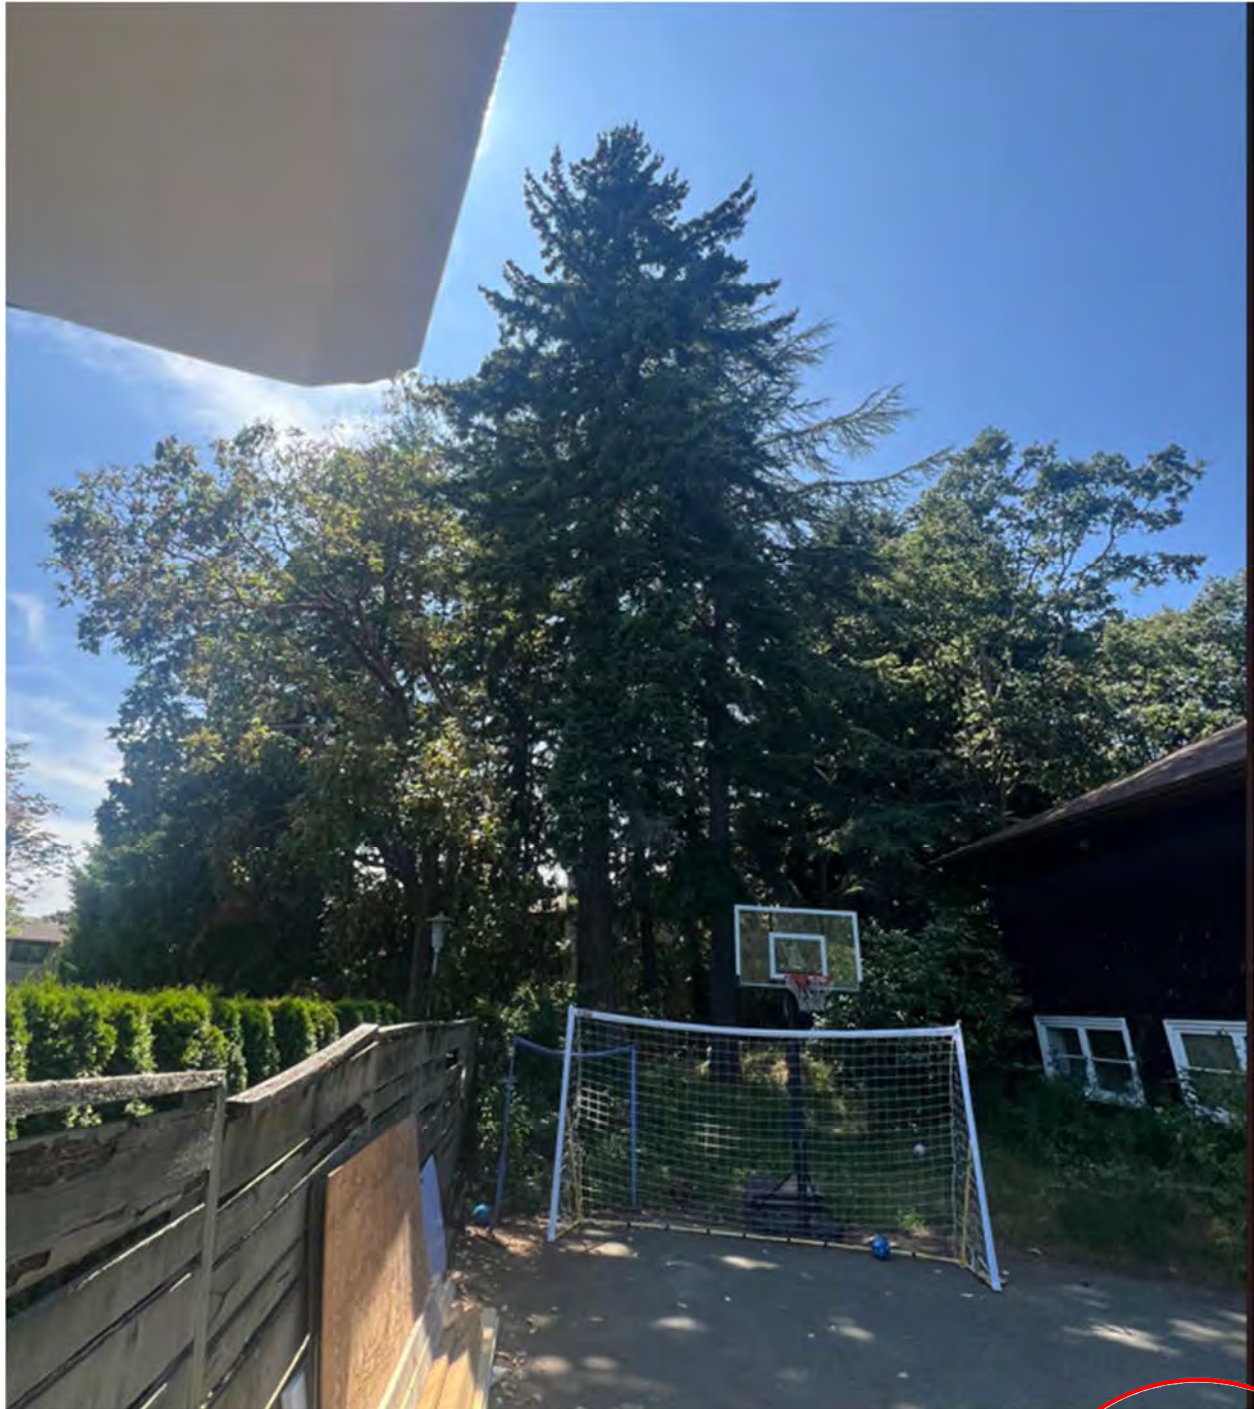
Figure 7. View from driveway of southwest corner of property.
