1209 LYALL STREET—ESQUIMALT, BC

CONSTRUCTION IMPACT ASSESSMENT & TREE MANAGEMENT PLAN

Date of Issuance: July 13, 2022

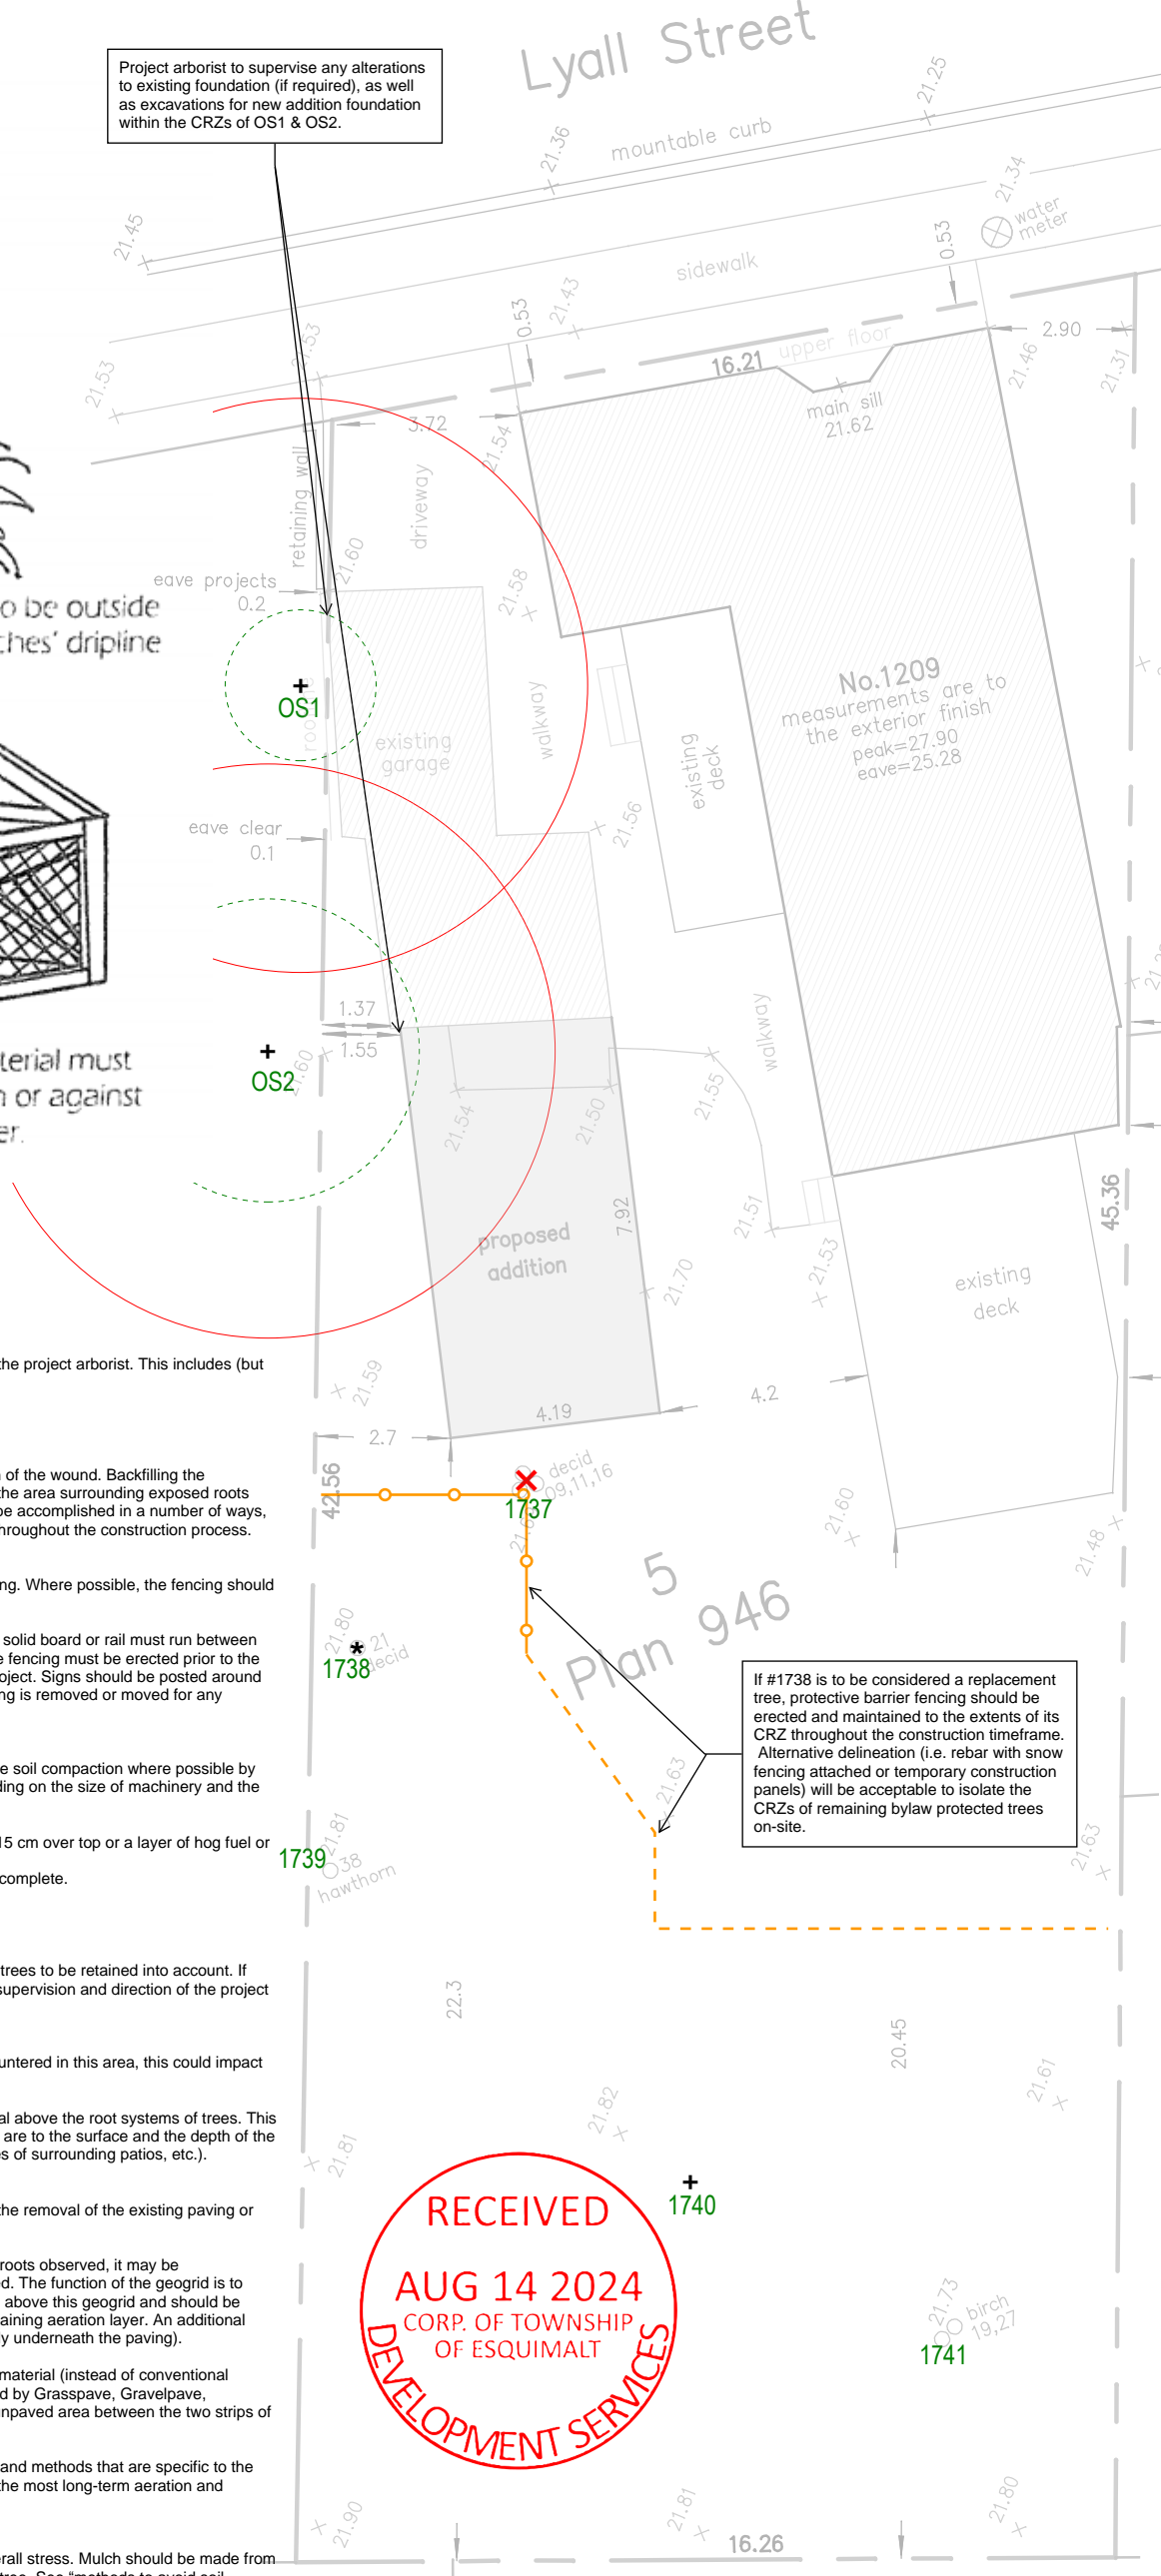
TREE MANAGEMENT PLAN

Project arborist to supervise any alterations to existing foundation (if required), as well as excavations for new addition foundation within the CRZs of OS1 & OS2.
