SouthShore Forest Consultants

May 23, 2023

RE: Proposed Development – Tree Protection Plan (TPP)

Location – 900 Carlton Place – Town of Esquimalt

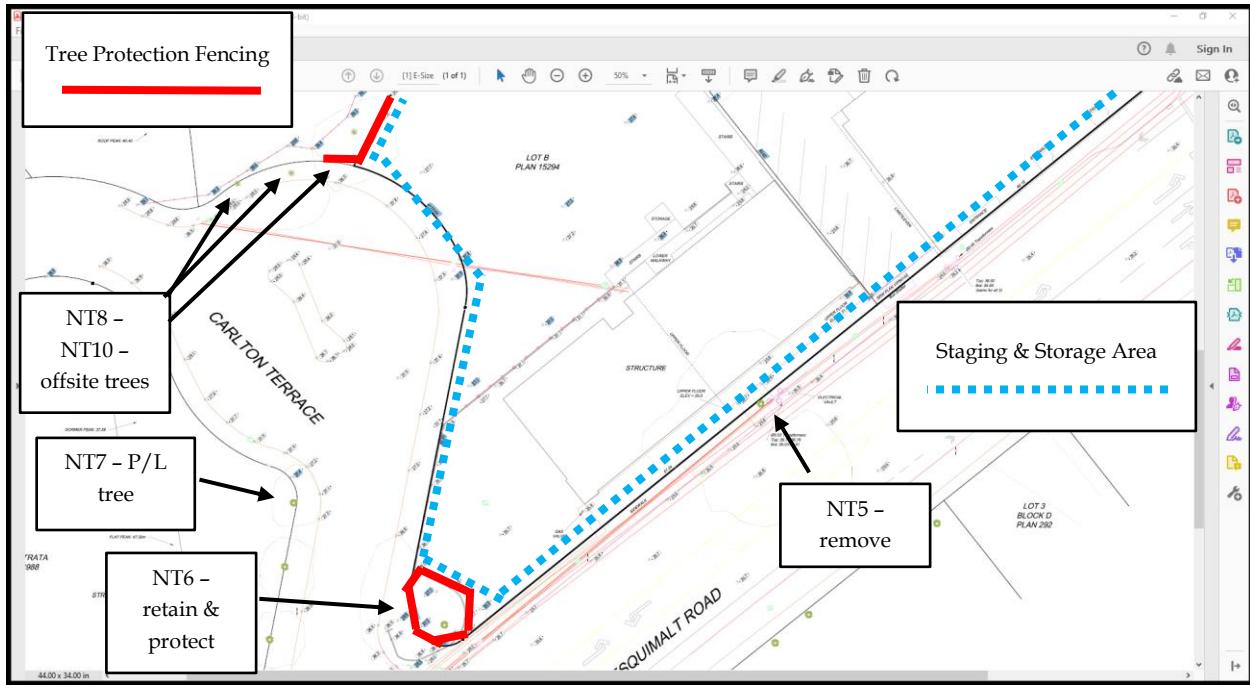
Figure #3 – Ground Level – Tree Protection Plan – West Side of Development Area

In this figure you can see the approximate positioning of the tree protection fencing and the identified staging area. In this case we expect that excavation and equipment staging may require the repositioning of the TPFing. Excavation requirements could affect grade specific root impacts and therefore the Project Arborist must provide site specific impacts in and around trees identified for retention.

- Staging Area has been identified in Appendix B - Figure #3 – Developer to ensure that all materials are staged and stored in Staging Area.
- Root Armouring will not be required in the primary impact zone - $\frac{3}{4}$ inch plywood sheeting may be utilized. Project Arborist to determine upon completion of TPFing installation.

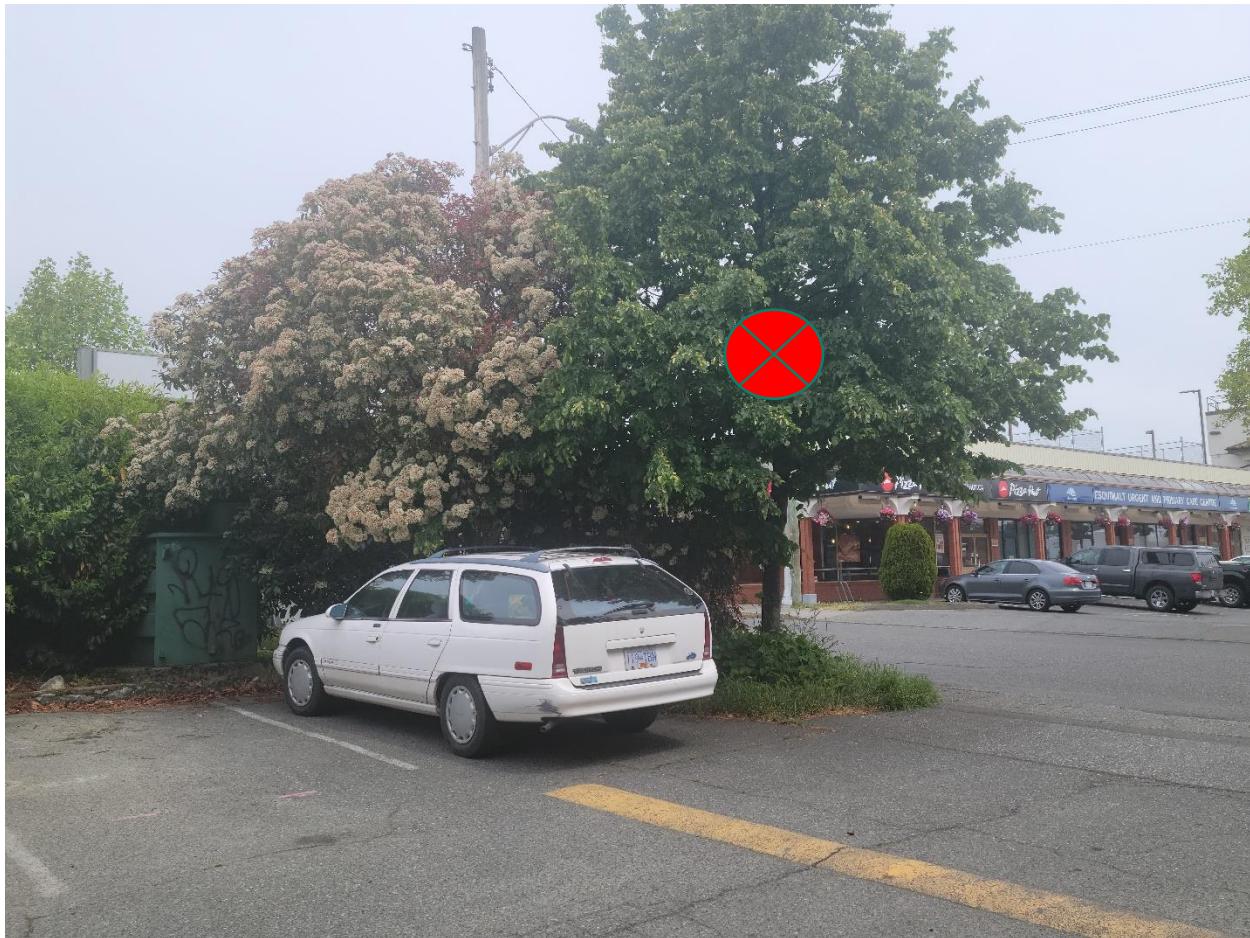
Photo #1 - NT1M - Linden Tree - Boulevard Tree

In this photo you can see NT1M linden tree positioned in the Municipal Boulevard. Under the existing proposal, this tree has been identified for removal due to landscape /hardscape improvements.

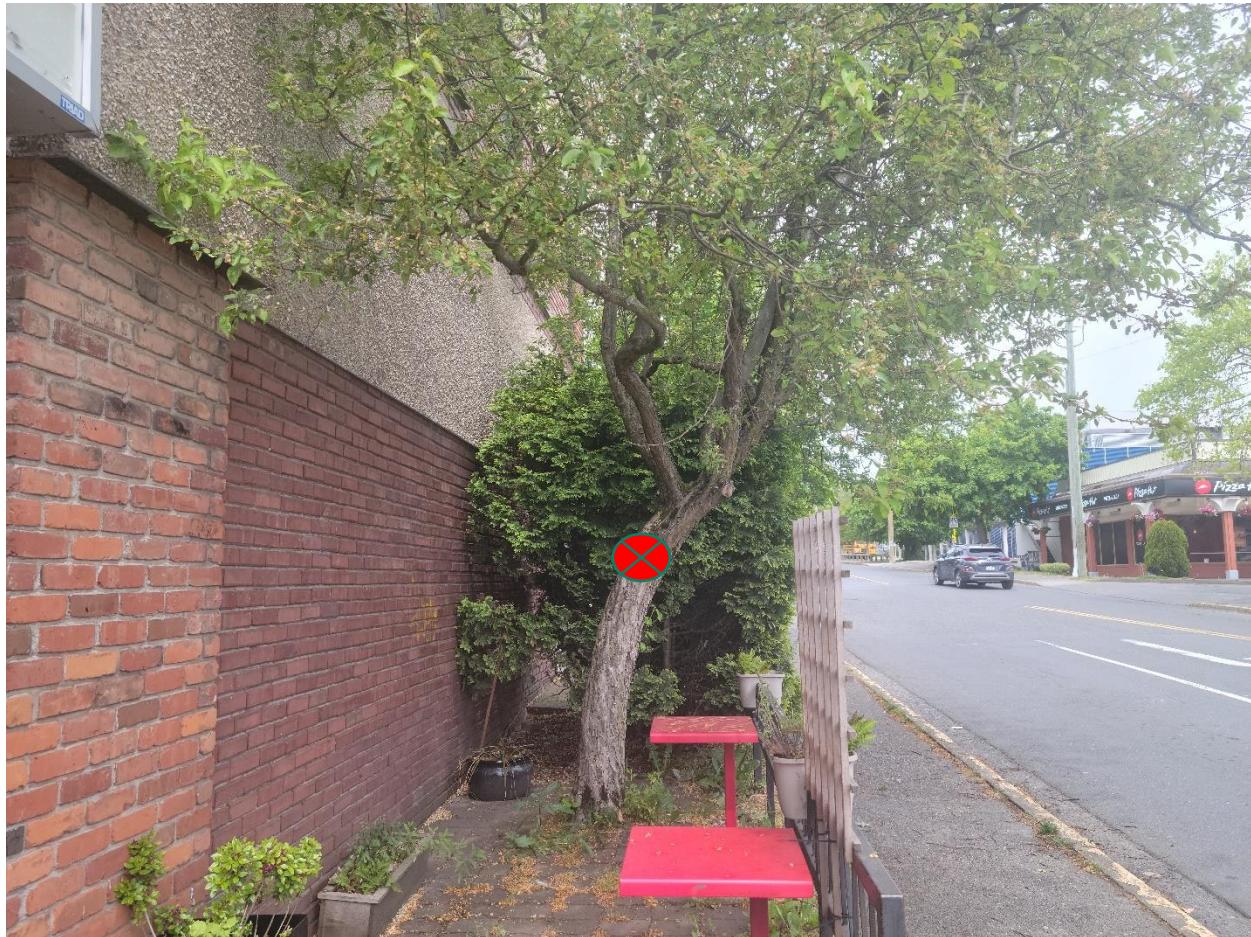
Photo #2 – NT3M – C Apple – Municipal Boulevard

In this photo you can see NT3M C apple tree positioned in the Municipal Boulevard. Under the existing proposal, this tree has been identified for removal due to landscape /hardscape improvements.

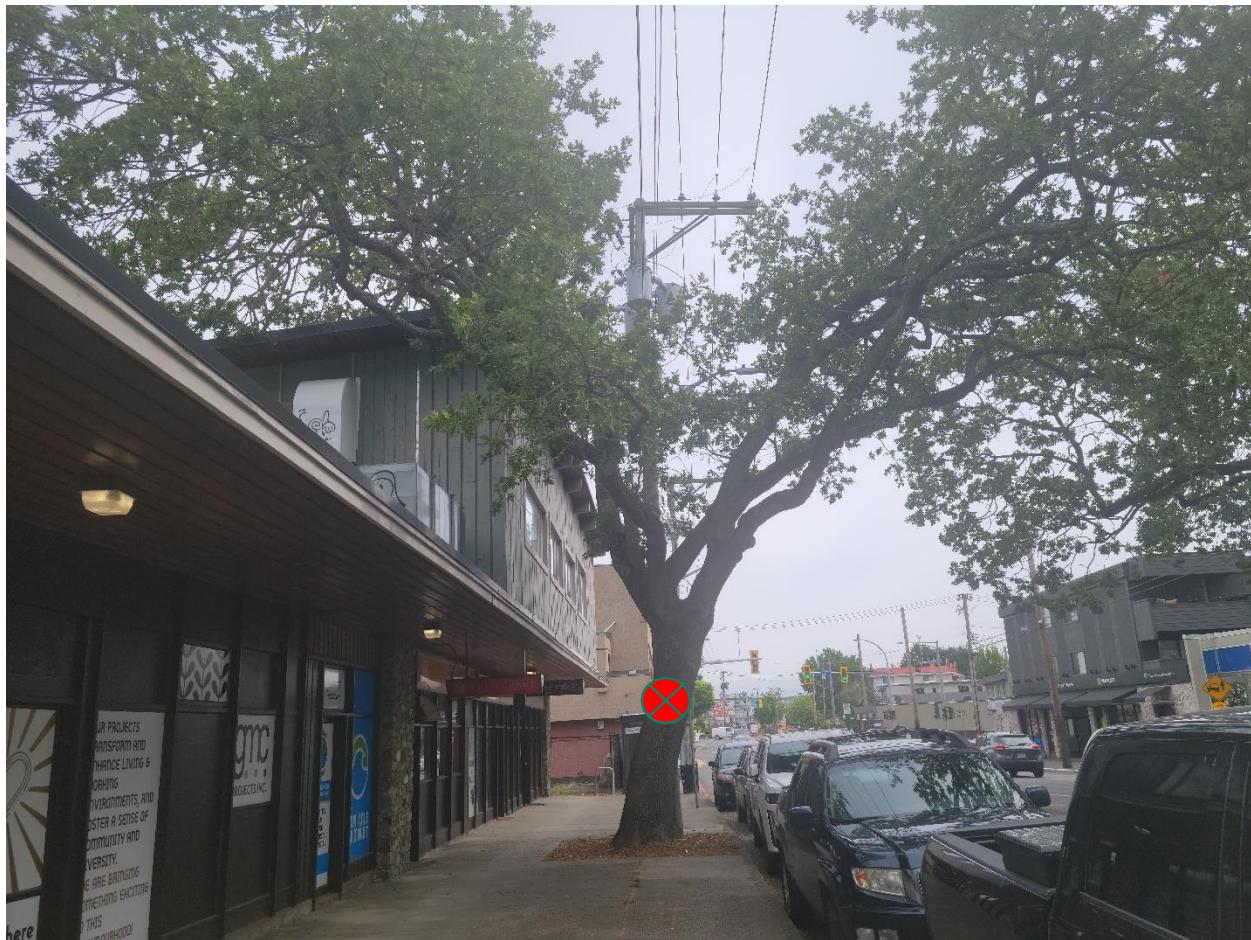
Photo #3 – NTM5 – Garry Oak – Boulevard Tree

In this photo you can see NT5M Garry oak tree positioned in the Municipal Boulevard. Under the existing proposal, this tree has been identified for removal due to its position and the proposed setback/step back. The tree's structure has been compromised due to the overhead utility lines. Proposed improvements to the sidewalk and right-of-way will affect the oaks Critical Root Zone (CRZ) further affecting the trees sustainability to the site. Removal of tree NT5M is highly recommended.

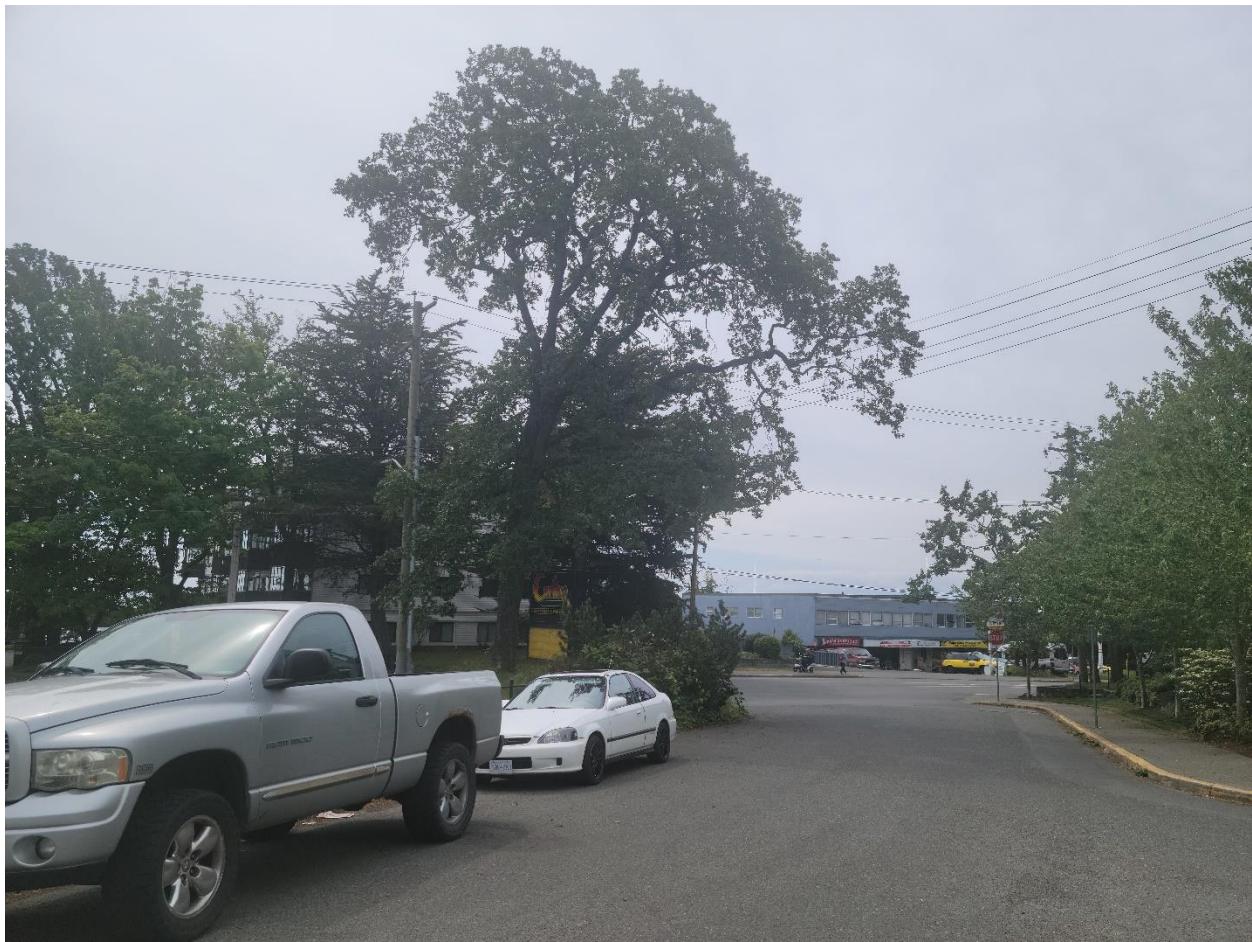
Photo #4 – NT6 – Garry Oak – Retain & Protect

- Tree NT6 oak is elevated in a small planting pit. Observed to have a rock retaining wall protecting grade, this tree was observed to have a wound at the base of the tree at grade. Further assessment of this tree will be required during the grading/ devilmnt phase of the site.

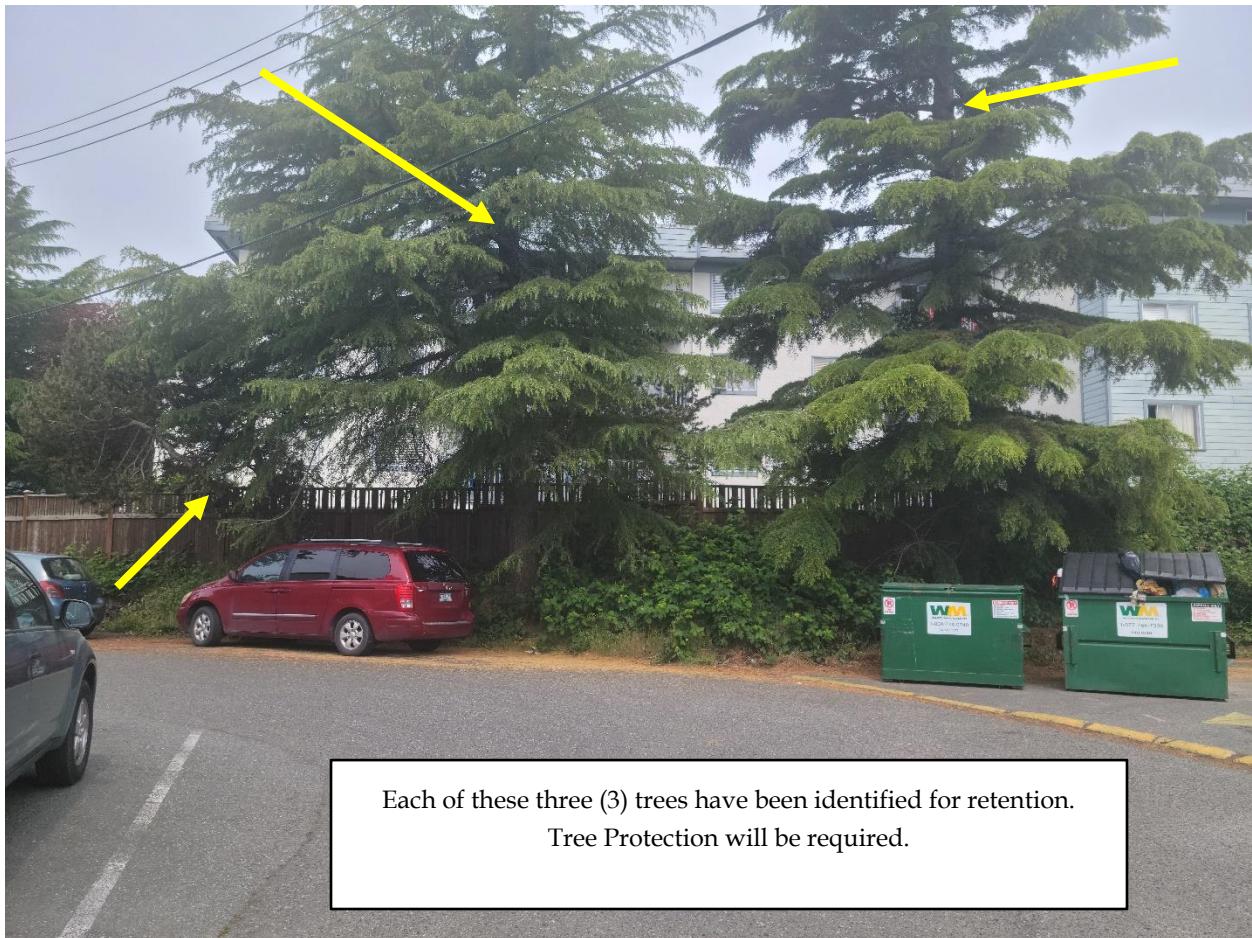
Photo #6 – NT8 – NT10

- Trees NT8 -NT10 may be impacted due to landscaping and proposed grade improvements.
- Tree NTM4 ginkgo has been identified for retention. Tree well to be “Boxed” in to provide stem protection due to its proximity to the sidewalk right-of-way.

- The Project Arborist shall provide excavation monitoring and assessment within Bylaw Protected Tree PRZ's. (NT6, NT7 & NT8 - NT10) Please confirm and schedule appropriately with the Project Arborist. NT7 maple appears to straddle the property line across from the site - limited impacts may occur.

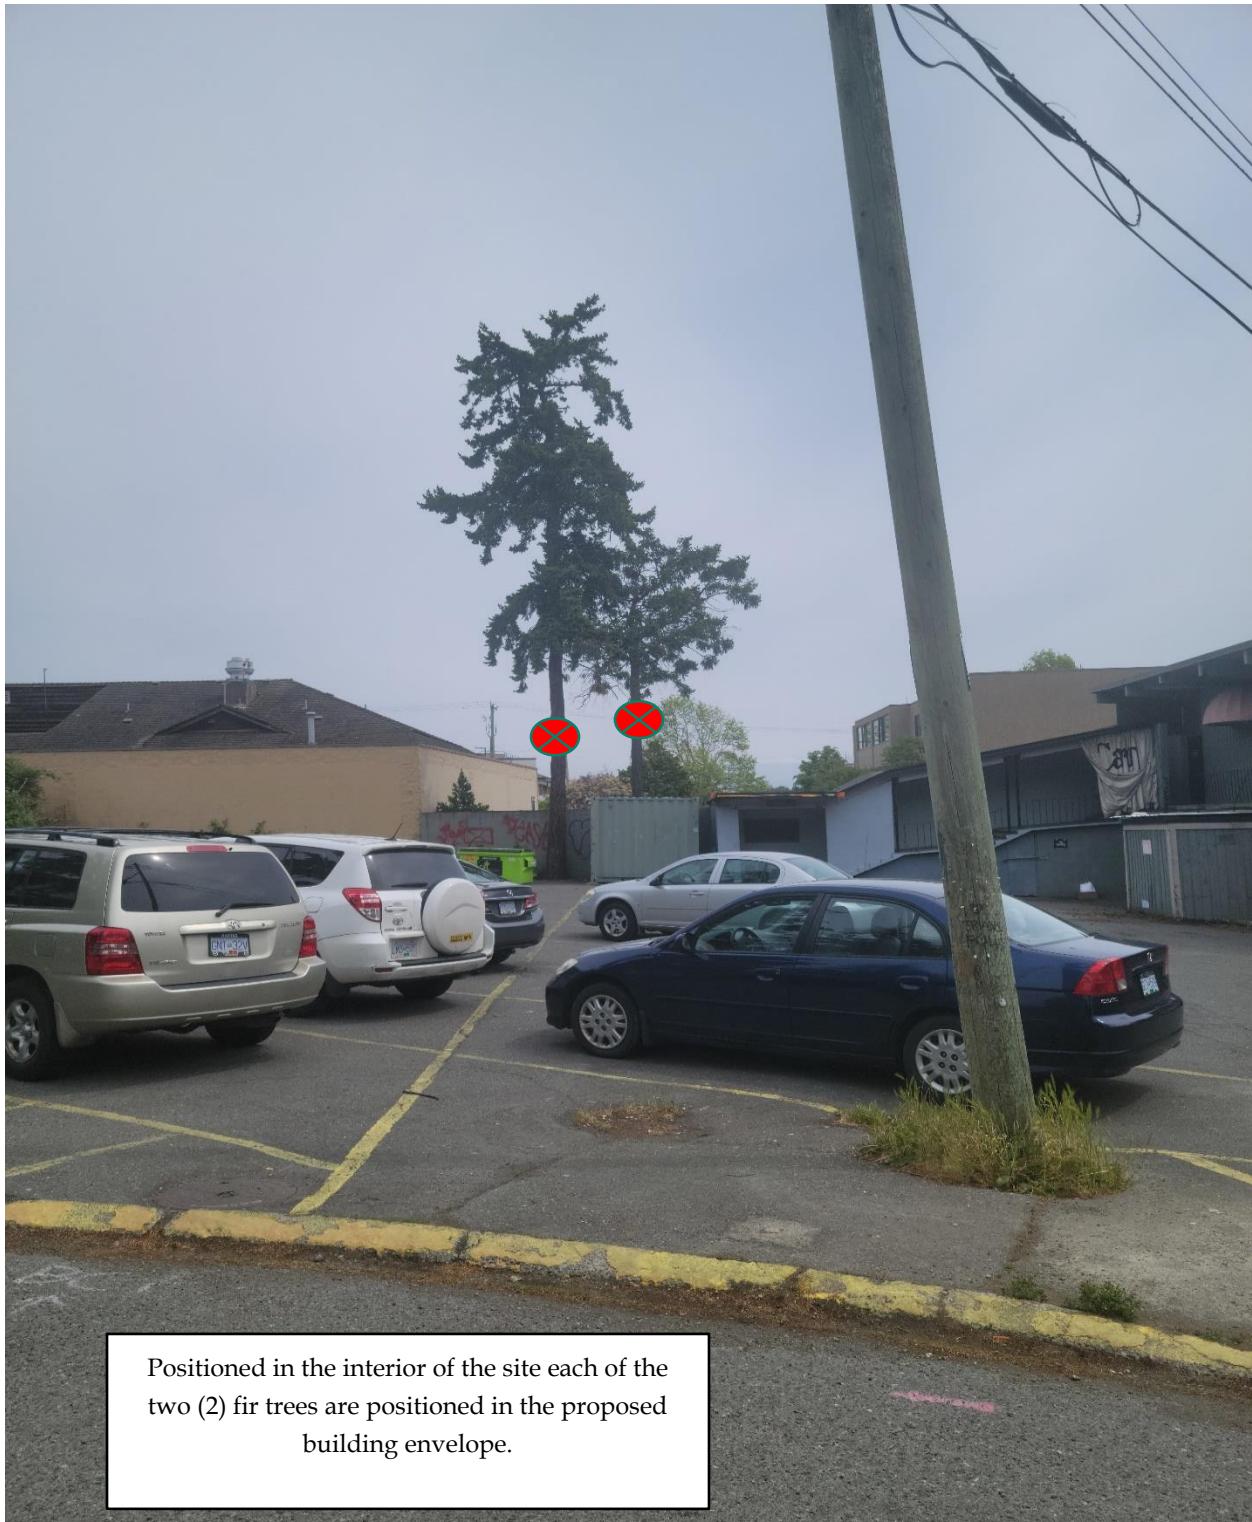
Photo #7 – NT11 & NT12 – Fir Trees

- Trees NT11 & NT12 will be directly impacted and must be removed under the existing proposal.
- The Project Arborist shall confirm TPFing positioning and construction.
