**TALMACK**  
URBAN FORESTRY  
— Consultants Limited —

**1337 Saunders Ave. & 1340 Sussex St.**

**Construction Impact Assessment &  
Tree Management Plan**

DATE OF ORIGINAL ISSUANCE: May 13, 2024

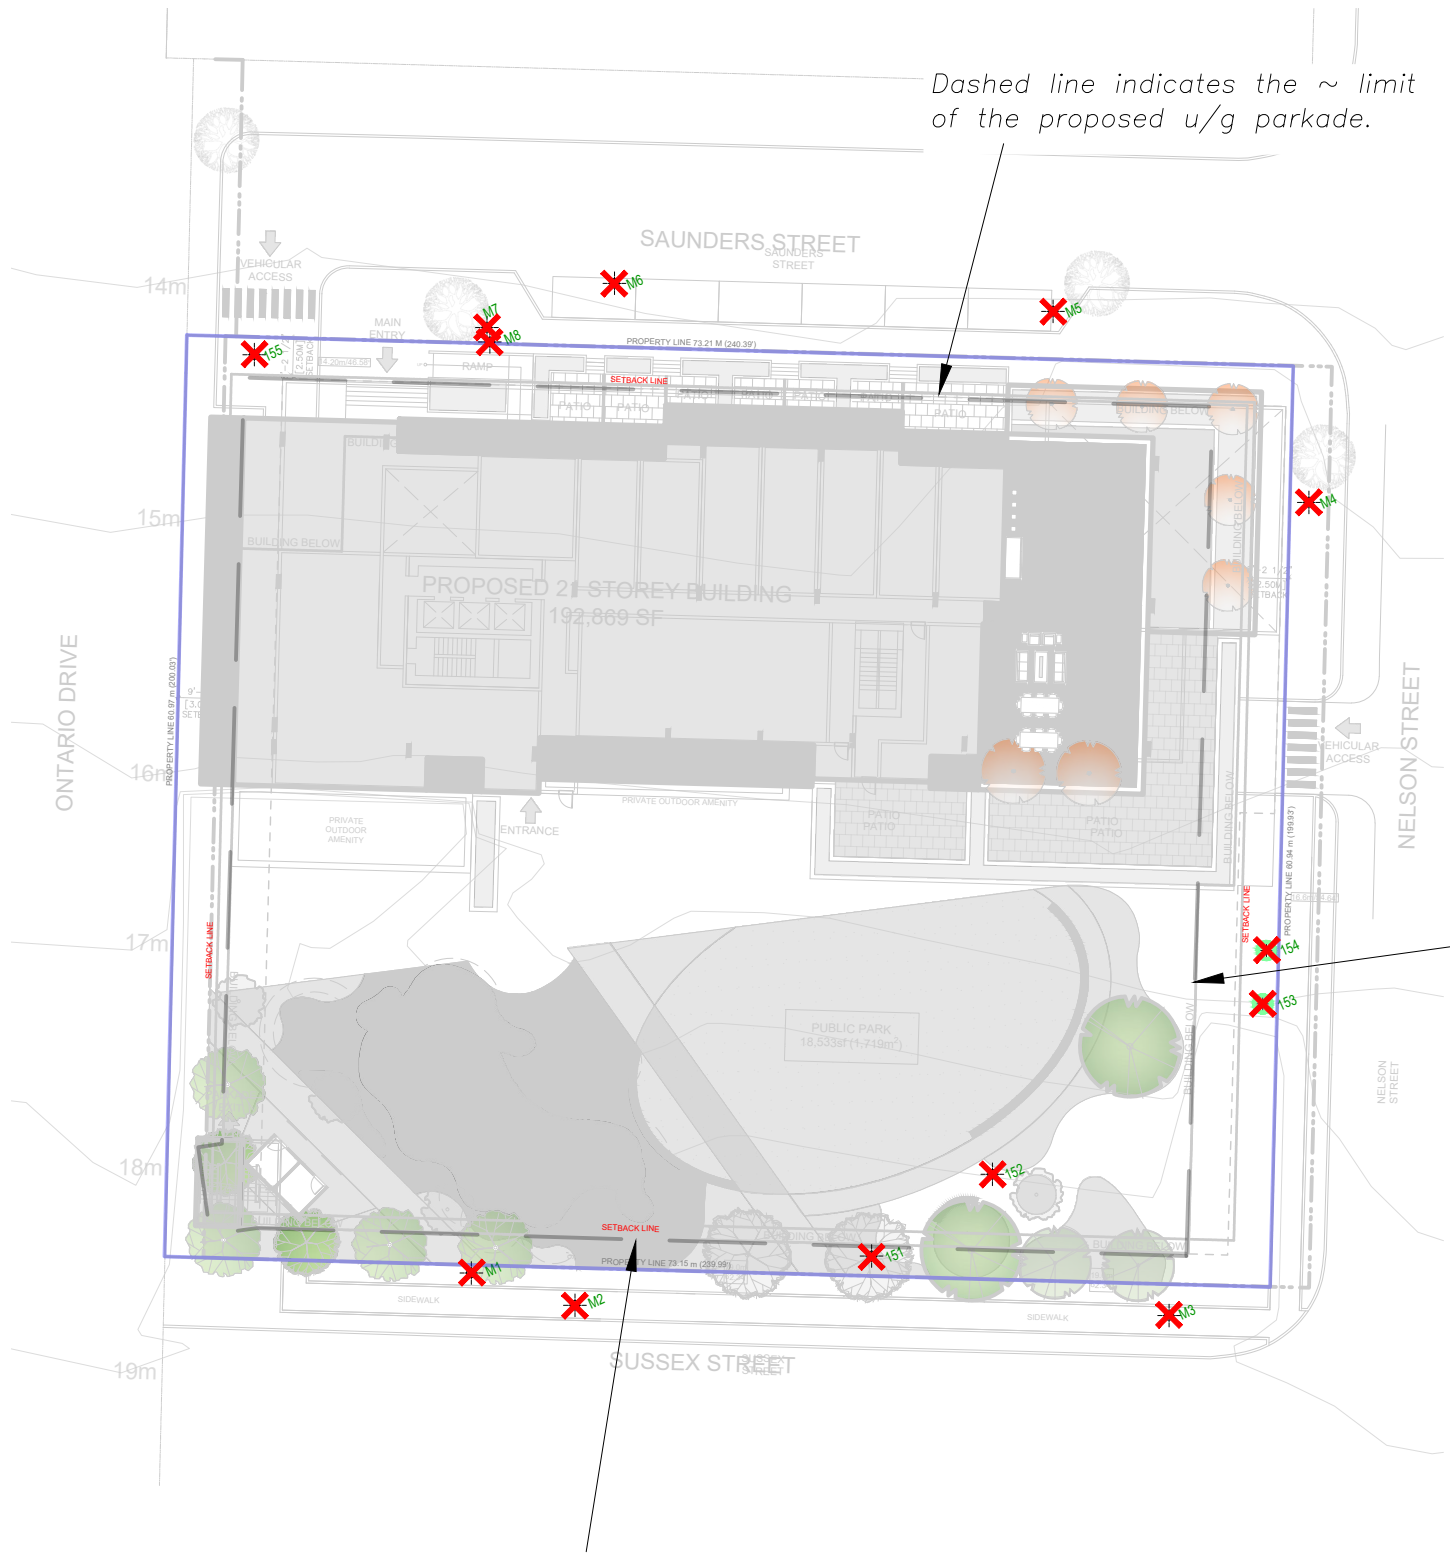
**Tree Management Plan - T1**  
1340 Sussex St. & 1337 Saunders Ave.  
Esquimalt, BC

The following bylaw protected onsite trees (indicated by tag #) are located where they are in conflict with proposed construction and will require removal:

The following municipal trees (indicated by tag #) are located where they are in conflict with proposed construction and will require removal:

**Tree Protection Barrier:** The areas, surrounding the trees to be retained should be isolated from the construction activity by erecting protective barrier fencing (see [Appendix A](#) for municipal barrier specifications). Where possible, the fencing should be erected at the perimeter of the critical root zone. The barrier fencing to be erected must be a minimum of 4 feet in height, of solid frame construction that is attached to wooden or metal posts. A solid board or rail must run between the posts at the top and the bottom of the fencing. This solid frame can then be covered with flexible snow fencing. The fencing must be erected prior to the start of any construction activity on site (i.e. demolition, excavation, construction), and remain in place through completion of the project. Signs should

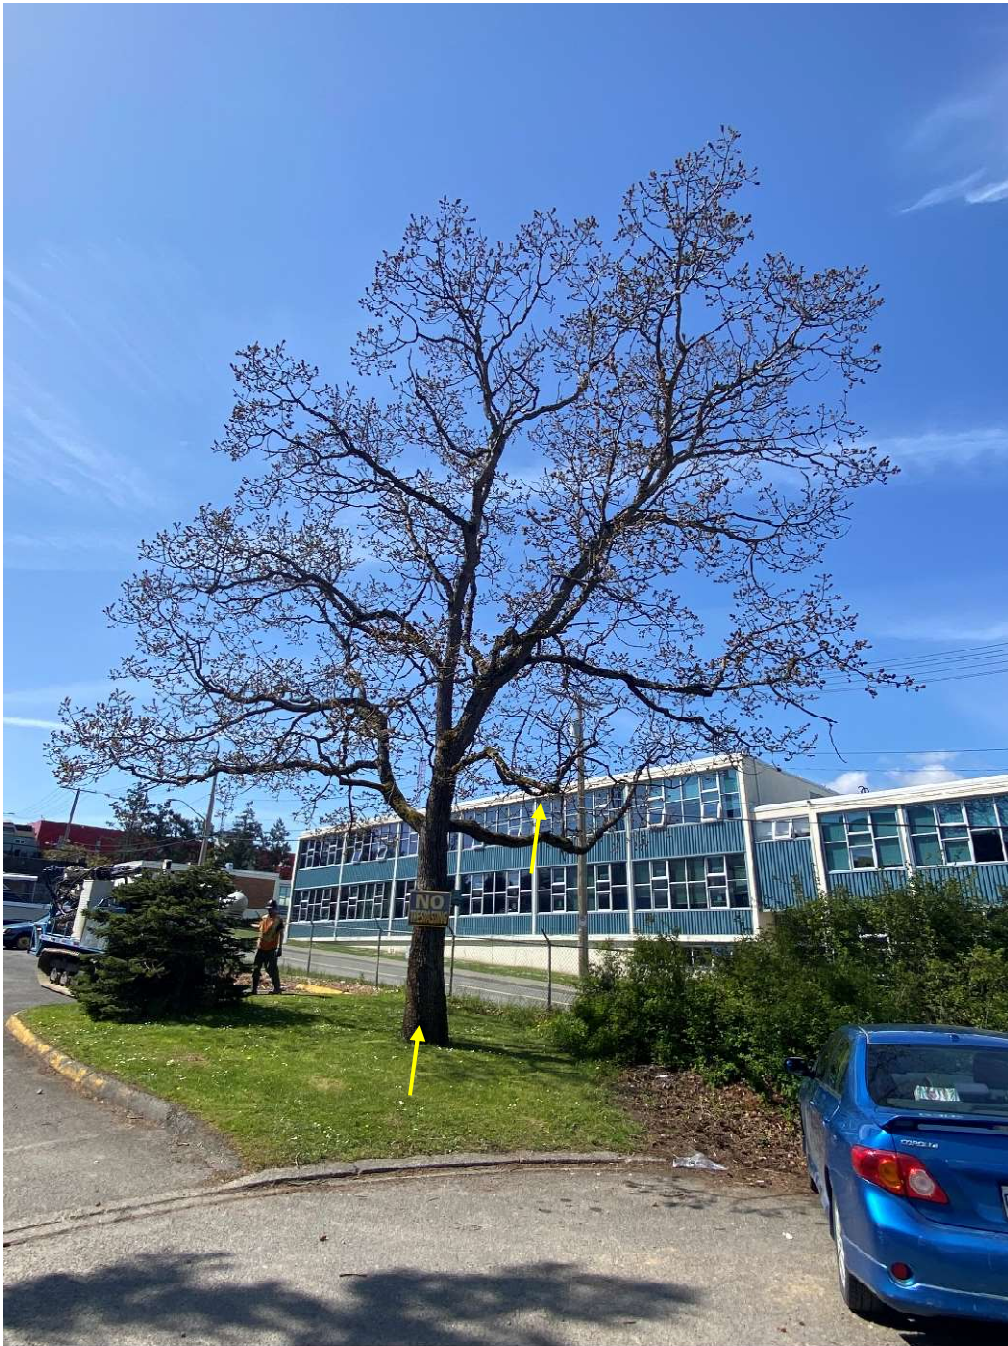
| Tag<br>or ID<br># | Surveyed<br>? (Yes /<br>No) | Location<br>(On, Off,<br>Shared,<br>City) | Bylaw<br>protected<br>? (Yes /<br>No) | Name | | dbh<br>(cm) | Ht<br>(m) | Critical<br>root<br>zone<br>radius<br>(m) | Dripline<br>radius<br>(m) | Condition | | Retention<br>Suitability<br>(onsite<br>trees) | Relative<br>tolerance | Remarks | Tree Retention/Location Comments | Retention<br>status |
|---|---|---|---|---|---|---|---|---|---|---|---|---|---|---|---|---|
| 155 | Yes | On | Yes | Garry oak | <i>Queercus<br/>garryana</i> | 51 | 20 | 5.1 | 7 | Fair/good | Fair/good | suitable | Good | Small deadwood, historic pruning wounds<br>with associated surface decay. | Located within the footprint of the<br>proposed vehicular access. | Remove<br>(3:1) |

*Photograph 1. Yellow arrow indicates Garry oak (tag# 155).*

- 151, 152, 153, 154, 155.

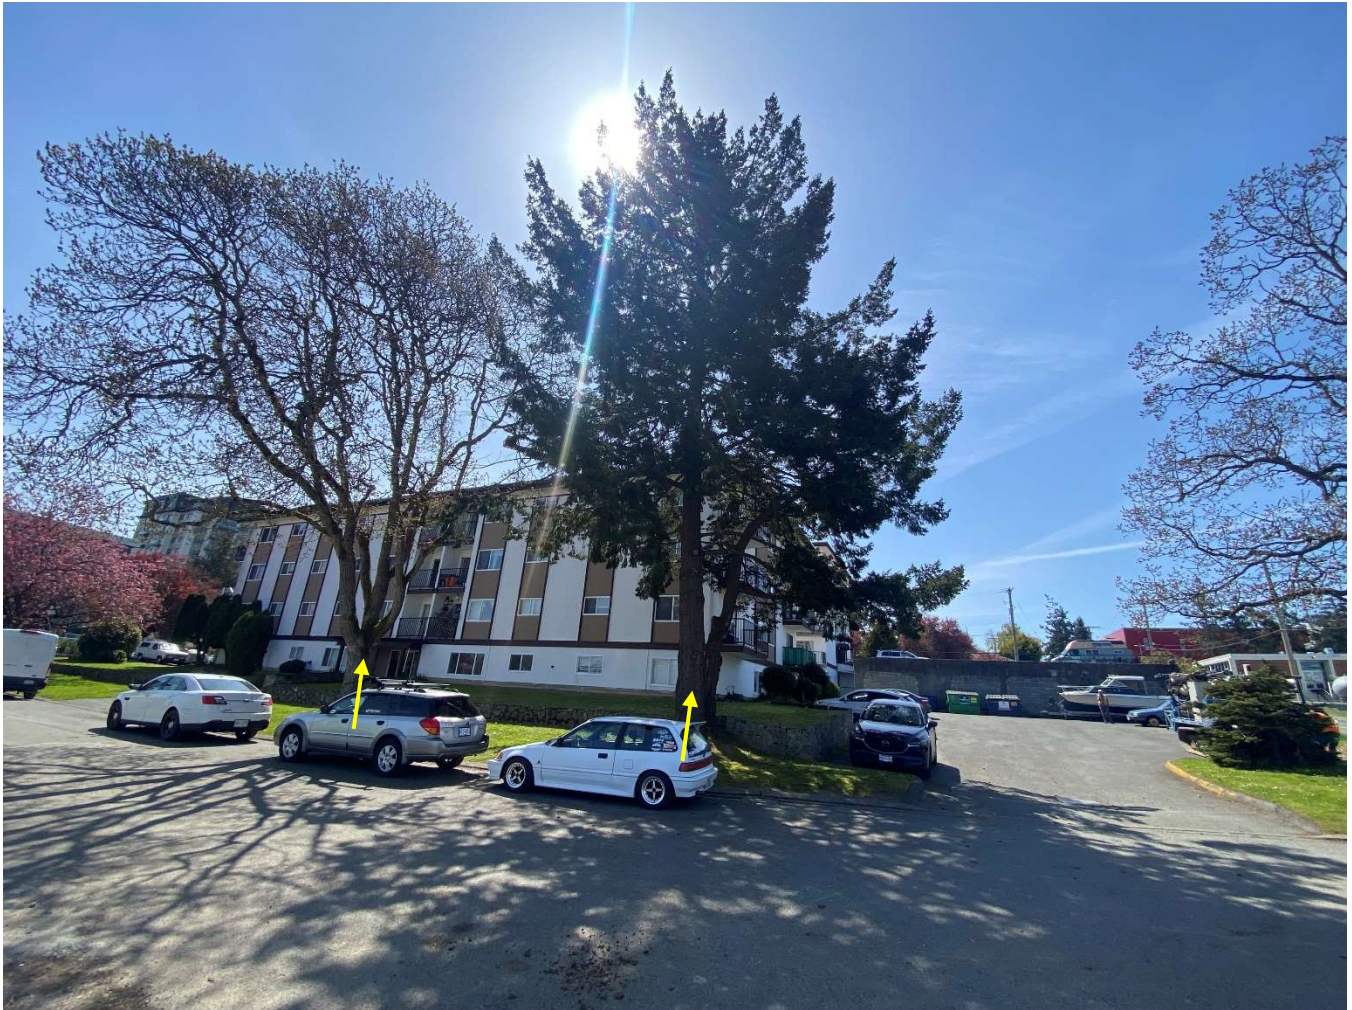
| Tag<br>or ID<br># | Surveyed<br>? (Yes /<br>No) | Location<br>(On, Off,<br>Shared,<br>City) | Bylaw<br>protected<br>? (Yes /<br>No) | Name | | dbh<br>(cm) | Ht<br>(m) | Critical<br>root<br>zone<br>radius<br>(m) | Dripline<br>radius<br>(m) | Condition | | Retention<br>Suitability<br>(onsite<br>trees) | Relative<br>tolerance | Remarks | Tree Retention/Location Comments | Retention<br>status |
|---|---|---|---|---|---|---|---|---|---|---|---|---|---|---|---|---|
| M6 | Yes | City | Yes | Garry oak | <i>Queercus<br/>garryana</i> | 59 | 15 | 5.9 | 6 | Good | Fair | | Good | Multiple stems form at 3m above grade -<br>no major weakness visible at stem union,<br>asymmetric crown on West side due to<br>shading. | Located within the footprint of the prosed<br>road realignment. | Remove |
| M7 | Yes | City | Yes | Douglas-fir | <i>Pseudotsuga<br/>menziesii</i> | 70 | 25 | 8.4 | 7 | Good | Fair | | Moderate | Heavily surface rooted. | Will be heavily impacted by excavation<br>required to construct the foundation of<br>the proposed u/g parkade. | Remove |
| M8 | Yes | City | Yes | Douglas-fir | <i>Pseudotsuga<br/>menziesii</i> | 49 | 10 | 5.9 | 4 | Fair | Fair/poor | | Moderate | Suppressed by M7 - stunted growth form,<br><i>phaeolus schweinitzii</i> fruiting body<br>attached to root collar, growing within<br>close proximity to existing retaining wall. | Will be heavily impacted by excavation<br>required to construct the foundation of<br>the proposed u/g parkade. | Remove |

*Photograph 2. Yellow arrows indicate Garry oak (M6 - left) and (M7 & M8 – right).*

- M1, M2, M3, M4, M5, M6, M7, M8.

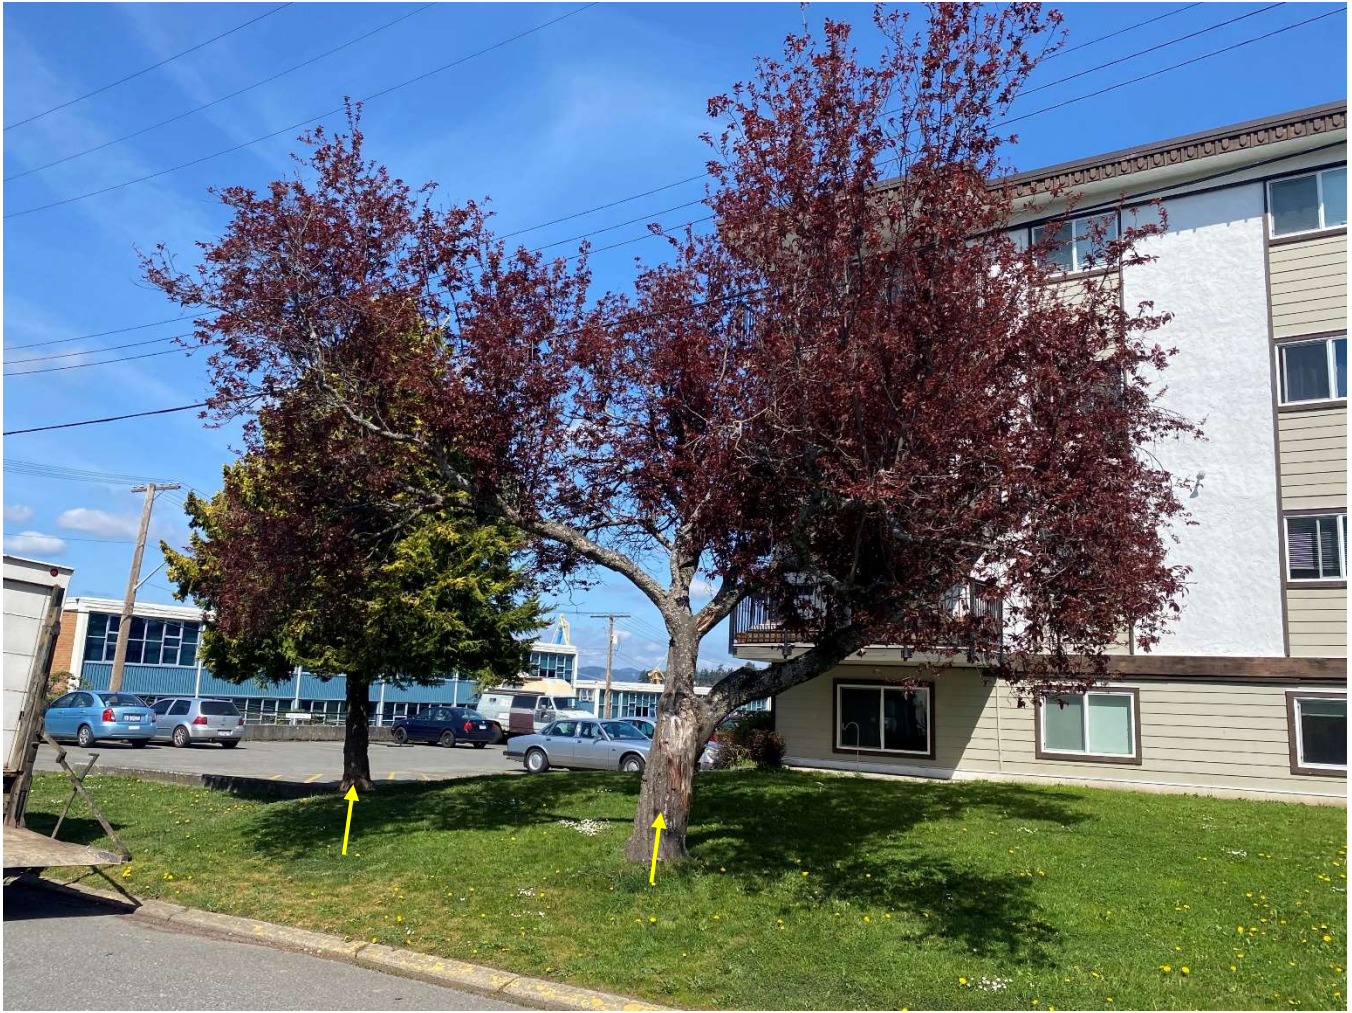
| Tag<br>or ID<br># | Surveyed<br>? (Yes /<br>No) | Location<br>(On, Off,<br>Shared,<br>City) | Bylaw<br>protected<br>? (Yes /<br>No) | Name | | dbh<br>(cm) | Ht<br>(m) | Critical<br>root<br>zone<br>radius<br>(m) | Dripline<br>radius<br>(m) | Condition | | Retention<br>Suitability<br>(onsite<br>trees) | Relative<br>tolerance | Remarks | Tree Retention/Location Comments | Retention<br>status |
|---|---|---|---|---|---|---|---|---|---|---|---|---|---|---|---|---|
| M1 | Yes | City | Yes | Lawson<br>cypress | <i>Chamaecyparis<br/>lawsoniana</i> | 30 | 10 | 3.6 | 3 | Good | Fair/good | | Moderate | Located within close proximity to existing<br>overhead utility lines. | Will be heavily impacted by excavation<br>required to construct the foundation of<br>the proposed u/g parkade. | Remove |
| M2 | Yes | City | Yes | Cherry<br>plum | <i>Prunus<br/>cerasifera</i> | 47 | 10 | 5.6 | 4 | Fair | Poor | | Moderate | Large stem tore out historically on South<br>side of trunk. <i>Ganoderma applanatum</i><br>fruiting body attached to trunk. | Will be heavily impacted by excavation<br>required to construct the foundation of<br>the proposed u/g parkade. Also located<br>within the footprint of the proposed<br>municipal sidewalk. | Remove |

*Photograph 3. Yellow arrows indicate Lawson cypress (M1 – left) and cherry plum (M2).*
