TALMACK
URBAN FORESTRY
— Consultants Limited —

914 MCNAUGHTON AVENUE—
ESQUIMALT, BC
CONSTRUCTION IMPACT ASSESSMENT &
TREE MANAGEMENT PLAN

DATE OF ISSUANCE: May 19, 2023

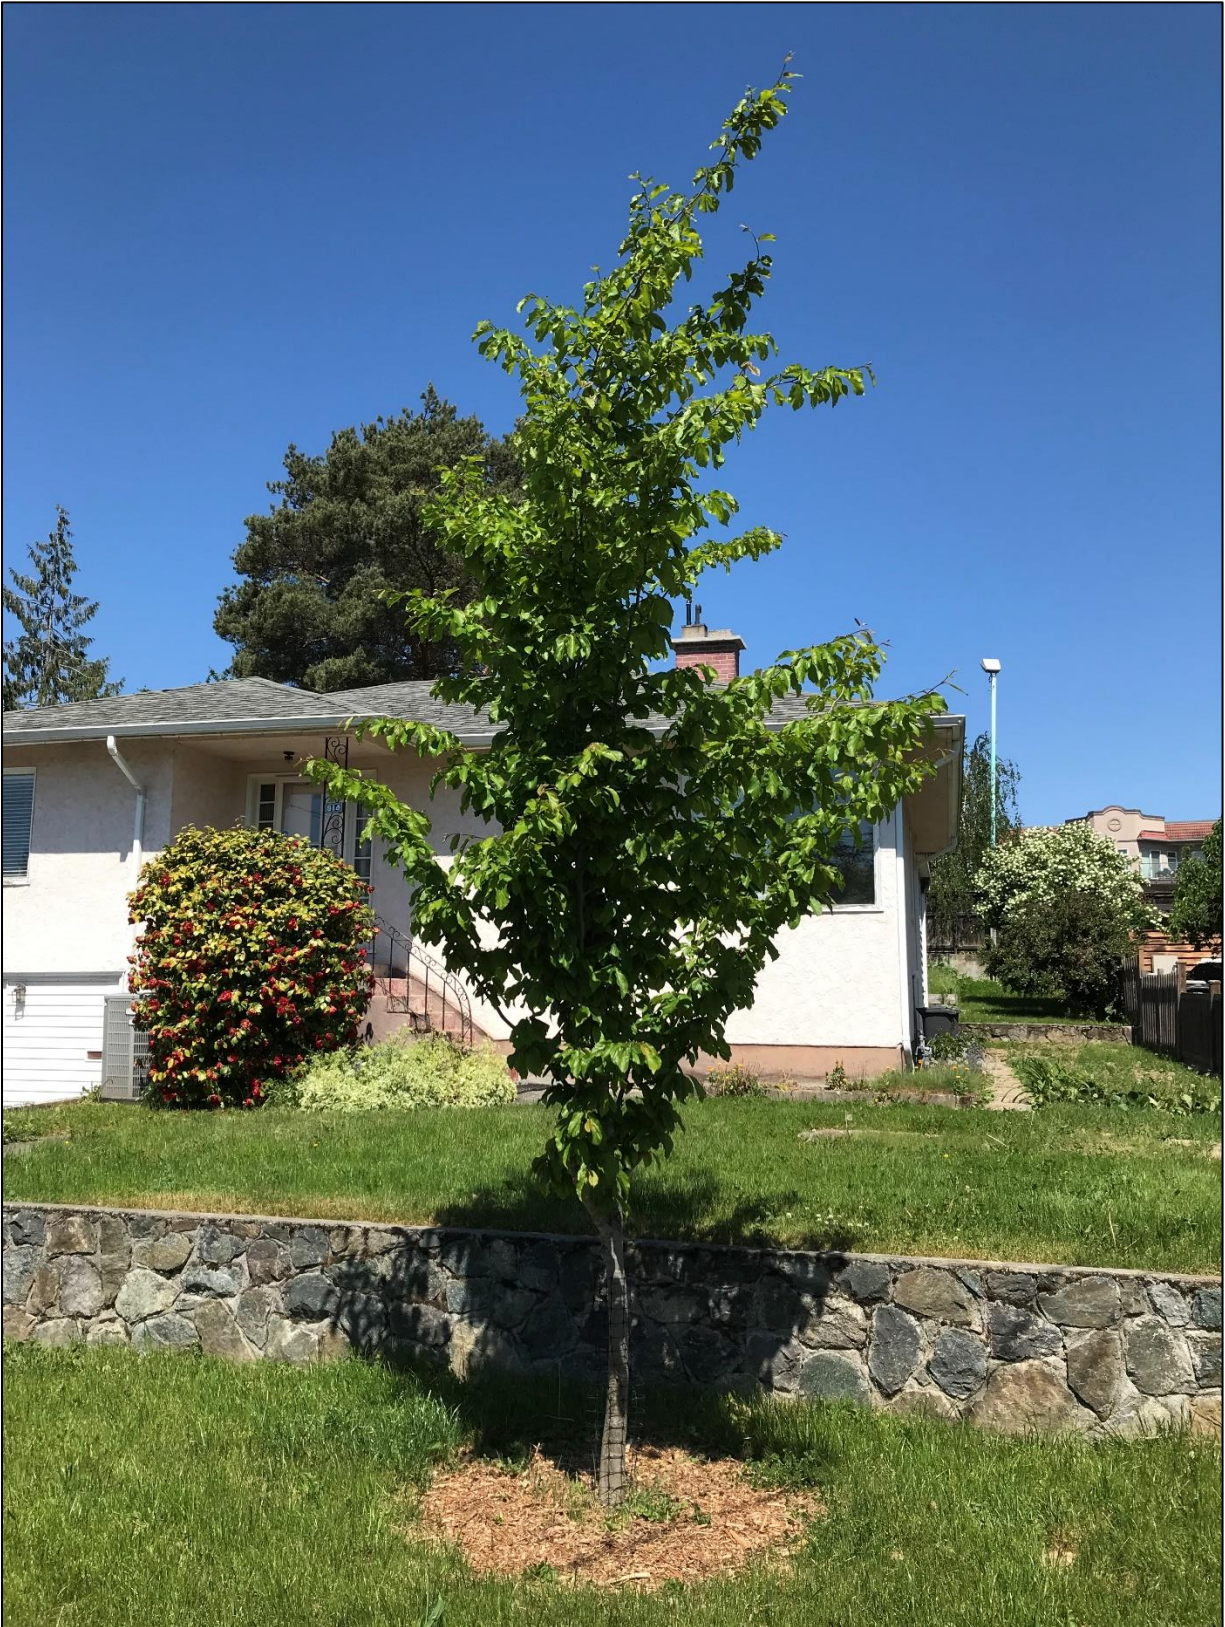
Photograph 1: *Municipal Persian Ironwood within footprint of proposed driveway. Potential candidate for transplanting.*

If desired by municipal authorities, this young and healthy tree could be transplanted into an alternate location on the boulevard fronting the subject property. This will depend on final locations of storm drain (SD), sanitary sewer (SS), water service, and gas service (if required). If possible, services should be routed below the proposed driveways, resulting in three (3) available planting locations (meeting CLS standards for small-large class trees) to the east and west of these crossings and/or between them.

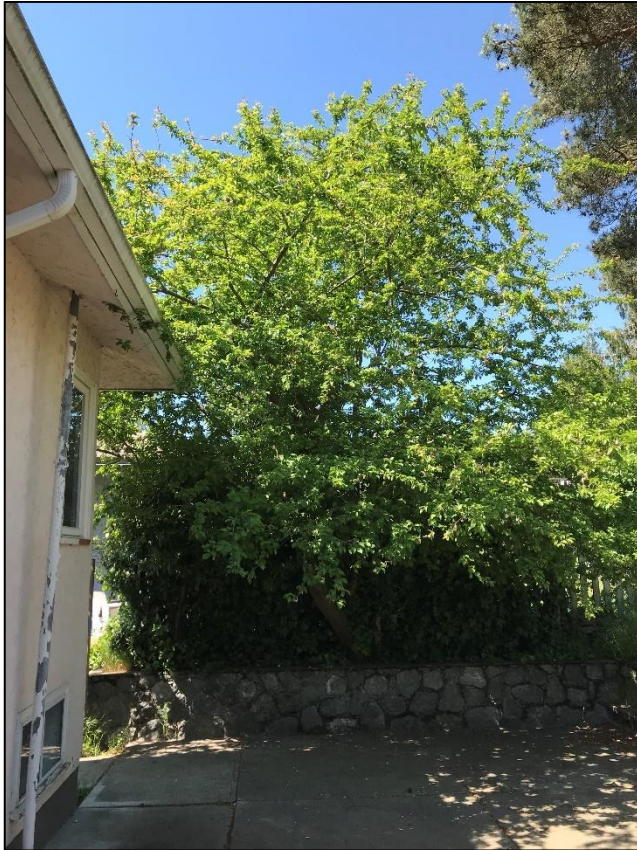
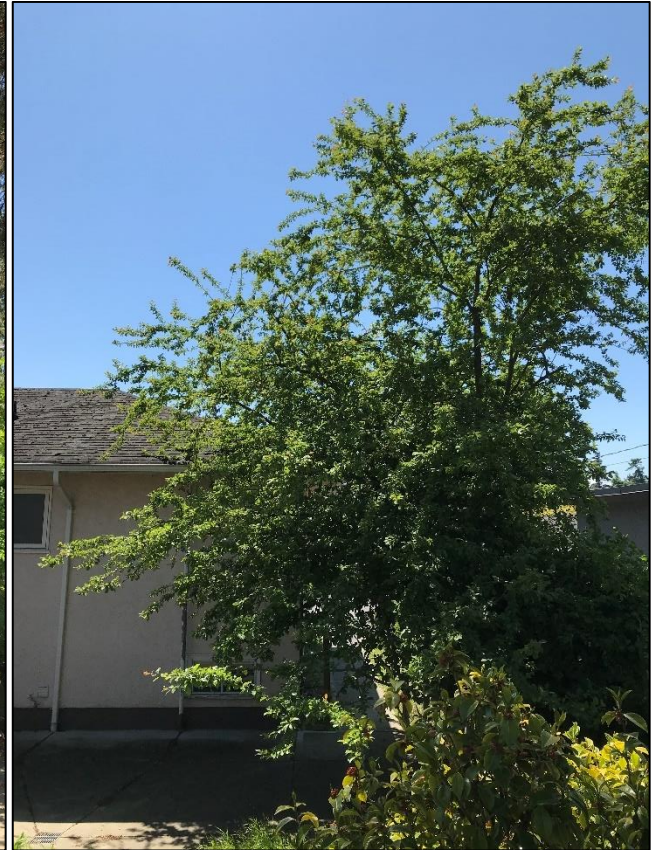
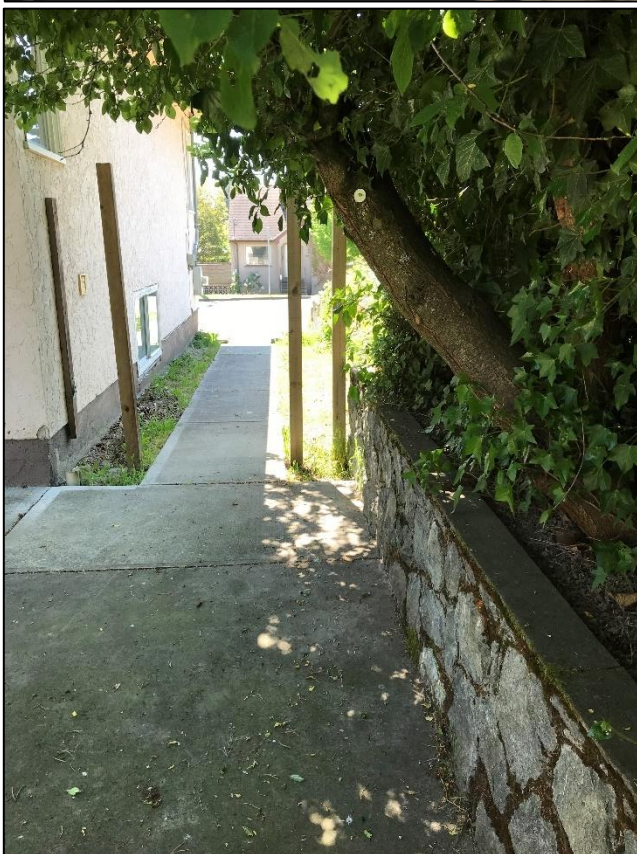
Photographs 2-4: Canopy of Plum #698 overhanging existing house (above); rooted next to existing retaining wall (lower left).

- We recommend **Plum (*Prunus spp.*) #698** be removed prior to the demolition phase, as it is likely to be severely impacted by the removal of the existing retaining wall.

If #698 must be retained during the demolition phase, we recommend hard surfaces and retaining walls be left in place until the building permit stage—these will provide effective root armoring when house moving equipment is staged. In this scenario, protective barrier fencing shall also be installed to the edge of the existing retaining walls.

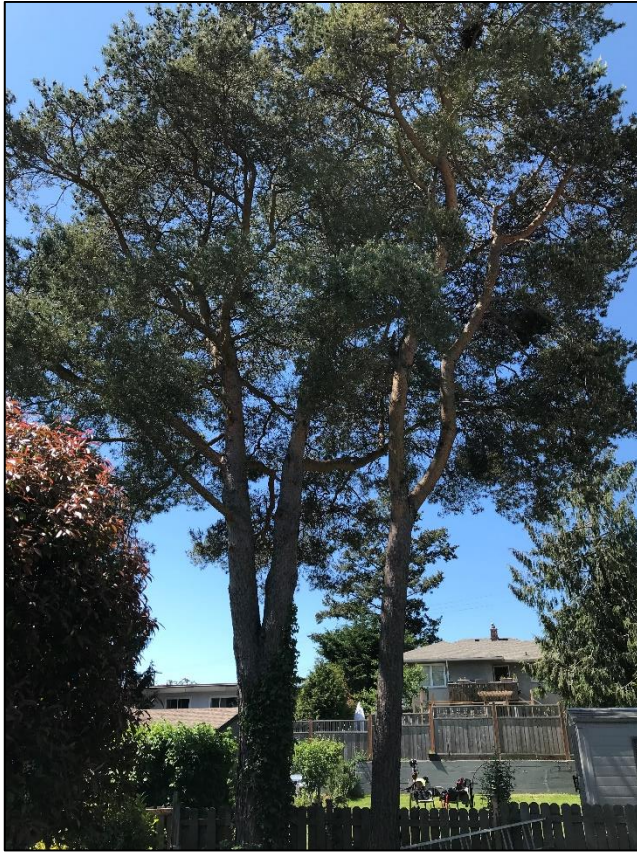
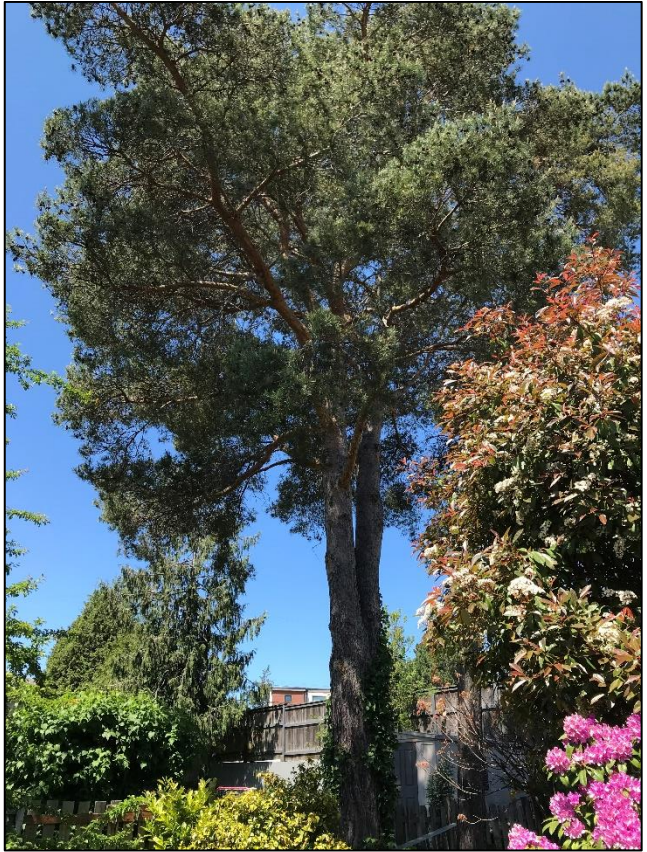
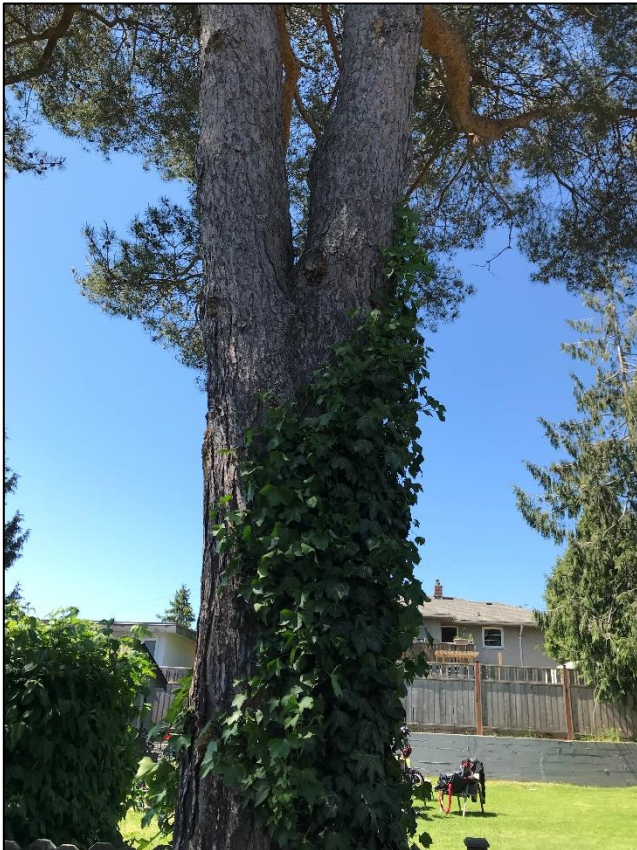
Photographs 5-7: Scots Pines #699 & 700—to be retained (upper left). Codominant structure of #699 (upper right) with active inclusion (lower left); tree recommended for cable bracing.

- The project arborist should be contacted to supervise the removal of the existing retaining wall within the CRZ of **Scots Pines (*Pinus sylvestris*) #699 & 700**, and be on-site during the installation of the proposed building foundation, patios, stairs, or deck footings (where these excavations encroach within the CRZs). Given that these installations encroach on a small percentage of the CRZs, we do not anticipate significant health impacts to ensue concerning either tree.

Codominant structure with active inclusion in the attachment was observed in #699. As a proactive measure, cable bracing should be considered to reduce the risk associated with large limb failure (considering the proposed introduction of new targets in the area). This work should be completed by an ISA Certified Arborist to ANSI standards.

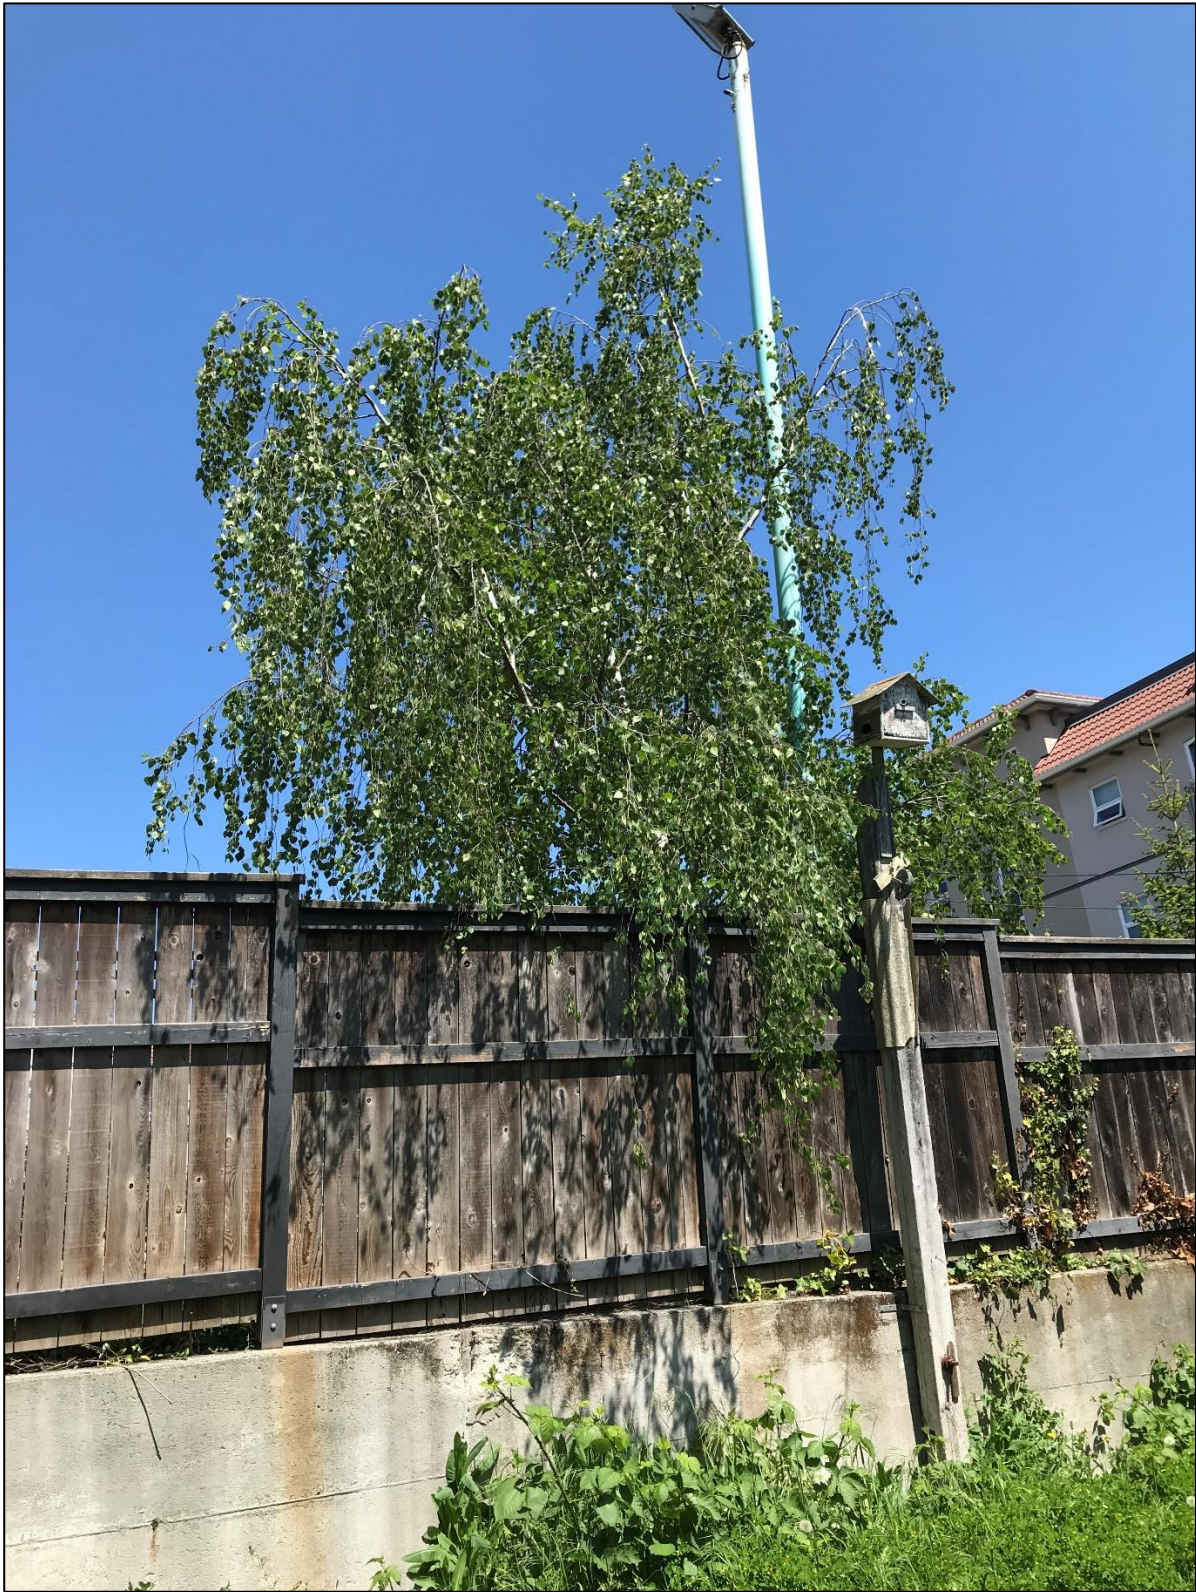
Photograph 6: *European Birch OS1 (recommended for removal).*

- OS1 will likely require removal due to installation of underground services within the proposed 3m wide easement along the east property boundary of 914 McNaughton Avenue. Removal of any trees on neighbouring properties requires prior written authorization from the tree owners—it is our understanding that the adjacent property to the north is owned by the client (Abstract Developments).
