## Arborist Report for Development Re: Demolition and Construction

Site Location:  
445 Grafton Street, Victoria BC  
Darryl Clark  
ISA Certified Arborist- PN 6523A TRAQ  
December 11, 2025  
Revised April 22, 2026  
Revised July 13, 2026

MAC Reno-Design-Build has retained D. Clark Arboriculture to provide comments on trees on-site, off-site, and municipally owned that may be impacted by the proposed demolition of an existing structure and construction of a new single-family dwelling. A Tree Management Plan is also provided as required by the Township of Esquimalt Bylaw 2022. no 3076.

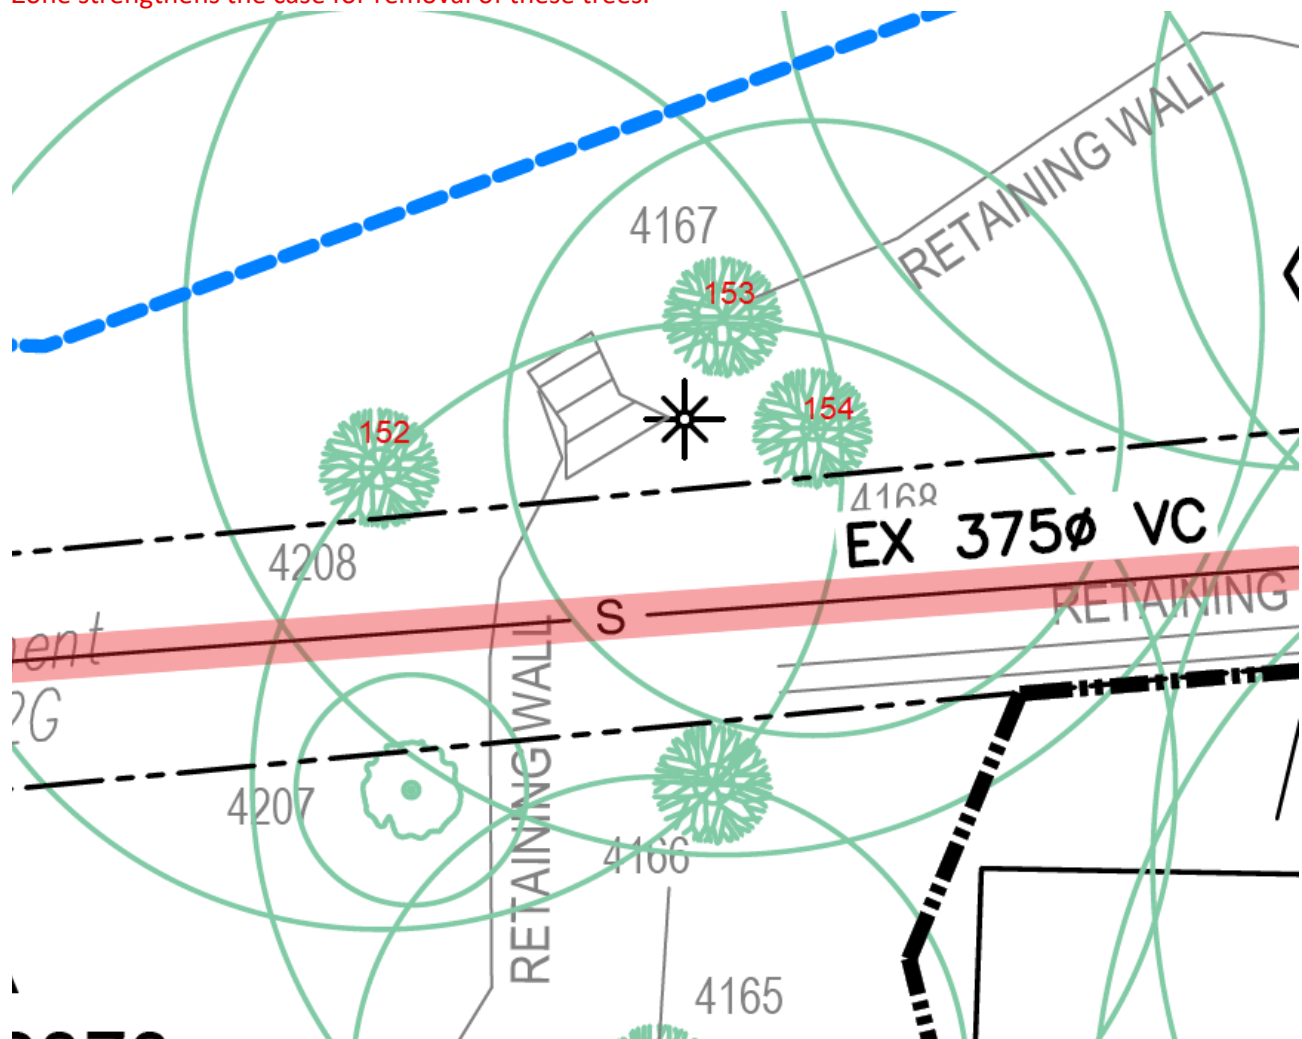
With regards to trees #152, 153, and 154, additional anticipated impacts were considered in their removal. A municipal sewer easement exists on the south side of the property near to the trees. This existing clay tile sewer line is beyond its expected lifespan and overdue for renewal. Esquimalt

engineering has indicated that it will be in use until failure, at which point it will be considered for replacement/renewal. Due to the pipe material and condition, it is unlikely that the pipe would simply be repaired. Because the pipe services multiple properties it is also unlikely to be abandoned. Whether the issues with this pipe and its known condition are addressed during this project, or sometime after, it is understood that the impact of that work would also require the removal of these trees due to root and available soil volume conflicts. Even if the pipe were to be abandoned, the next option for the house services is understood to be westerly towards Grafton, and considering the water line in this area already affects these trees unfavorably, adding sewer and storm laterals further into the Protected Root Zone strengthens the case for removal of these trees.

Figure 2. Detail from civil submission showing municipal sewer (highlighted in red), easement boundaries (black dashed lines parallel to sewer) and trees #152, 153, and 154 relative to existing sewer and proposed water service (blue dashed line).

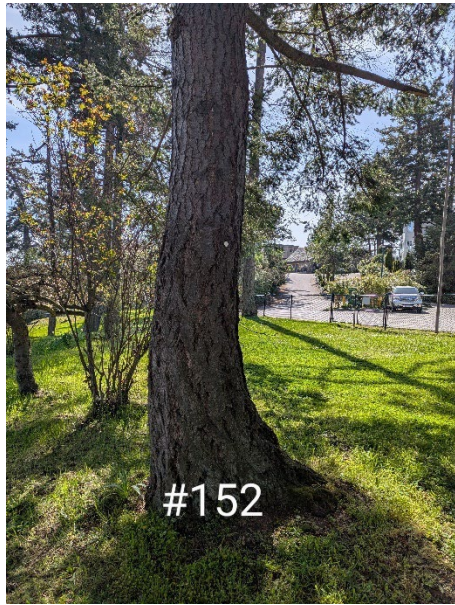
| Summary of Tree removals | | | | |
|---|---|---|---|---|
| 152 | <i>Pseudotsuga menziesii</i> | 60 | 7 | Tree is within the area of a new water lateral. Anticipated depth will significantly impact the PRZ of this tree. Additionally, grade changes on the north side ~ 1m deep will severely impact the PRZ. |

| 445 Grafton Street Tree Inventory | | | | | | | | | | |
|---|---|---|---|---|---|---|---|---|---|---|
| 152 | <i>Pseudotsuga menziesii</i> | 60 | 25 | 13 | 7 | Fair | Fair | Yes | Remove | Refer to summary table |

Figure 3 – tree #152 facing South

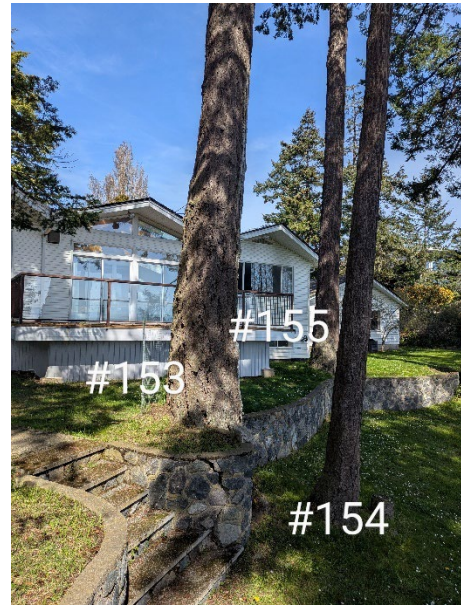
| Summary of Tree removals | | | | |
|---|---|---|---|---|
| 153 | <i>Pseudotsuga menziesii</i> | 90 | 11 | Tree is within the area of a new water lateral. Anticipated depth will significantly impact the PRZ of this tree. Additionally, grade changes on the north side ~ 1m deep will severely impact the PRZ. |
| 154 | <i>Pseudotsuga menziesii</i> | 36 | 4 | Grade changes, and the removal of two trees and their stumps related to infrastructure improvements will impact the PRZ of this tree. |
| 155 | <i>Pseudotsuga menziesii</i> | 85 | 10 | Tree is within the footprint of the proposed residence, and the location of new water, sewer, and storm laterals. Excavation impacts exceed limits required for retention. |

Figure 4 – Trees #153, #154, and #155, facing northeast with retaining wall in foreground

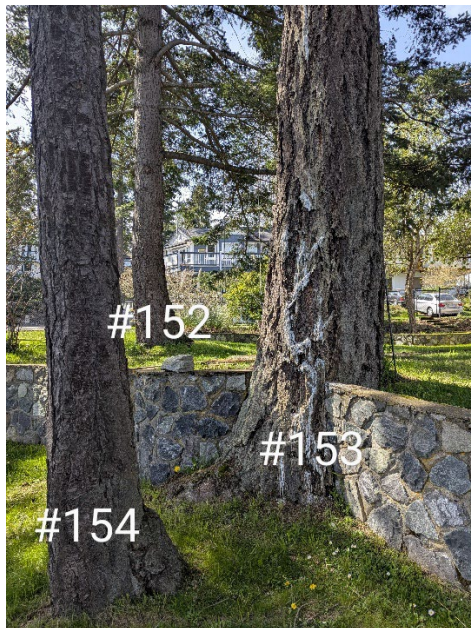
Figure 5 – Trees #152, #153, and #154, facing northwest with retaining wall in foreground

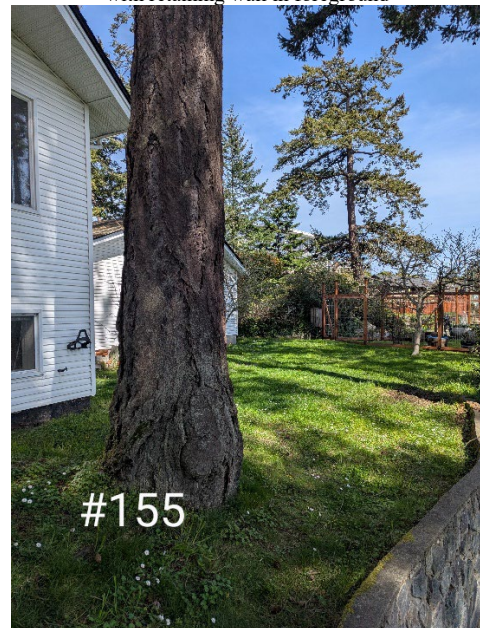
| 445 Grafton Street Tree Inventory | | | | | | | | | | |
|---|---|---|---|---|---|---|---|---|---|---|
| 155 | <i>Pseudotsuga menziesii</i> | 85 | 25 | 19 | 10 | Fair | Fair | Yes | Remove | Refer to summary table |

Figure 6 – Tree #155 facing northeast

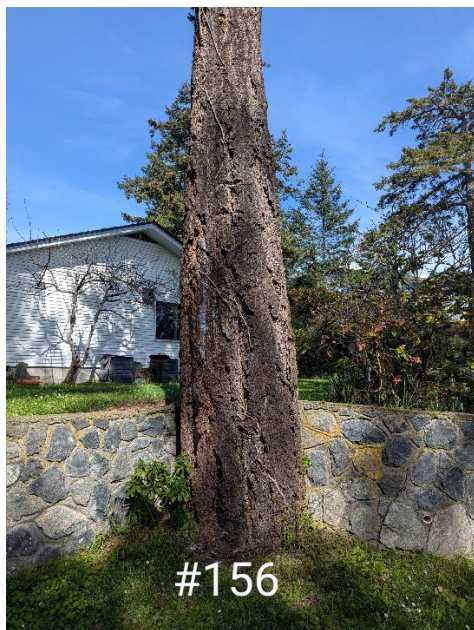
| Summary of Tree removals | | | | |
|---|---|---|---|---|
| 156 | <i>Pseudotsuga menziesii</i> | 77 | 9 | Tree is within the footprint of the proposed residence, and the location of new sewer and storm laterals. Excavation impacts exceed limits required for retention. |

| 445 Grafton Street Tree Inventory | | | | | | | | | | |
|---|---|---|---|---|---|---|---|---|---|---|
| 156 | <i>Pseudotsuga menziesii</i> | 77 | 18 | 12 | 9 | Fair | Fair | Yes | Remove | Refer to summary table |

Figure 7 – Tree #156 facing northeast

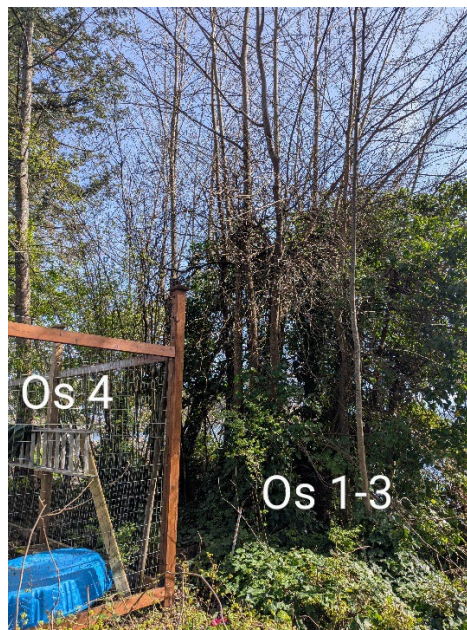
Figure 8 – Trees OS 1, OS 2, OS 3, and OS 4 facing southeast

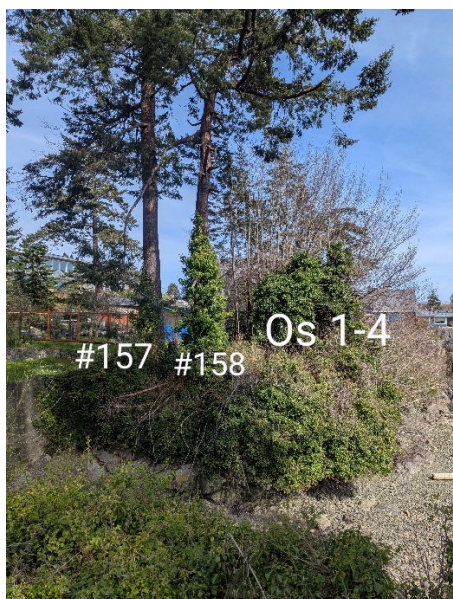
Figure 9 – Trees #157, #158, OS 1, OS 2, OS 3, and OS 4 facing east

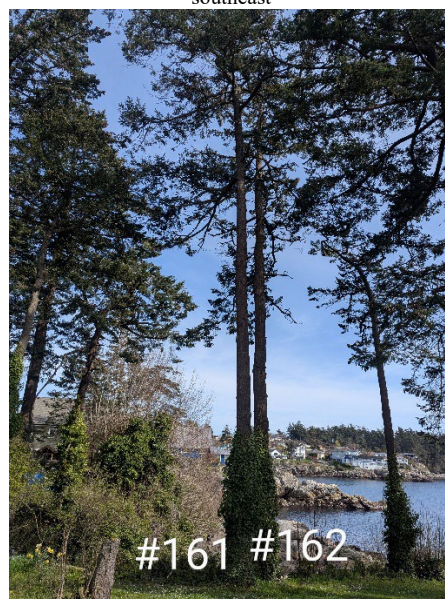
Figure 10 – Tree #161, #162 facing southeast

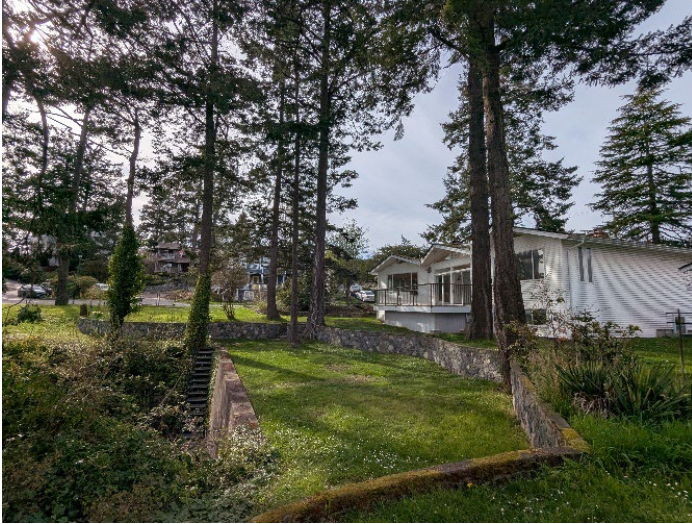
Figure 13 – View of front yard, retaining walls, and existing structure

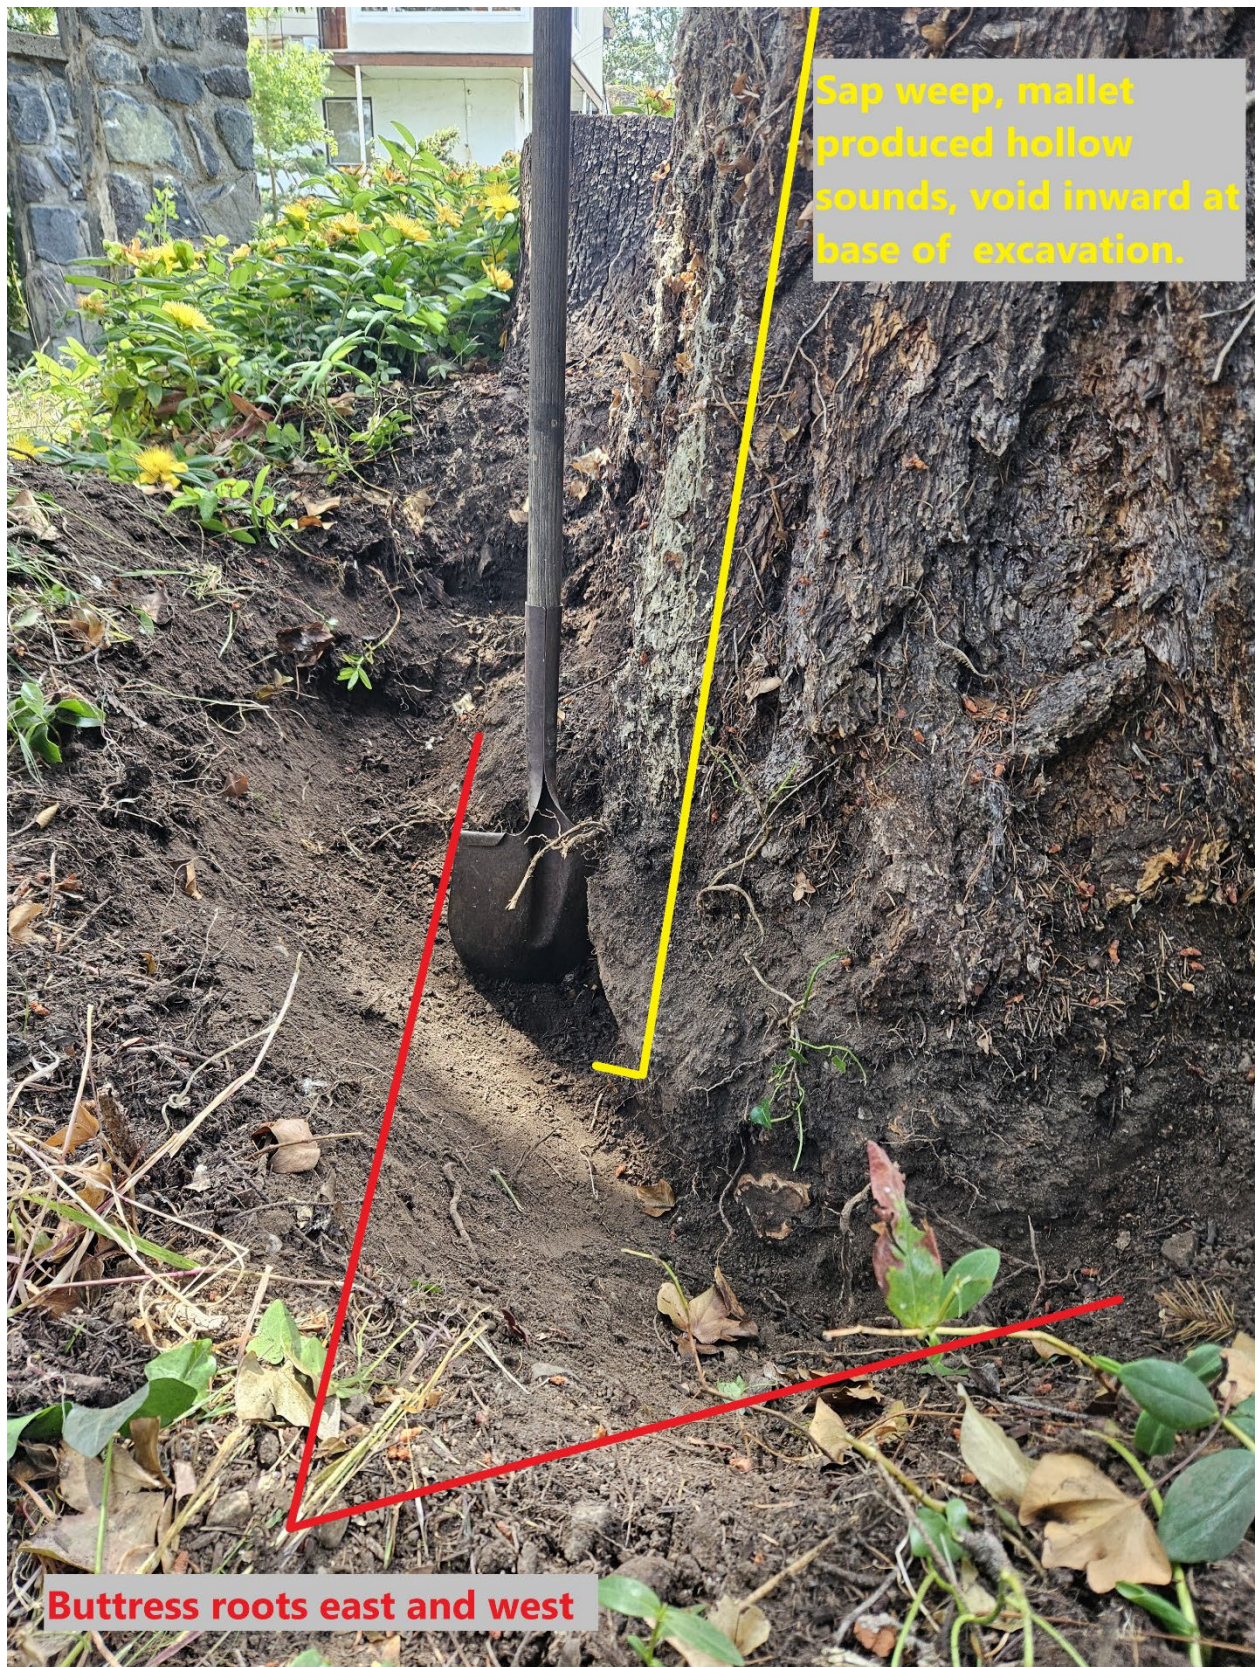
- At a depth of ~45cm no large structural roots were noted on the south side of the tree.
- Buttress roots appear to move easterly and westerly away from the trunk.

- The south side of the tree has evidence of decay/hollow areas.
- No pavements or retaining walls in the immediate area show signs of conflict with the tree.
- Structural root impacts are not expected with the proposed construction.

The south side of the trunk appears flat and there is a significant flow of sap emitting from the bark in this area to a height between 4 and 5m. The bark buckles in places and is separating from the tree. I used a plastic mallet to sound the south side of the trunk to a height of ~2m and found that hollow areas may exist within the trunk of the tree on the south side.

Figure 14 – Tree M1 from the southeast side. Root excavation results.

It is recommended that during either the demolition phase or the excavation for the new building footprint, some further exploration of the area with a machine, under supervision of the project arborist be undertaken to further identify and potentially mitigate any impacts.
