## Arborist Report for Development Re: Demolition and Construction

Site Location:  
445 Grafton Street, Victoria BC

December 11, 2025  
 Attention: Margaret Cormode  
 MAC Island Construction –  
 5285 West Saanich Road  
 Victoria, BC V9E 2E8

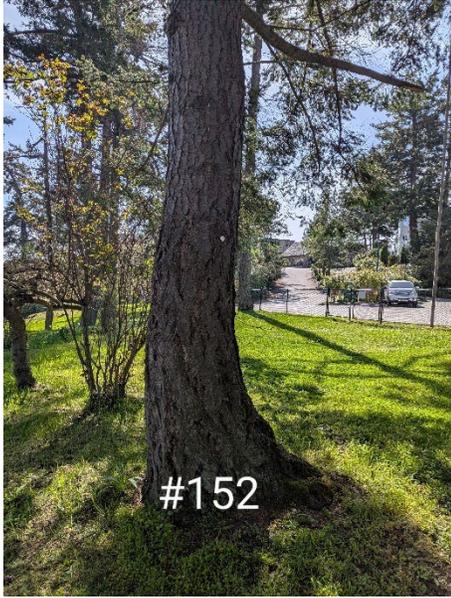
445 Grafton Street Tree Inventory										
#	Species	cm/DBH	Height	Canopy Spread	PRZ/m	Structure	Health	Bylaw Protected	Retain/Remove	Reason for Removal
152	<i>Pseudotsuga menziesii</i>	60	25	13	7	Fair	Fair	Yes	Remove	Grade changes.
153	<i>Pseudotsuga menziesii</i>	90	24	13	11	Fair	Fair	Yes	Remove	Grade changes.
154	<i>Pseudotsuga menziesii</i>	36	16	5	4	Fair	Poor	Yes	Remove	Grade changes.
155	<i>Pseudotsuga menziesii</i>	85	25	19	10	Fair	Fair	Yes	Remove	Grade changes and lot servicing.
156	<i>Pseudotsuga menziesii</i>	77	18	12	9	Fair	Fair	Yes	Remove	Grade changes and lot servicing.
157	<i>Pseudotsuga menziesii</i>	112	30	18	13	Fair	Fair	Yes	Retain	
158	<i>Pseudotsuga menziesii</i>	90	12	8	11	Fair	Poor	Yes	Retain	
159	<i>Pseudotsuga menziesii</i>	78	27	15	9	Fair	Fair	Yes	Retain	
160	<i>Pseudotsuga menziesii</i>	44	10	6	5	Fair	Poor	Yes	Retain	
161	<i>Pseudotsuga menziesii</i>	62	21	7	7	Fair	Poor	Yes	Retain

Figure 3 – tree #152 facing South

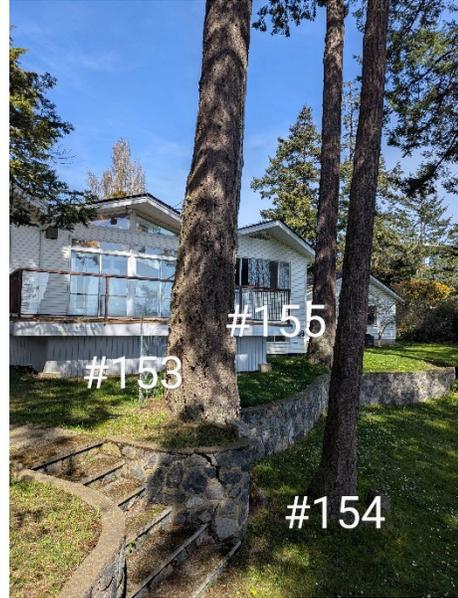
Figure 4 – Trees #153, #154, and #155, facing northeast with retaining wall in foreground

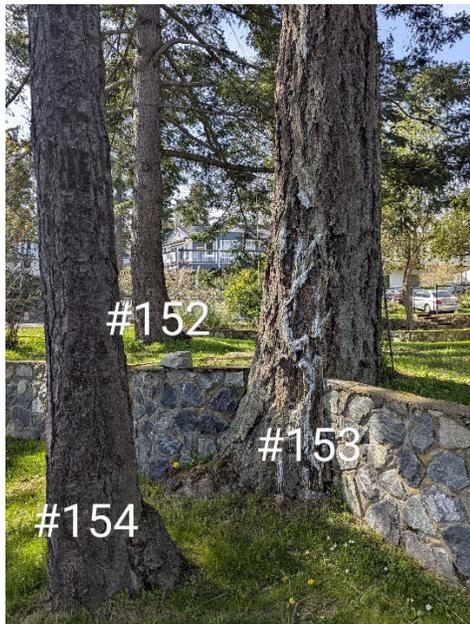
Figure 5 – Trees #152, #153, and #154, facing northwest with retaining wall in foreground

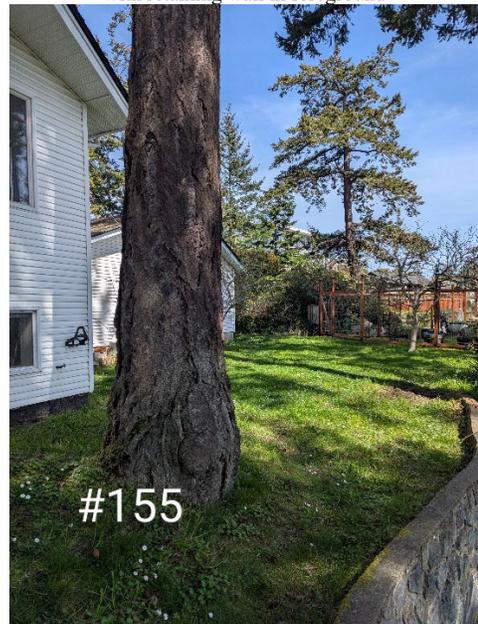
Figure 6 – Tree #155 facing northeast

Excavation for the removal of tree stump #155 and #156 are anticipated to impact (1) on-site tree #157 as tree PRZs are shared. Supervision will be required for the removal of these tree stumps, and the Project Arborist will conduct root pruning if deemed necessary. Additionally, it is anticipated that existing retaining walls will be removed during demolition and some regrading in the area of tree #157 will occur.

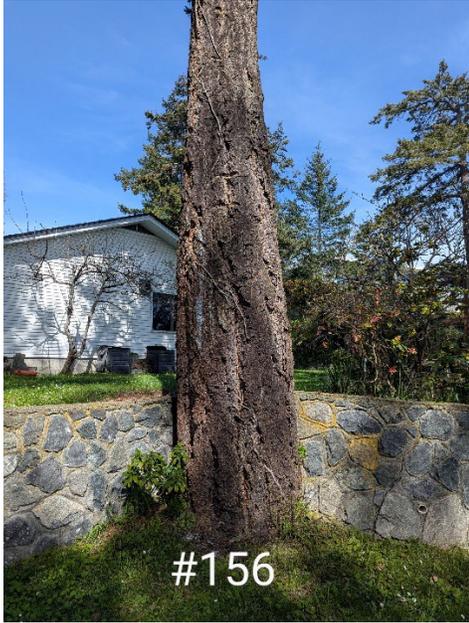
Figure 7 – Tree #156 facing northeast

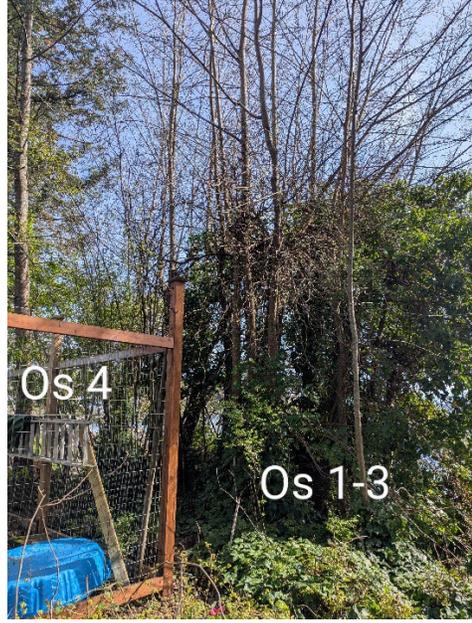
Figure 8 – Trees OS 1, OS 2, OS 3, and OS 4 facing southeast

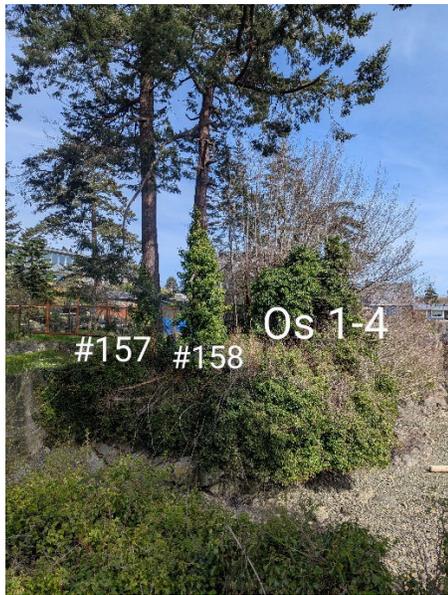
The property at 445 Grafton Street currently features a single-family bungalow-style home. The oceanfront site has multi-terraced topography, with a 1 m high retaining wall separating a semicircular lower lawn area to the south of the house. An additional 3 m high retaining wall separates the lawn from the waterfront and is accessible by a metal staircase at low tide (*Figures 11 & 13*). The western portion of the property extends 79 metres from north to south, culminating at a public right-of-way. The property is landscaped with maintained grass and several mature *Pseudotsuga menziesii* (Douglas-fir). A cluster of municipally-owned trees are in a raised garden bed at the northwest corner of the property within the property fence (*Figure 12*). Other off-site trees are located at the southwestern corner of the property (*Figure 9*).

Figure 9 – Trees #157, #158, OS 1, OS 2, OS 3, and OS 4 facing east

To minimize root damage and soil compaction from occurring, mitigation recommendations include the use of root zone armoring for foot and machinery access that occurs through PRZs of trees that do not have TPZ fencing enclosing the entire extent of their PRZs. All excavation and grading activities in the PRZ of tree #157 will be supervised by the project arborist.

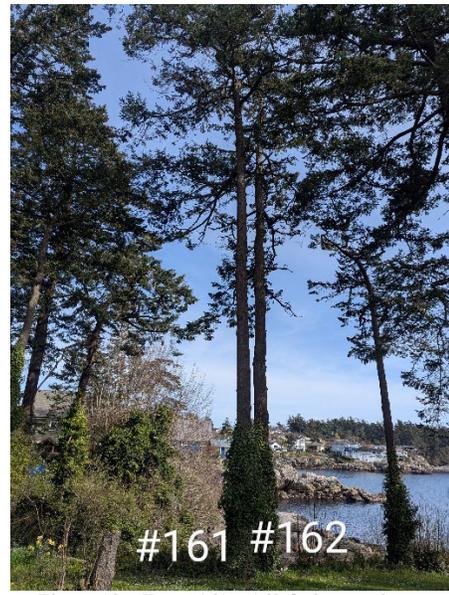
Figure 10 – Tree #161, #162 facing southeast

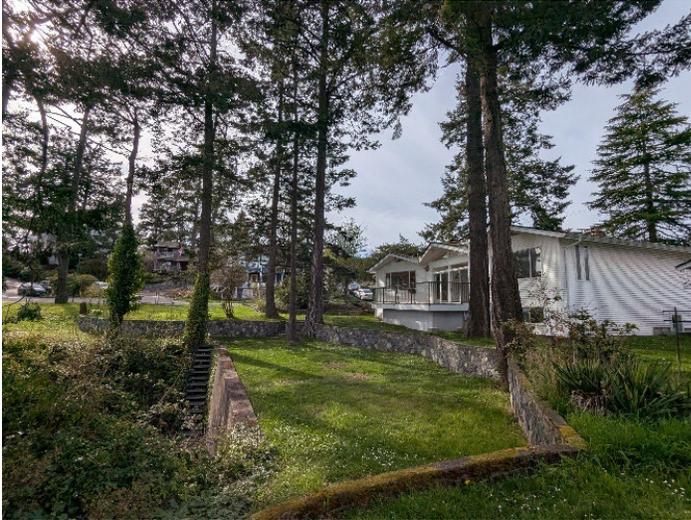
Figure 13 – View of front yard, retaining walls, and existing structure
