Scotty Tree & Arborist Service Ltd.

Tree Assessment and Development Report

Prepared for 1005 Tillicum Rd, Esquimalt BC
SUBMITTED
10 November, 2023

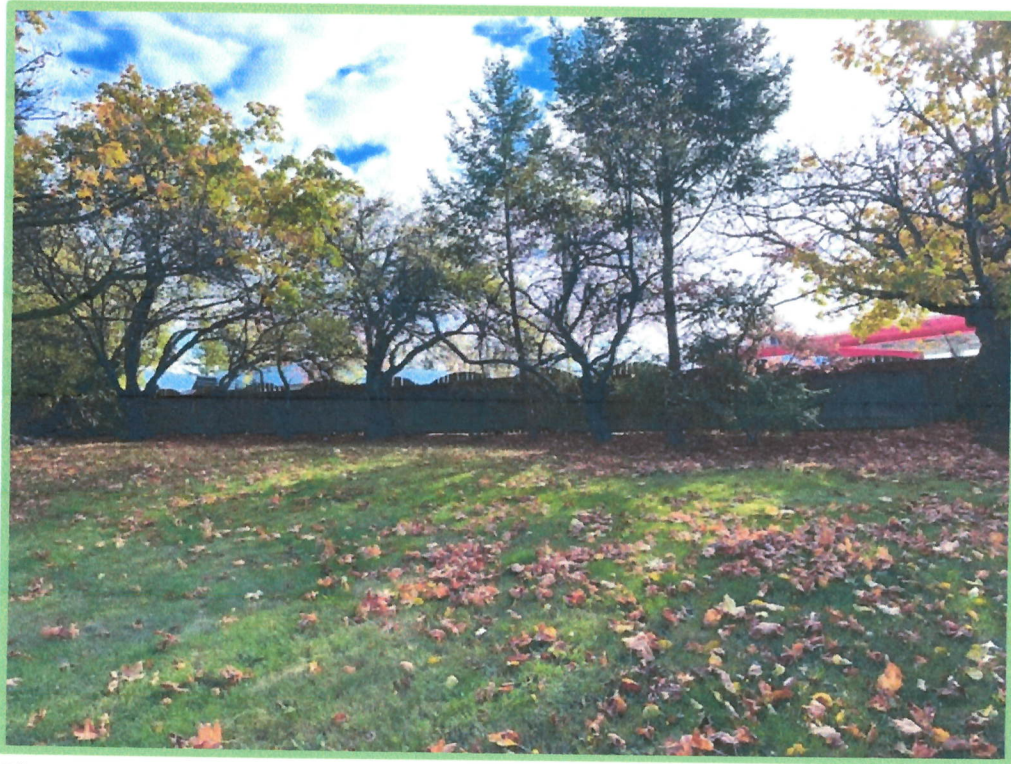
1. The lot dimensions require removal of the aging trees on the south property line:

The long and narrow lot and corresponding building design will result in the removal of the the trees on the south property line. Most of these trees are not in good health.

Picture 1: Decadent, mainly plum trees, are in poor health.

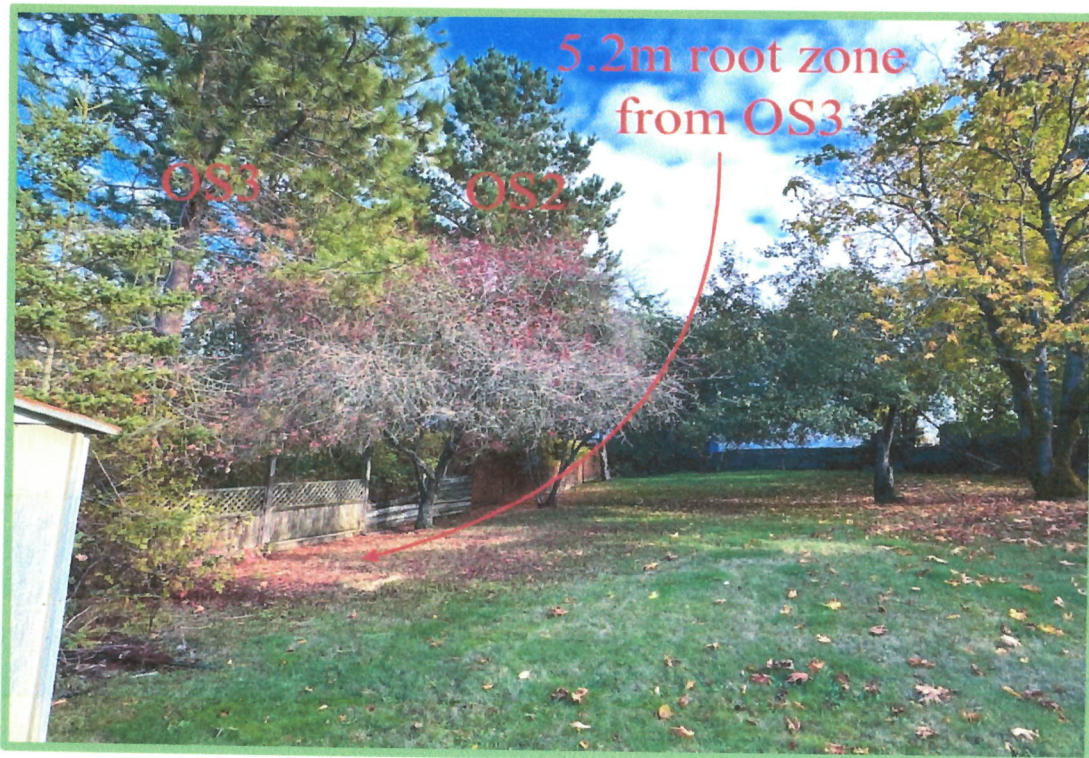
Fig 2. Neighbouring pine tree OS3 extends into the parking area more than other retained trees.

Root zones that are found in the proposed parking areas outside of protection fences require anti compaction (2 X19mm plywood or 20cm wood chips) until the final surface is placed. These areas should be a permeable surface such as pavers to allow water and air exchange to the roots. *See tree management site plan.*
