## **874 Fleming St, Esquimalt**

### **Construction Impact Assessment &**

### **Tree Preservation Plan**

Date of Issuance: June 26, 2019  
*Updated:* February 11, 2020

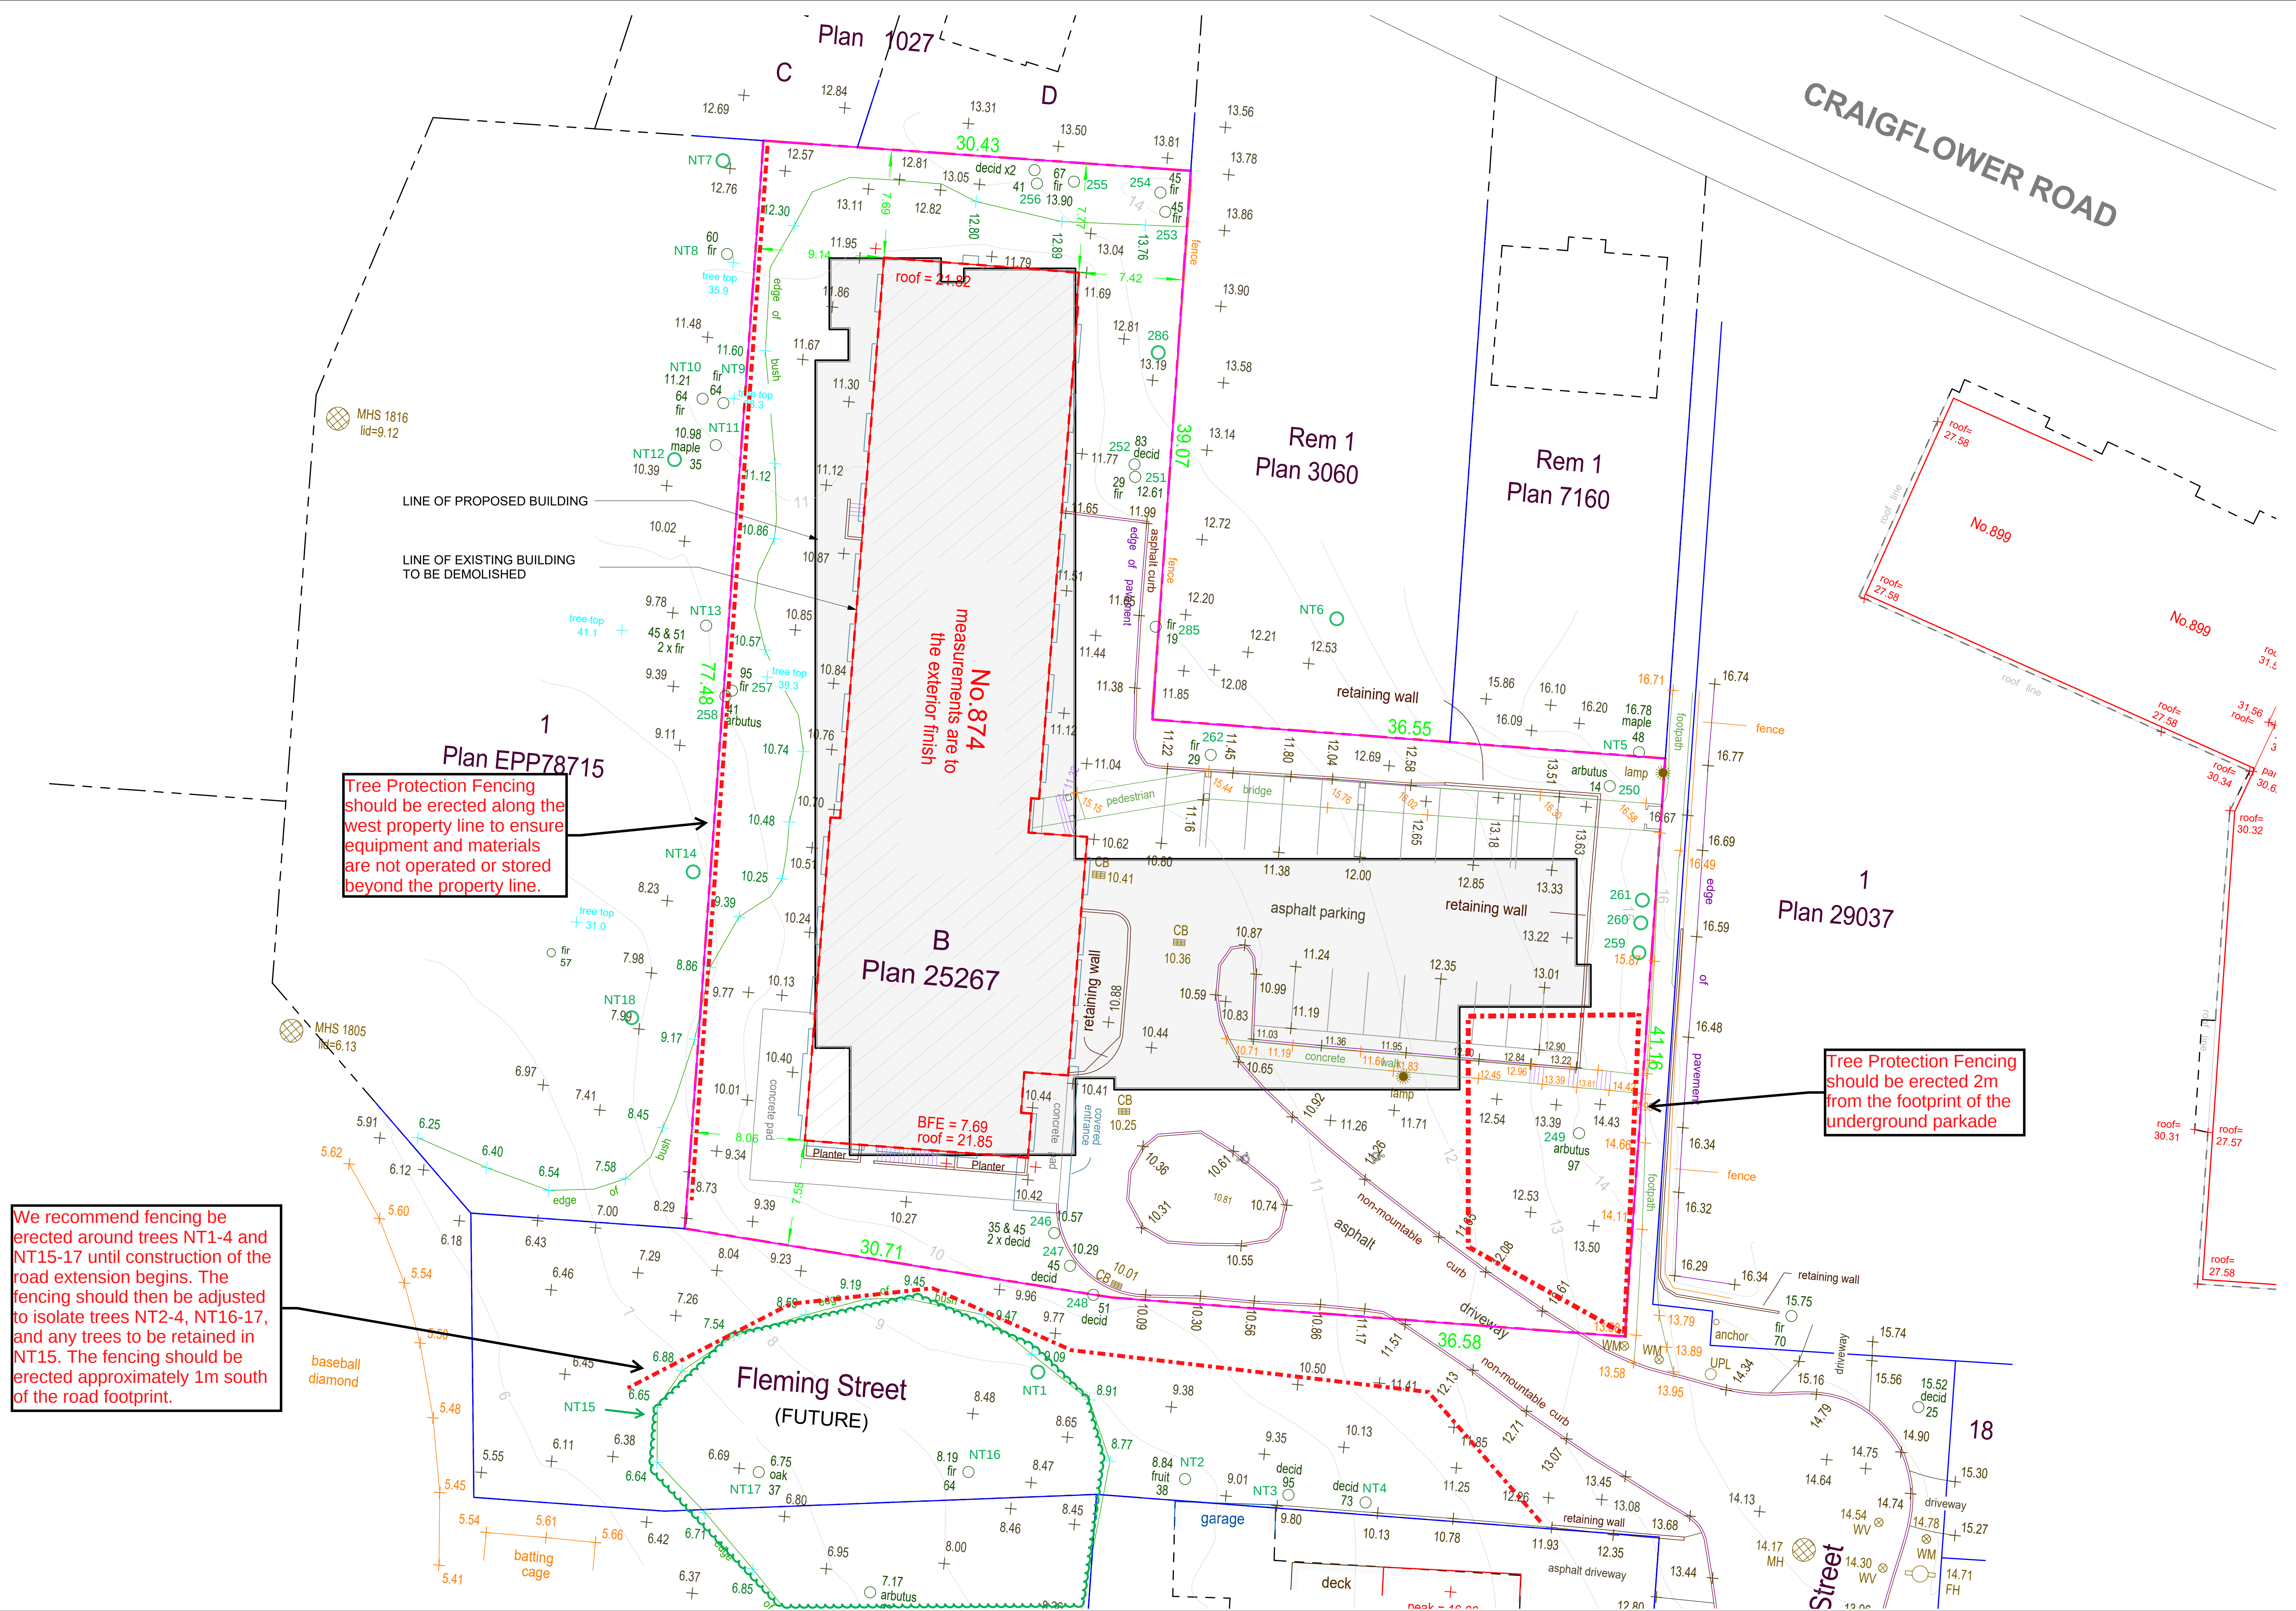
**OVERALL SITE PLAN**  
scale 1 : 200      date 2020.02.11

- **Trees #246-248, 250-262, 285, 286, NT5, NT7-9, NT11, NT13, and NT14:** Based on discussions with the applicants, it is our understanding that excavation will occur up to the west, north, and east property lines for construction of the underground parkade, except in the areas indicated that overlap with the CRZ of Arbutus #249 (see discussion below). The stumps of NT9 and NT11 should be left in place or routed to grade, rather than removed, to avoid damaging the root systems of trees to be retained (NT10 and NT12).

- **Arbutus #249** (101cm DBH): The underground parkade is located approximately 8m to the west and 8.5m to the north. The plans have been amended in an effort to minimize impacts to the health of the tree. Root growth will likely be partially restricted to the north by the presence of the existing stairway, retaining wall, and parking area. For this tree to be retained, shoring techniques will be required to limit the extent of excavation. Based on discussions with the applicant, it is our understanding that a significant amount of blasting is expected to be required for construction of the underground parkade and that excavation is expected to occur approximately 2m outside the parkade footprint. Arbutus trees typically exhibit poor tolerance to root loss and changes in hydrology. Depending on the extent of blasting and excavation, and on the number and size of roots encountered, particularly in the area west of the tree, the health of this tree may be significantly impacted.

The potential health impacts will likely be exacerbated by clearance pruning from the new building. This tree's crown extends approximately 9m to the north and west. The building is approximately 7m west of the tree and 8m to the north. If 1m of clearance from the building is desired, several large limbs (up to 15cm in diameter) growing westward will have to be pruned, in addition to one ~10cm limb extending 9-10m to the north. In total, this could amount to up to 15% of its crown being removed. All pruning must be completed by an ISA Certified Arborist to ANSI A300 pruning standards. Limbs should be pruned back to suitable laterals where appropriate. If additional clearance is required for building construction (e.g. to install scaffolding), this could result in additional health impacts. To limit the amount of pruning required, alternatives to full scaffolding should be considered, such as hydraulic lifts, ladders, or platforms.

We recommend the project arborist supervise all excavation within this tree's CRZ, including removal of the stairway, retaining walls, and paved parking areas and walkways. Any roots severed during excavation should be pruned back to sound tissue to encourage rapid wound compartmentalization and new root growth.

- Any excavation for construction of the underground parkade within the CRZs of trees #249, and NT6, NT10, and NT12
- Removal of the existing paved areas within the CRZ of Arbutus #249

- Excavation for the construction of the Fleming St Road extension within the CRZs of trees NT2-4, NT16, NT17, and any trees remaining in cluster NT15
- **Barrier Fencing:** The areas surrounding the trees to be retained should be isolated from the construction activity by erecting protective barrier fencing. Where possible, the fencing should be erected at the perimeter of the critical root zones. The barrier fencing must be a minimum of 4 feet in height, of solid frame construction that is attached to wooden or metal posts. A solid board or rail must run between the posts at the top and the bottom of the fencing. This solid frame can then be covered with plywood, or flexible snow fencing. The fencing must be erected prior to the start of any construction activity on site (i.e. demolition, excavation, construction), and remain in place through completion of the project. Signs should be posted around the protection zone to declare it off limits to all construction related activity. The project arborist must be consulted before this fencing is removed or moved for any purpose.
