April 20, 2026

## **RE: Environmental Review for Unpermitted Work in DPA #1 – Natural Environment and DPA #2 – Hazardous Conditions 322 Plaskett Place, Esquimalt, BC.**

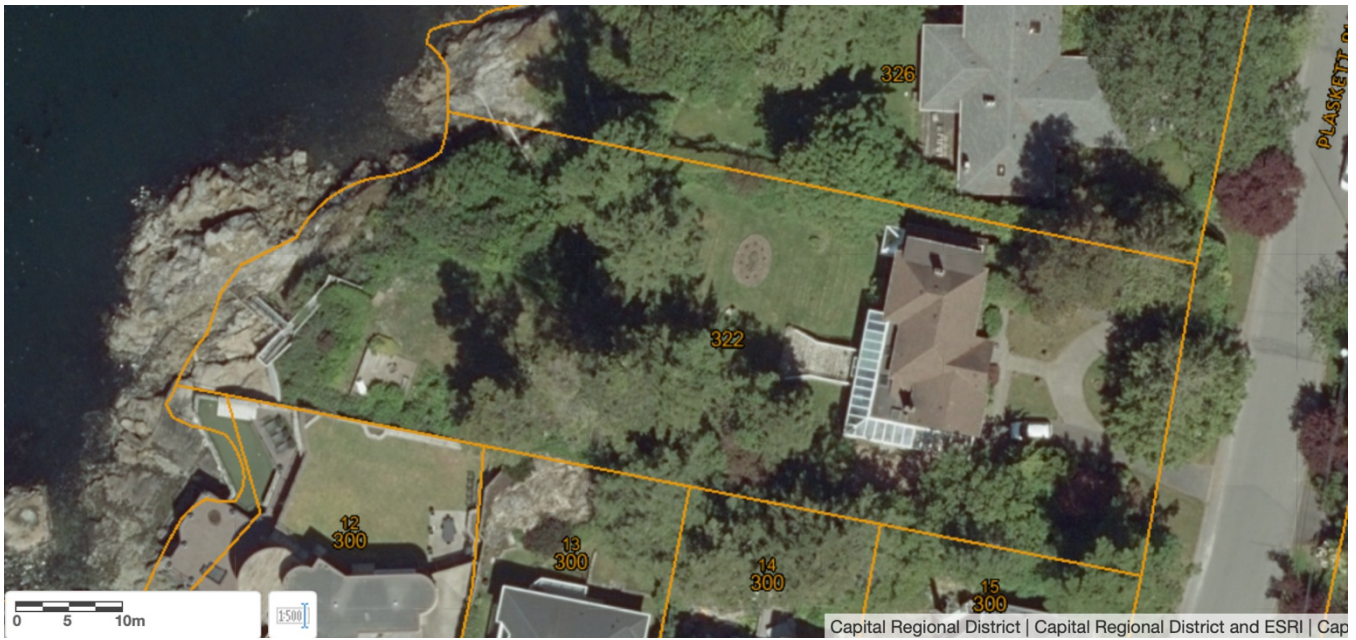
Historic shoreline access was removed from the site between 2017 and 2021 (Figures 1 and 2), leaving a gap in the shoreline vegetation that where agricultural grasses are established and yardwaste has been deposited, which is smothering the vegetation underneath (Photos 7 and 8). The footprint of the historic access was approximately 20m<sup>2</sup>.

Figure 1. 2017 Airphoto showing historic shoreline access.

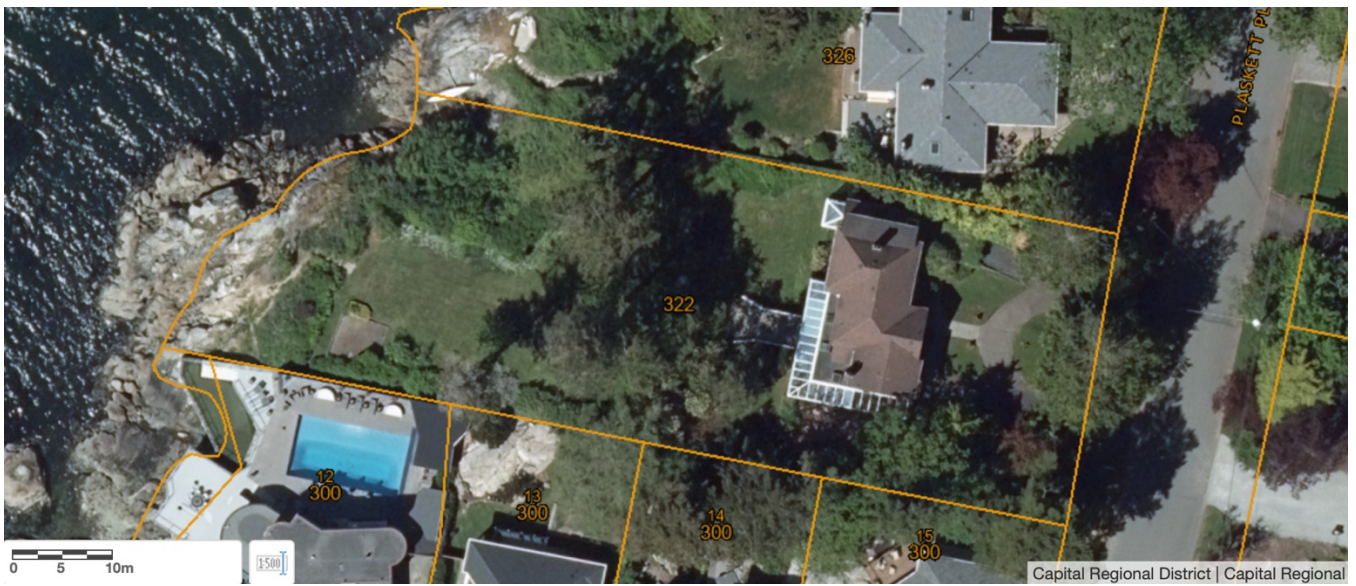
Figure 2. 2021 Airphoto showing historic shoreline access removed (2019 Airphoto was not clear if access was in place or removed).

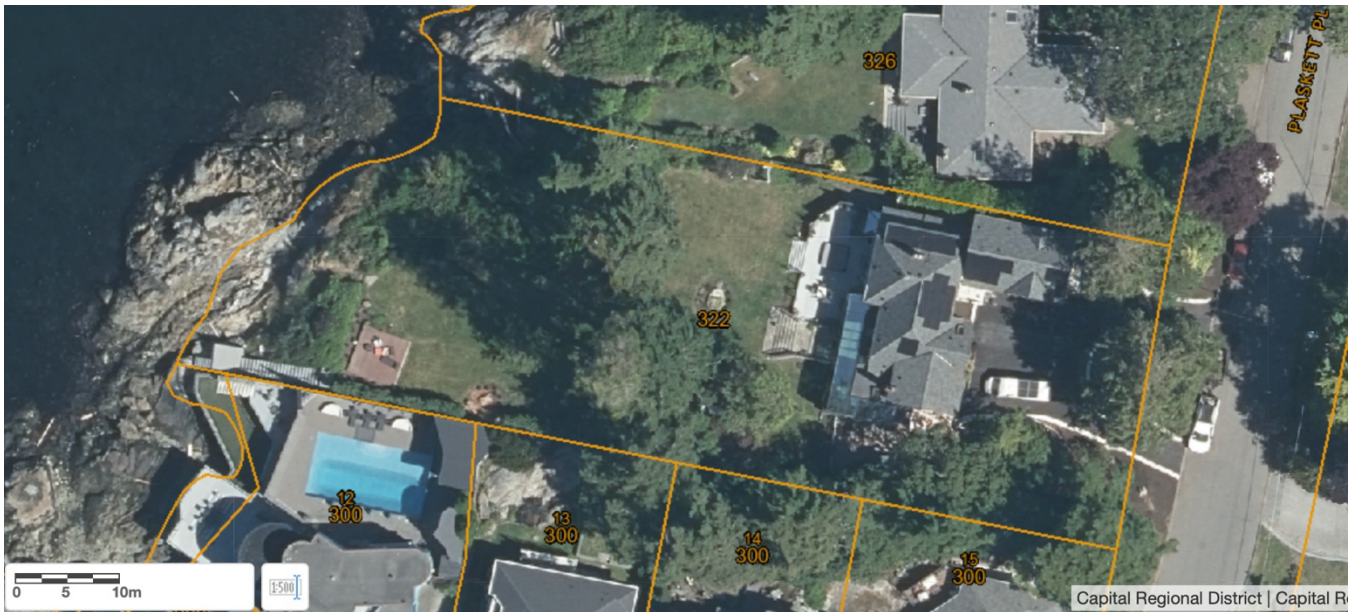
New stairs and landing to access the shoreline were installed, without a permit, between 2023 and 2025 along the south property boundary (Figures 3 and 4). The stairs were constructed with an aluminum frame and composite decking, on concrete footings (Photos X). The footprint of structure is 22.7m<sup>2</sup>. The new structure is suppressing, but not eliminating vegetation growth within the footprint (Photo 2-5).

Figure 3. 2025 Airphoto showing new shoreline access installed.

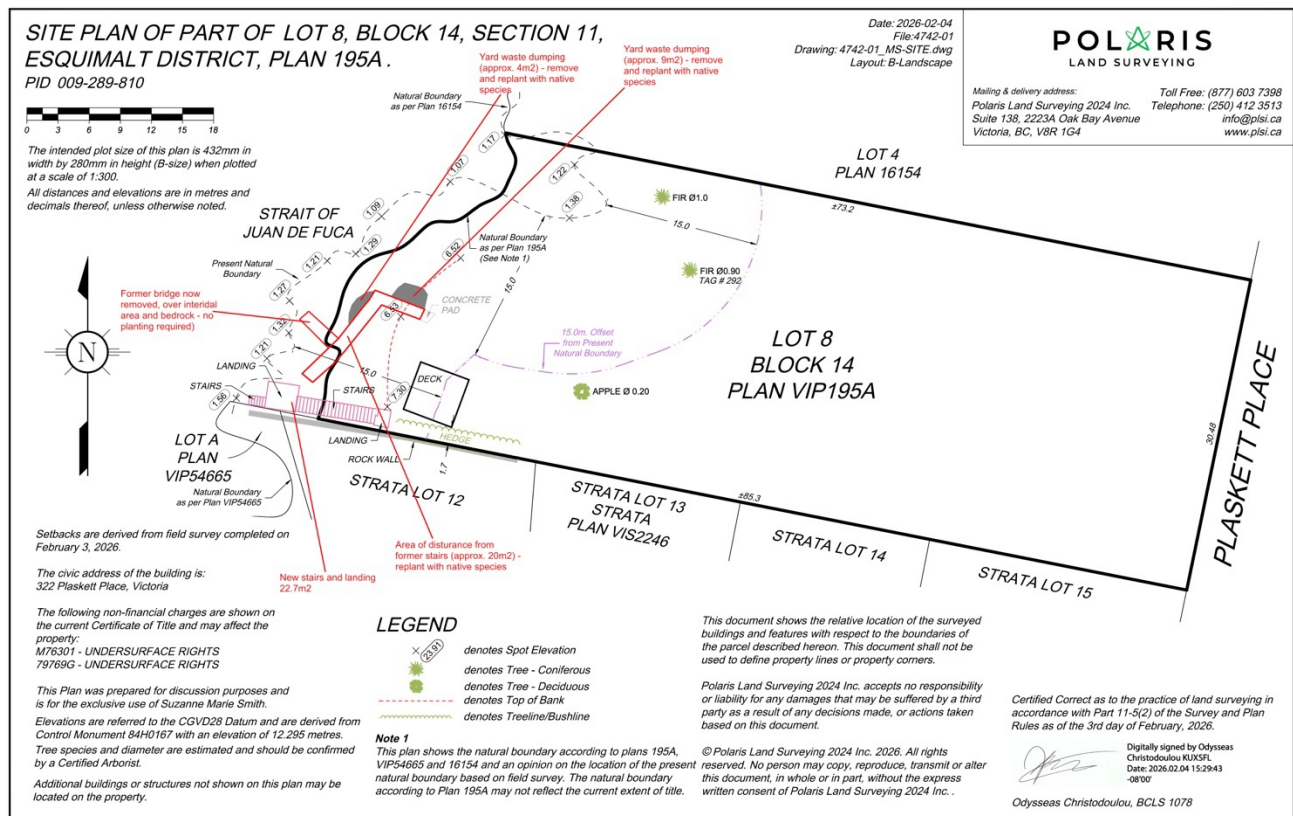
Figure 4. Survey plan with mark up by Swell Environmental..

To meet the DPA#1 Guidelines, the following actions are recommended to restore the area of the historic shoreline access that has been removed, to compensate for the area that is covered by the new structure. See Figure 4 for the proposed planting area and planting list.

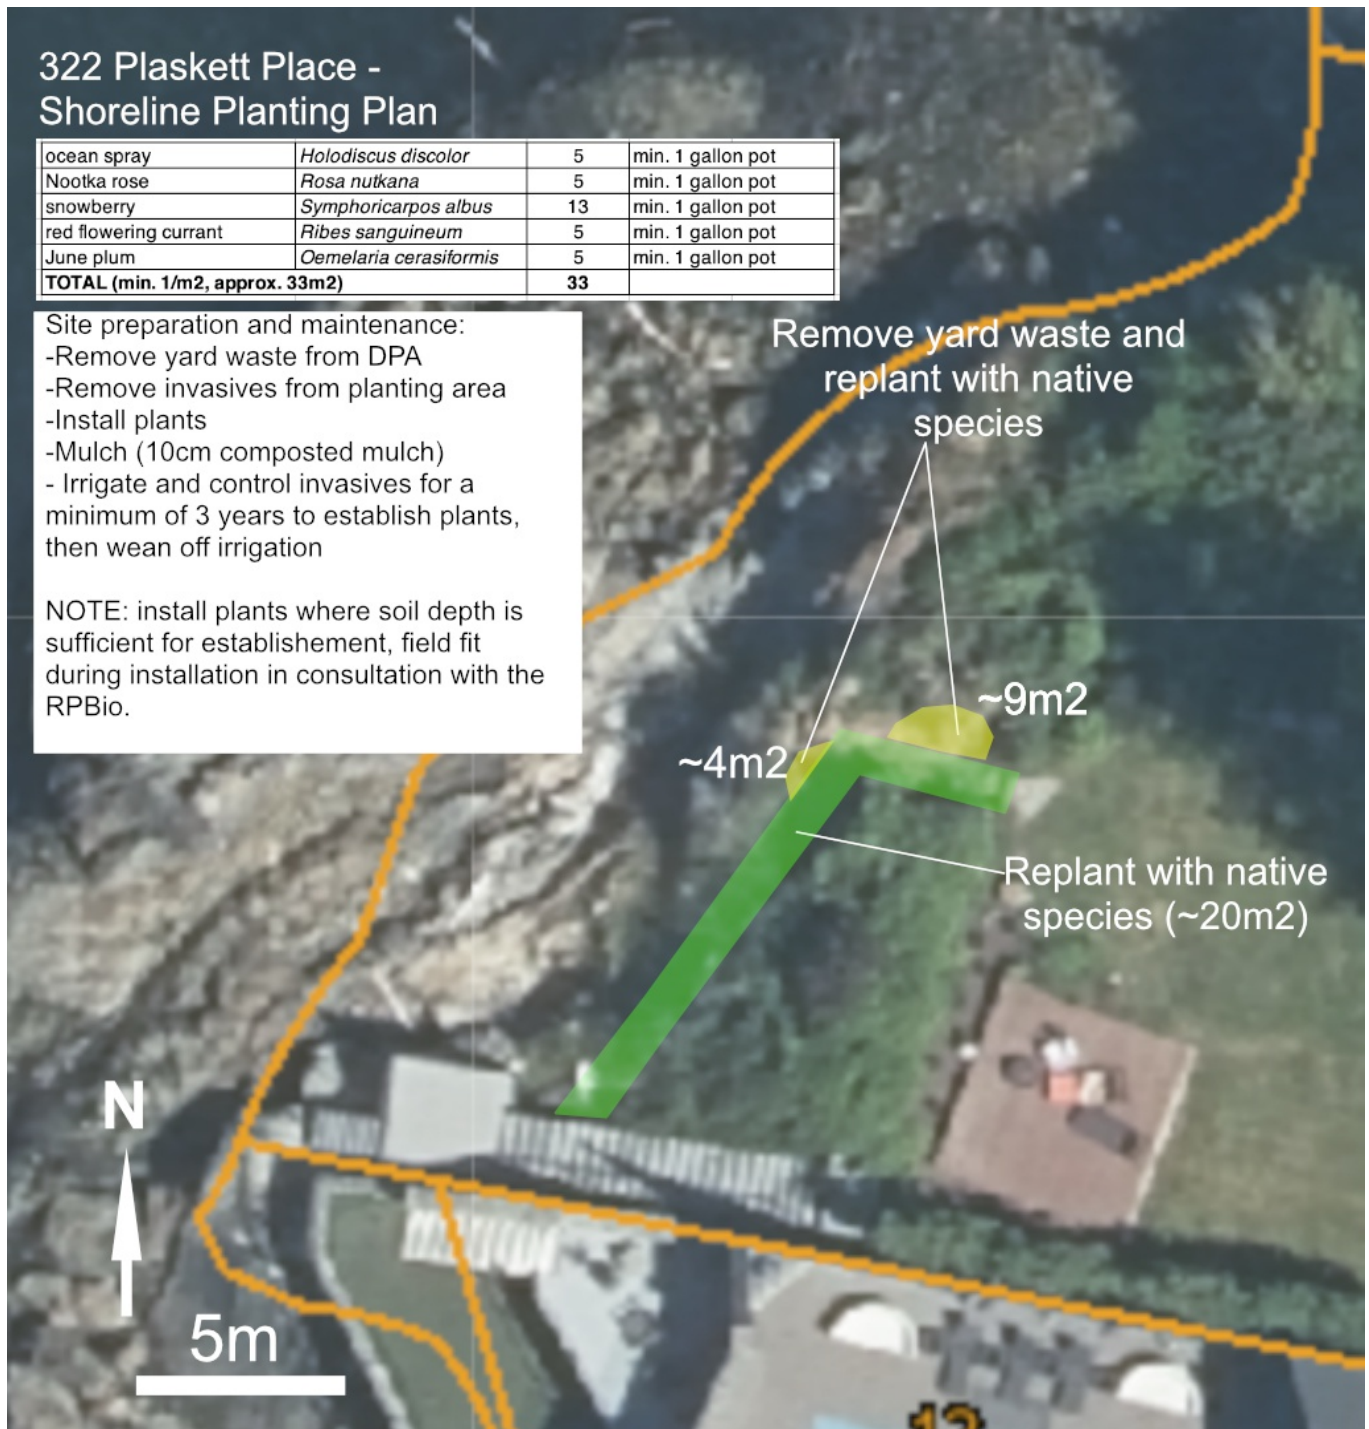
Figure 5. 2025 Airphoto with proposed restoration areas.

- Canadian Landscaping Standards should be met for sourcing plant materials, installation, and maintenance.
- Site preparation and maintenance:
  - Remove yard waste from DPA
  - Remove invasives from planting area
- Install plants
- Mulch (10cm composted mulch)
- Irrigate and control invasives for a minimum of 3 years to establish plants, then wean off irrigation

NOTE: install plants where soil depth is sufficient for establishment, field fit during installation in consultation with the RPBio.

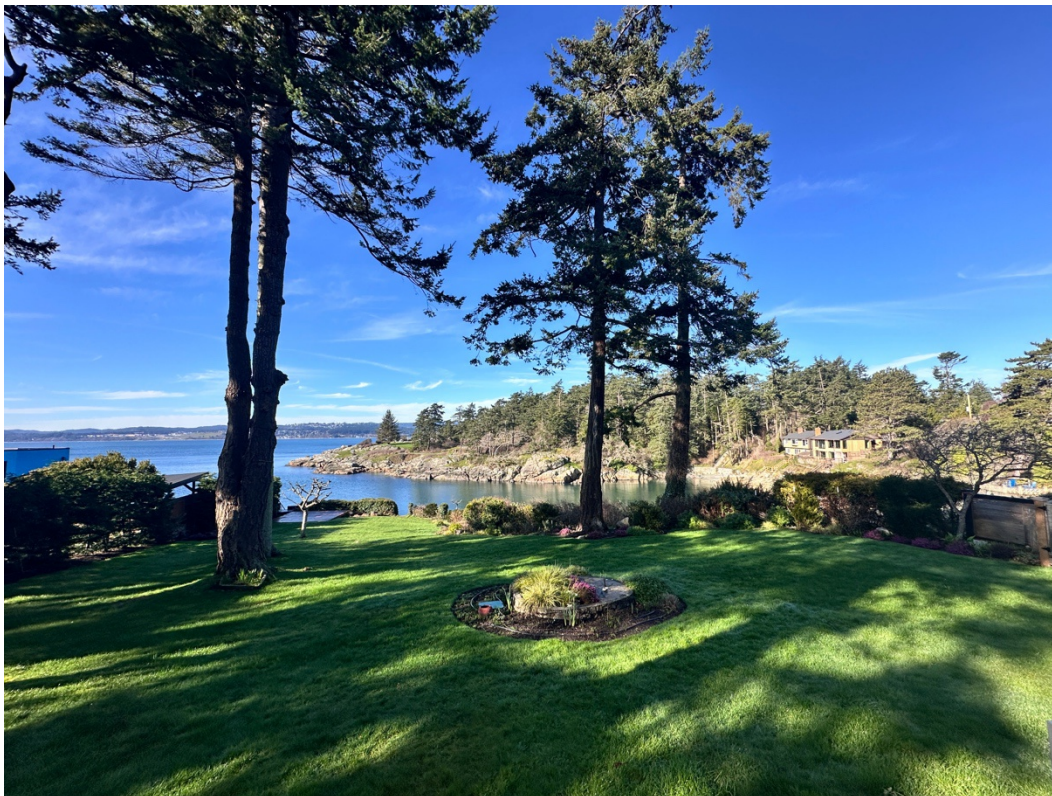
The property is a single family lot, with an existing home and extensive lawn, wooden deck, and landscaping with Douglas-fir (*Pseudotsuga menziesii*), arbutus (*Arbutus menziesii*) and grand fir (*Abies grandis*) (Photo 1). The shoreline slope, consists of a densely vegetated slope below the landscaped top of bank. The shoreline vegetation is a mix of native and invasive, non-native species (Photos 2-10). The native species consists of common snowberry (*Symphoricarpos albus*), Nootka rose (*Rosa nutkana*), ocean spray (*Holodiscus discolor*), June plum (*Oemelaria cerasiformis*), dull Oregon-grape (*Mahonia nervosa*), red flowering currant (*Ribes sanguineum*)(planted at the top of bank (*Sanicula crassicaulis*) and licorice fern (*Polypodium glycyrrhiza*). Non-native species include ornamentals, along with invasives such as Himalayan blackberry (*Rubus armeniacus*), English ivy (*Hedra helix*), spurge laurel (*Daphne laureola*), Scotch broom (*Cytisus scoparius*), thistles (*Cirsium* sp.), orchard grass (*Dactylis glomerata*), agricultural grasses, and dove's foot geranium (*Geranium molle*). *Note: vegetation identification was limited due to the time of year.*

Photo 1. Lawn, landscaping and wooden deck at the top of the shoreline bank.

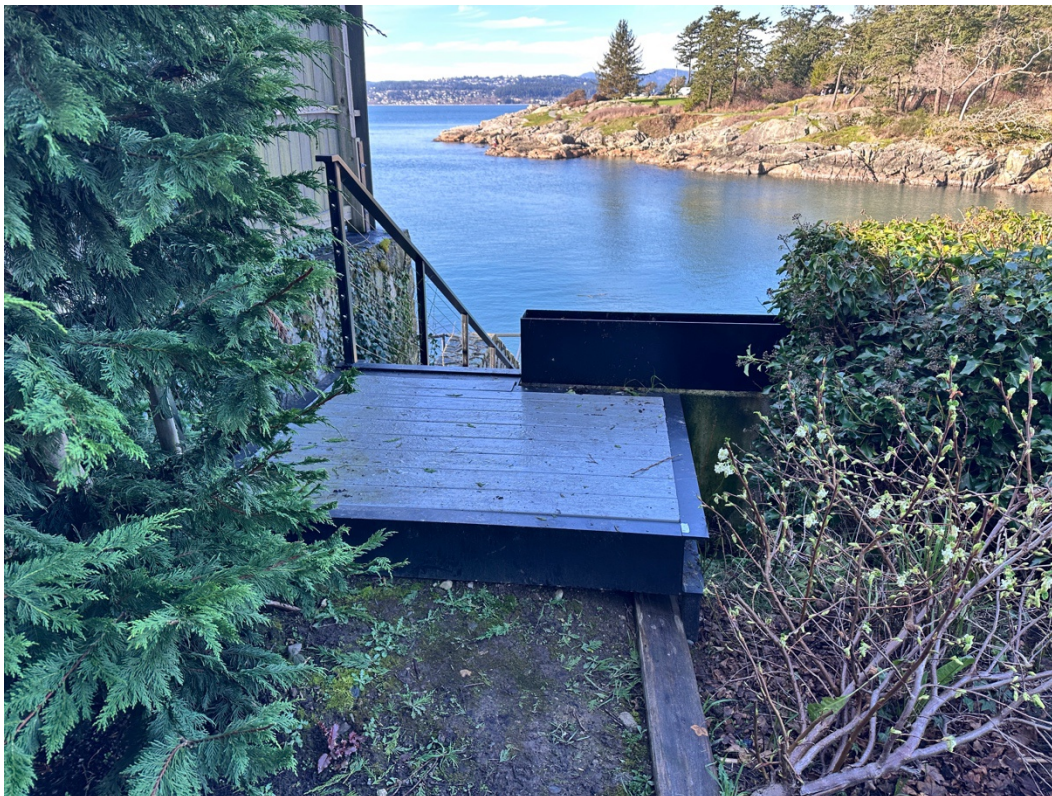
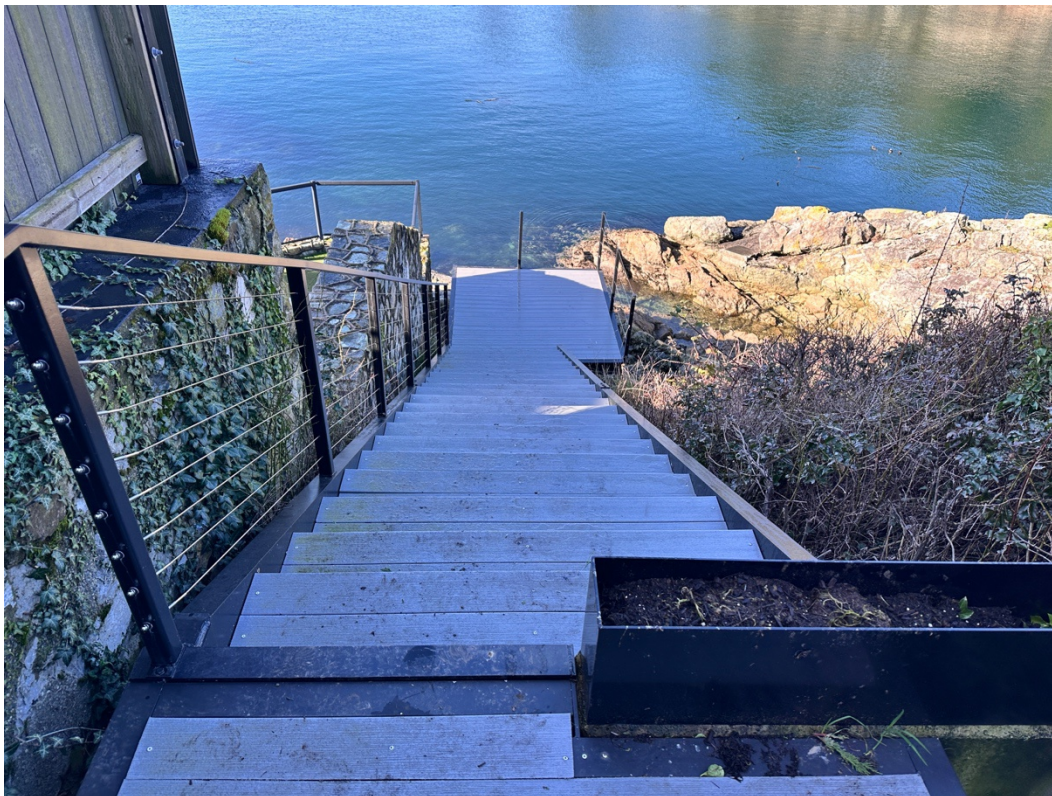
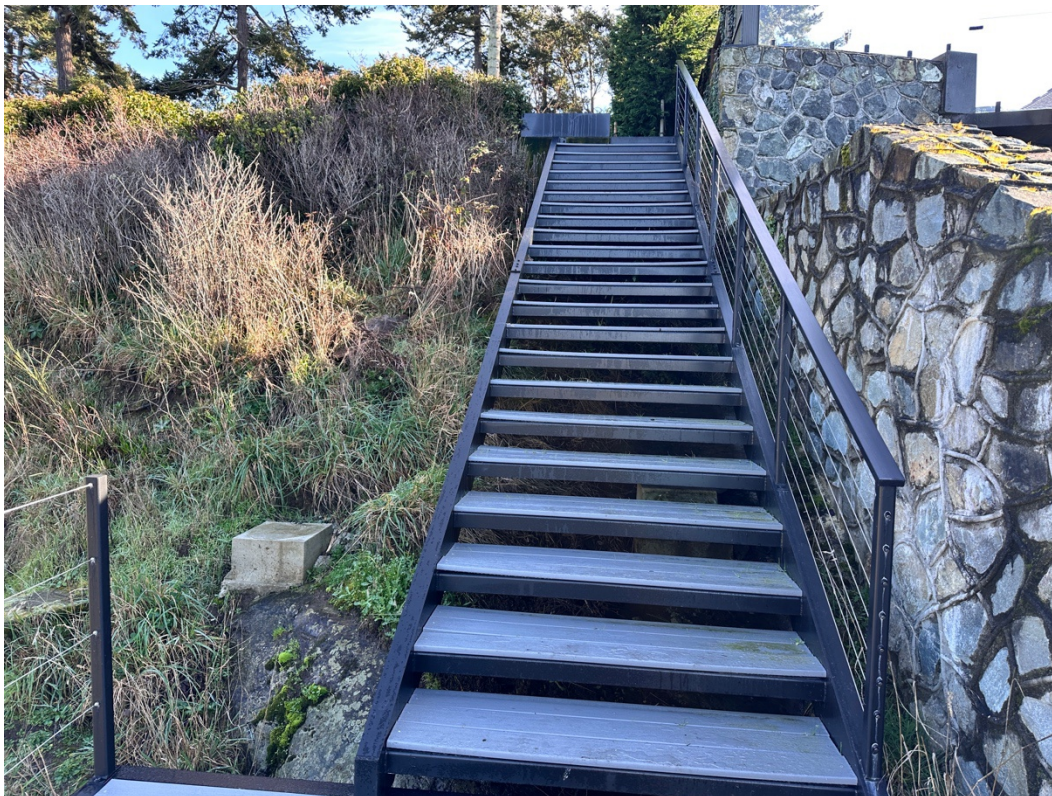
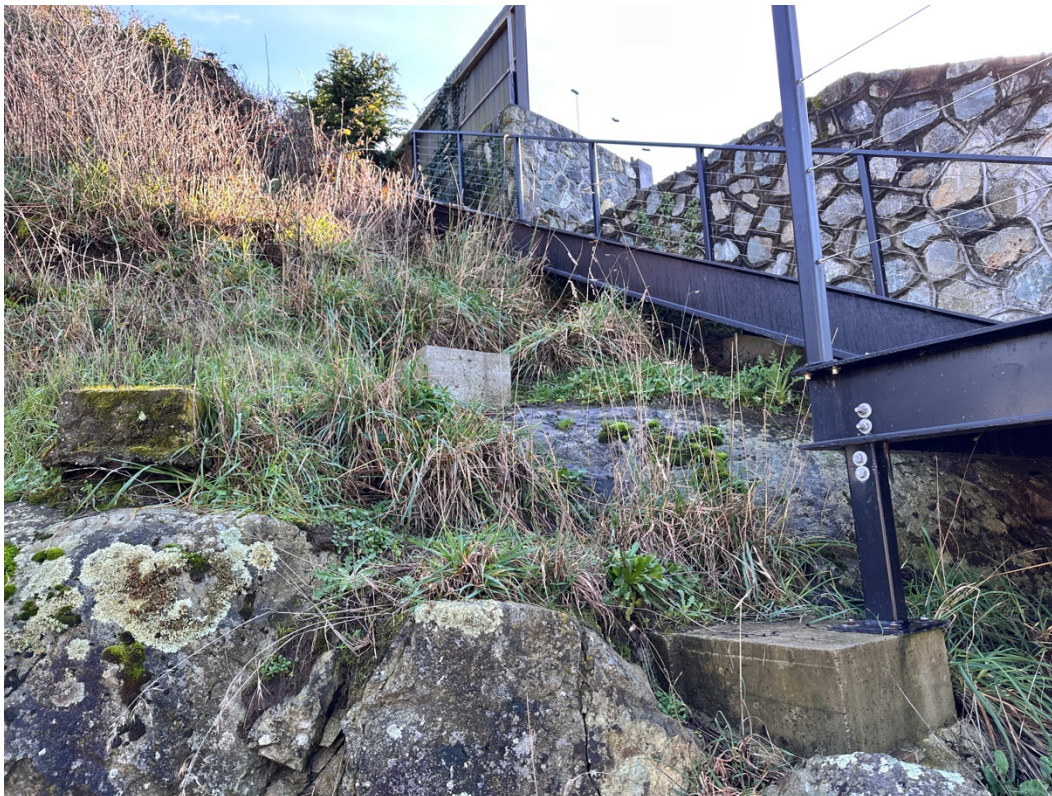
Photo 2. New landing and stairs installed between 2023 and 2025.

Photo 3. New landing and stairs installed between 2023 and 2025.

Photo 4. New landing and stairs installed between 2023 and 2025.

Photo 5. New landing and stairs installed between 2023 and 2025.

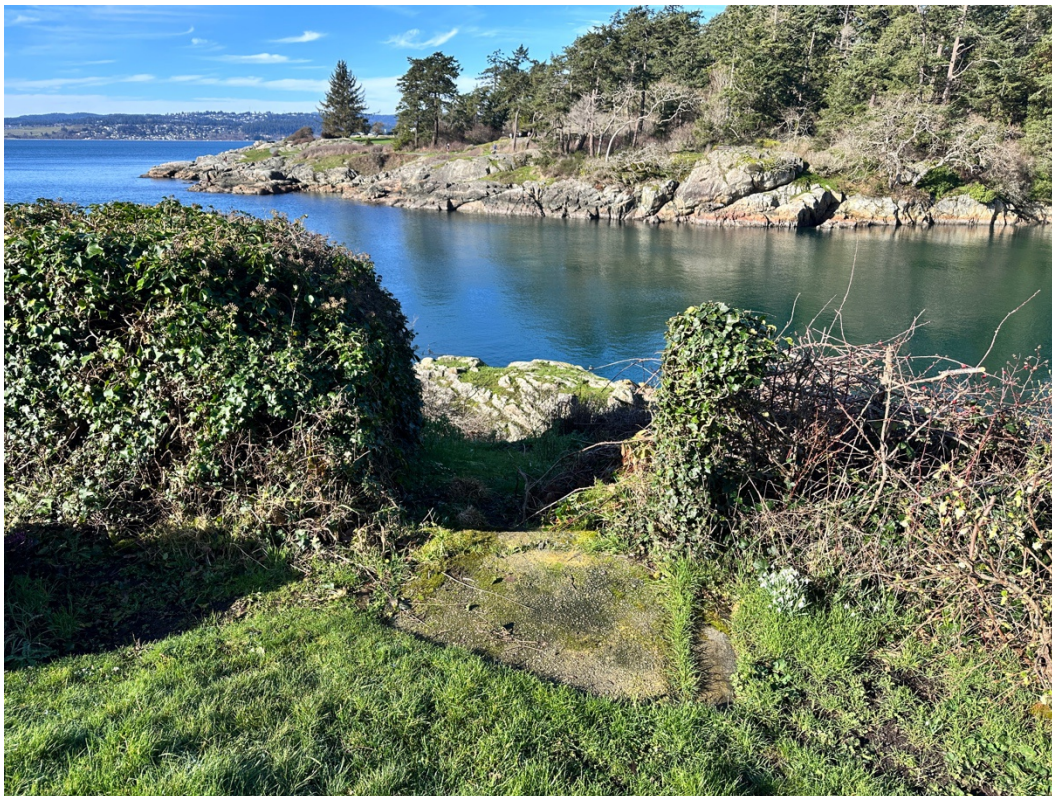
Photo 6. Historic shoreline access (removed between 2017 and 2021).

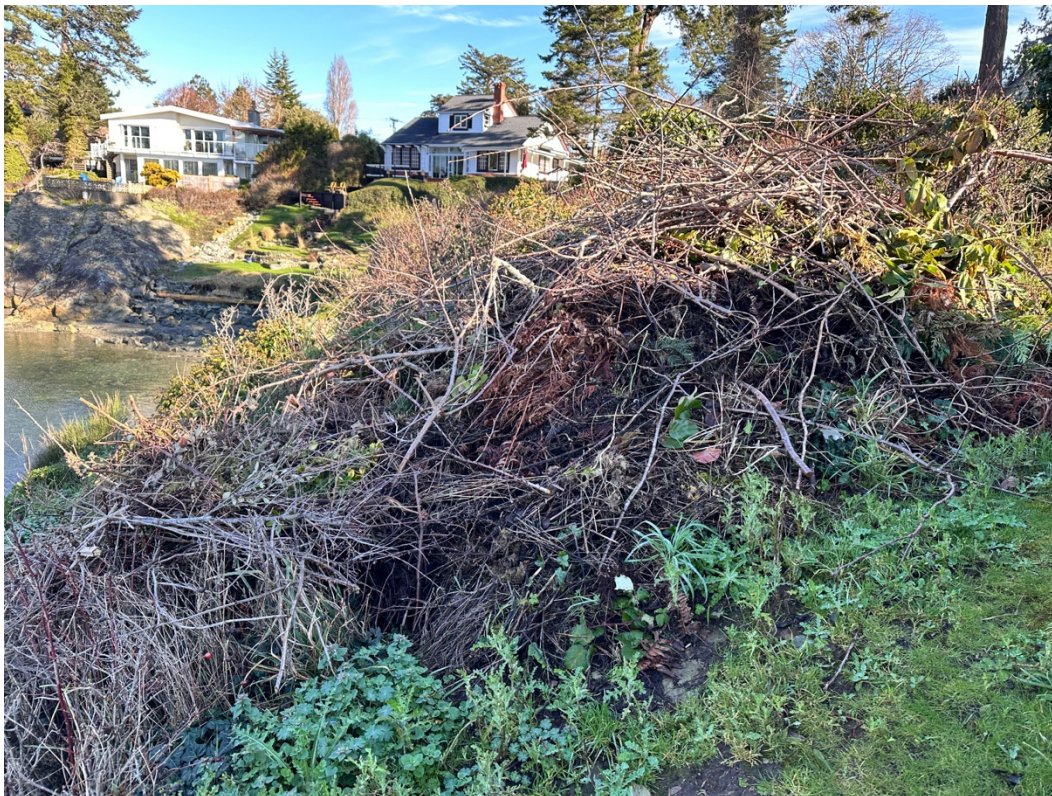
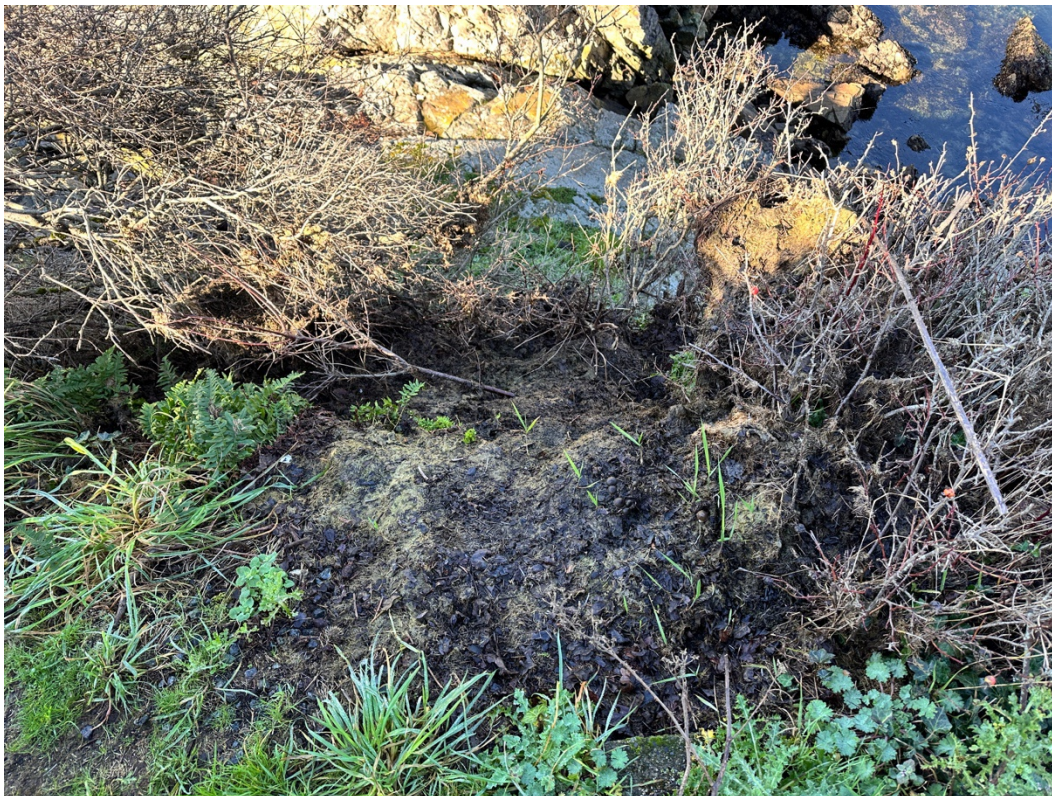
Photo 7. Yard waste on shoreline slope.

Photo 8. Yard waste on shoreline slope.

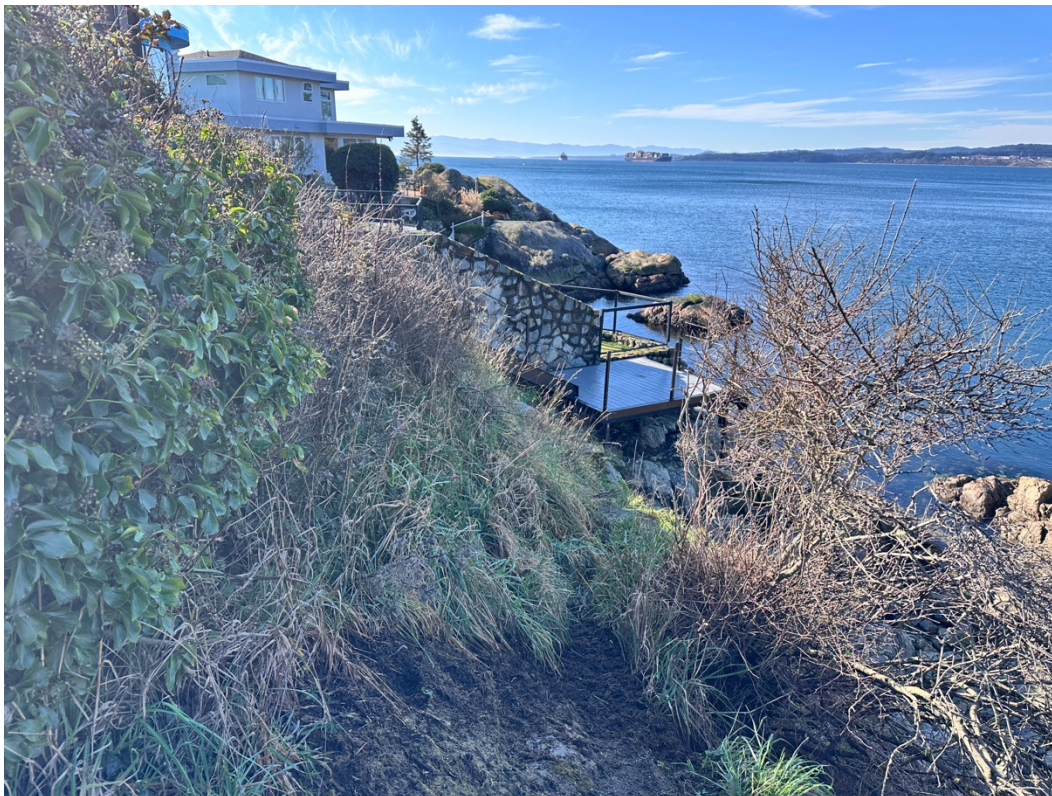
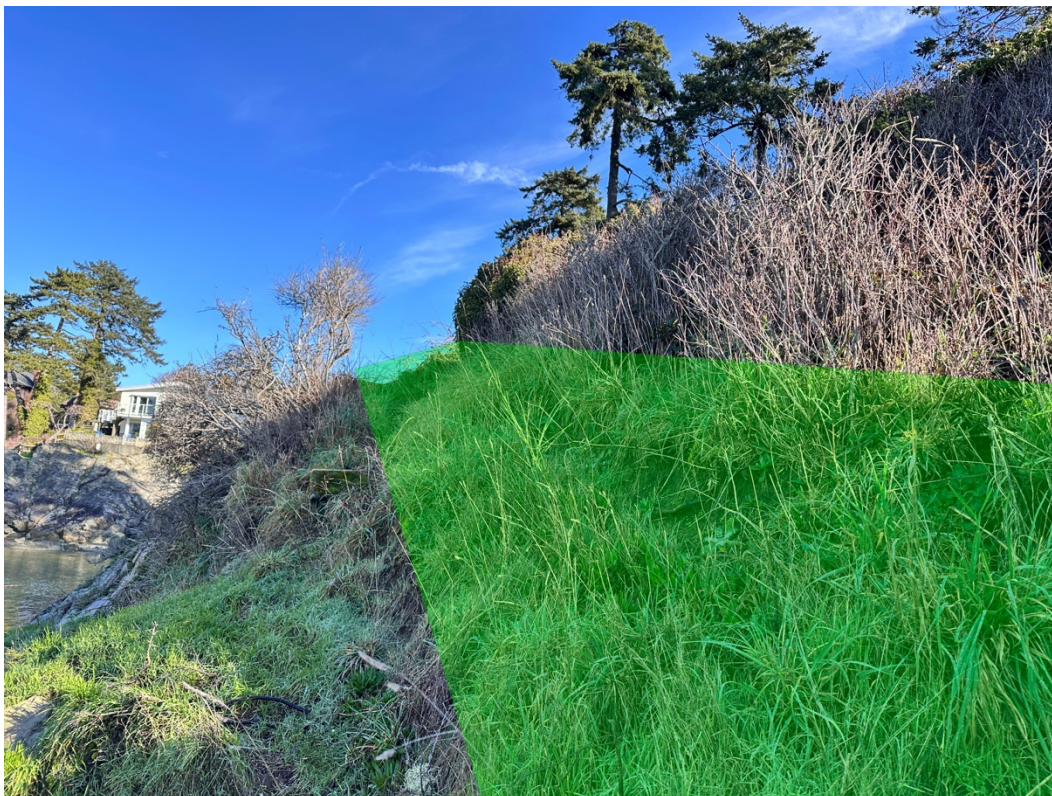
Photo 9. Grassy area is approximate footprint of historic shoreline access (removed between 2017 and 2021).

Photo 10. Grassy area is approximate footprint of historic shoreline access (removed between 2017 and 2021).
