**1337 Saunders Ave. & 1340 Sussex St.**

**Esquimalt, BC**

**Construction Impact Assessment &**

**Tree Management Plan**

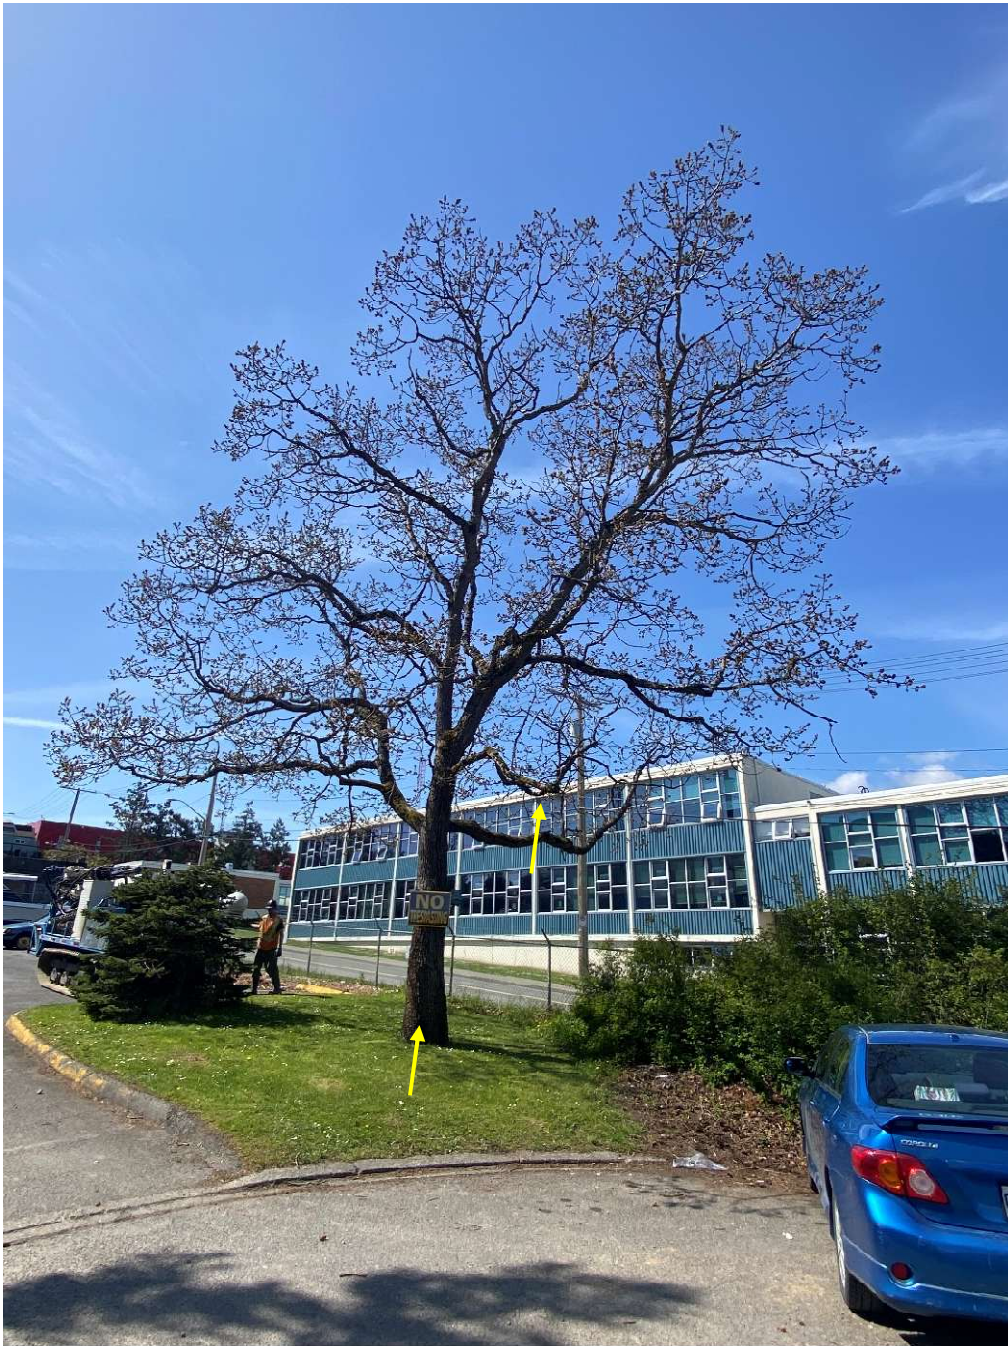
155	Yes	On	Yes	Garry oak	<i>Quercus garryana</i>	51	20	5.1	7	Fair/good	Fair/good	suitable	Good	Small deadwood, historic pruning wounds with associated surface decay.	Located within the footprint of the proposed vehicular access.	Remove (3:1)

*Photograph 1. Yellow arrow indicates Garry oak (tag# 155).*

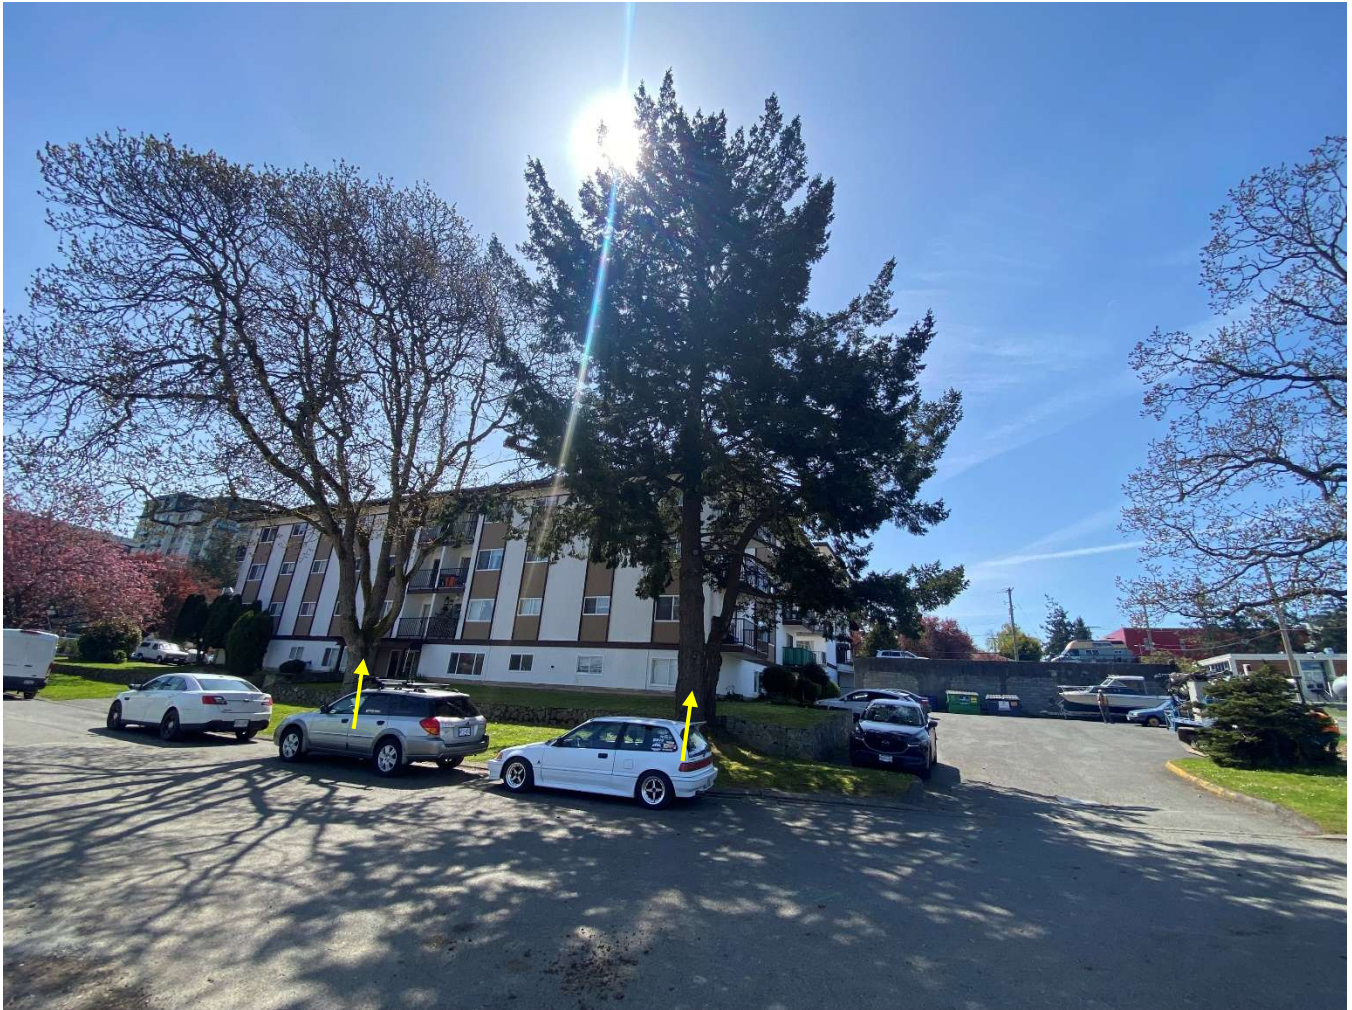
M6	Yes	City	Yes	Garry oak	<i>Quercus garryana</i>	59	15	5.9	6	Good	Fair		Good	Multiple stems form at 3m above grade - no major weakness visible at stem union, asymmetric crown on West side due to shading.	*new curb and sidewalk alignment proposed within the critical root zone. The project arborist must be onsite to supervise all excavation required within the critical root zone. A modified curb and sidewalk design must be utilized to bridge over any structural roots encountered during excavation.	Retain*
M7	Yes	City	Yes	Douglas-fir	<i>Pseudotsuga menziesii</i>	70	25	8.4	7	Good	Fair		Moderate	Heavily surface rooted.	Will be heavily impacted by excavation required to construct the foundation of the proposed u/g parkade.	Remove
M8	Yes	City	Yes	Douglas-fir	<i>Pseudotsuga menziesii</i>	49	10	5.9	4	Fair	Fair/poor		Moderate	Suppressed by M7 - stunted growth form, <i>phaeolus schweinitzii</i> fruiting body attached to root collar, growing within close proximity to existing retaining wall.	Will be heavily impacted by excavation required to construct the foundation of the proposed u/g parkade.	Remove

*Photograph 2. Yellow arrows indicate Garry oak (M6 - left) and (M7 & M8 – right).*

\*Note that a modified curb and sidewalk must be utilized to bridge over any structural roots that are encountered during excavation. See hard surface over tree roots detail (appendix C).

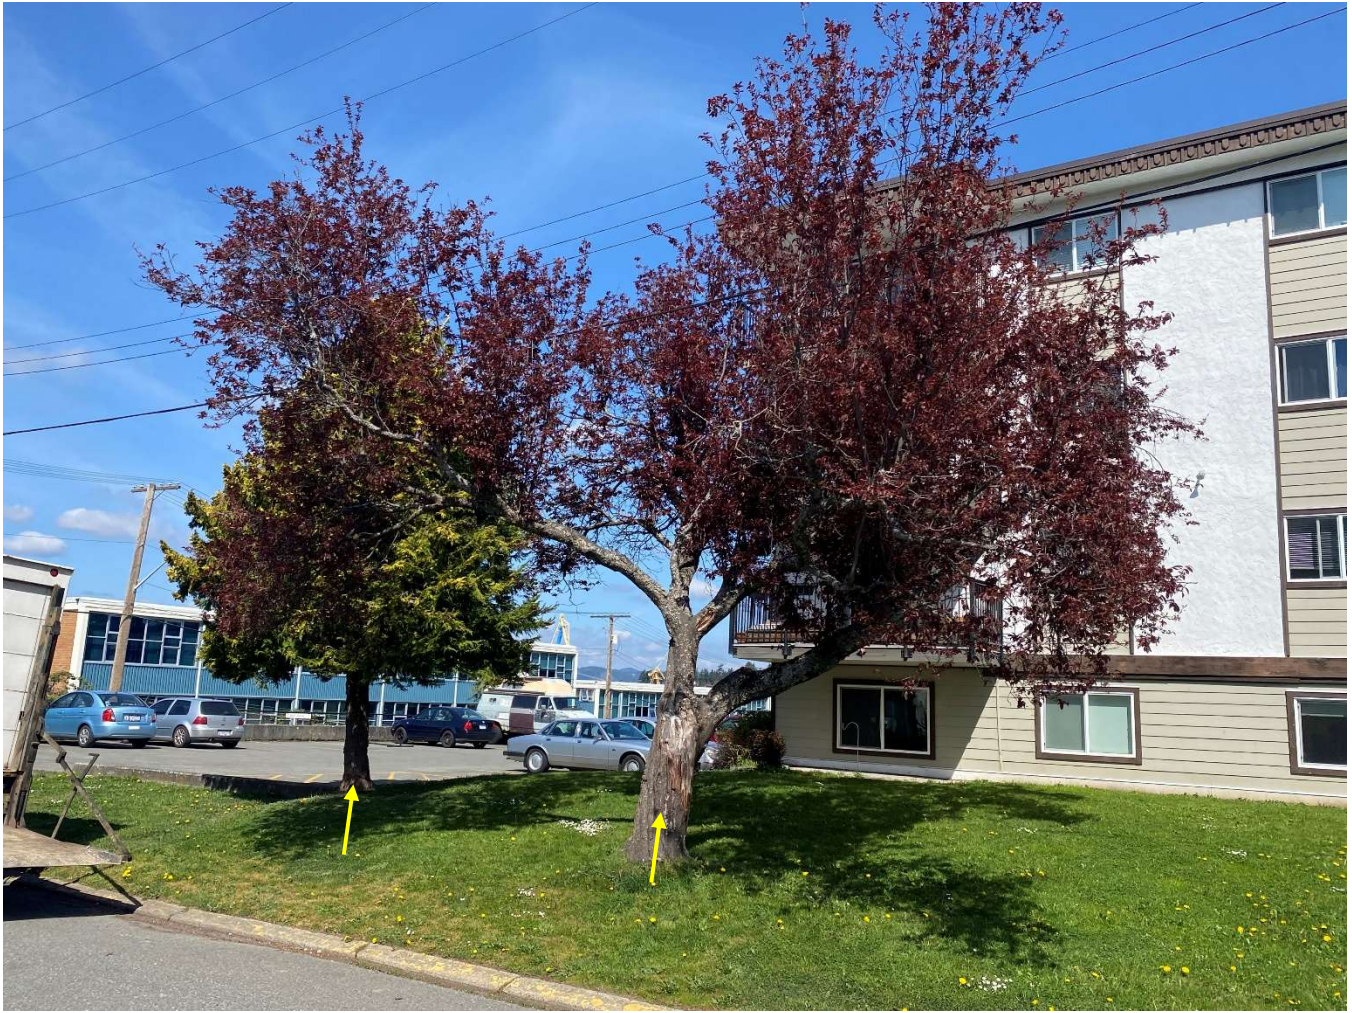
*Photograph 3. Yellow arrows indicate Lawson cypress (M1 – left) and cherry plum (M2).*
