838-842 Admirals Road, Esquimalt

Construction Impact Assessment &

Tree Preservation Plan

DATE OF ISSUANCE: January 23, 2018

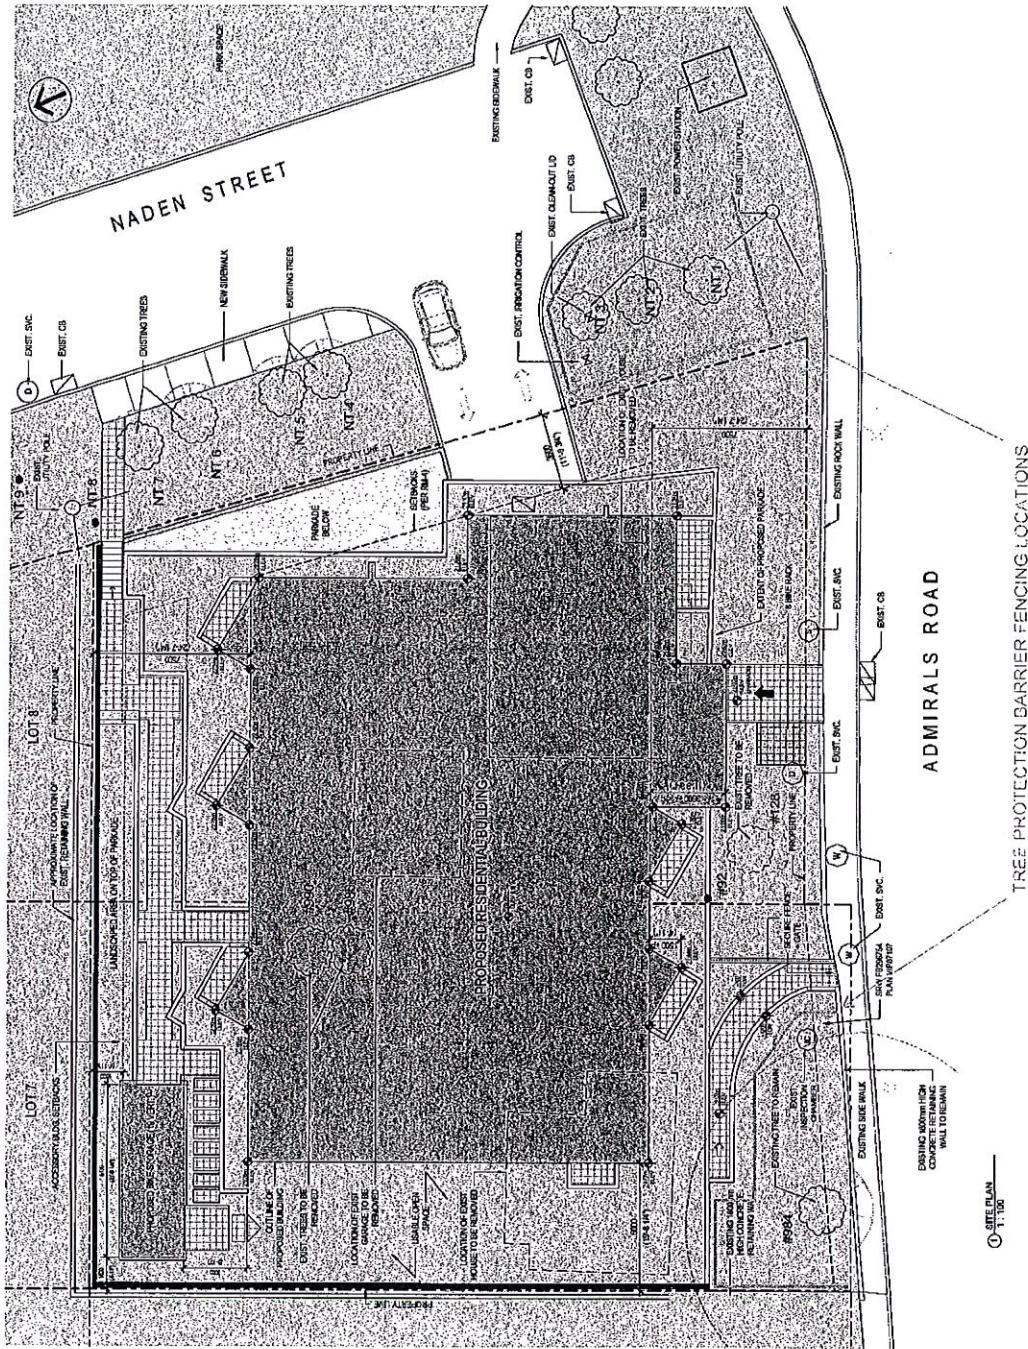
A01

- **Garry Oaks #986 and 990** (78 and 87cm DBH respectively): Located within the proposed building footprint.
- **Purple Leaf Plum #128** (multiple stems): Located less than 1.5 metres from the underground parking excavation and will require multiple large diameter stems be removed for building clearance.
- **English Holly #92** (two stems, 26 and 18cm in DBH): Located within the underground parking footprint.
- **Municipal Horsechestnut Trees NT 04-08**

In our opinion, these five municipal Horsechestnut trees are not suitable for retention. They are in poor structural condition due to being topped for the three primary hydro lines above them. NT 08 will be 1.5m from the underground parking and will likely require removal as a result. NT 06 will require removal for the proposed water service. This water service excavation may have an impact on NT 05 and NT 07 as well. The underground parkade will be approximately 4m away from the remaining trees; even with shoring techniques restricting the excavation to 4m, there will likely be some root loss.

There is a 1.8m tall retaining wall that runs 1.5m south and a 3.5m west of the tree (along the sidewalk and along the neighbouring driveway). The rooting area of the oak has thus been confined mostly to the north and east, so we expect to find a significantly higher density of roots in this area compared to if the roots had not been confined on two sides.

The proposed underground parkade is located 5m north of this tree. Even if sheet piling or other shoring techniques are used to restrict the extent of excavation to approximately 5m, we expect that a significant amount of root loss will occur. Additionally, the pathway that runs from the sidewalk to the doorway of the underground parkade will require significant excavation (approximately 1.5m in depth) to match the height of the underground parking floor height. Working room will also be required to construct a retaining wall adjacent to this pathway which will likely result in significant root loss.

Additionally, the grading plans (A06, South side) show the finished grade as below the existing grade around the tree. If this occurs, the tree will likely have to be removed immediately. If the tree is to be retained, we would recommend no significant grade change in this area.

As a result of these excavations, we anticipate that the health of the tree will be significantly impacted and may decline as a result. If tree retention is desired in the long-term, we recommend restricting the extent of excavation to within the footprint of the existing house foundation (approximately 2m from where the underground parking is currently proposed) and eliminating the below-grade pathway which requires excavation.

Despite these impacts, it is our understanding that tree retention is desired and thus have included mitigation measures. We recommend that the retaining wall adjacent to the sidewalk and neighbour's driveway be left in place to prevent further damage to roots that could be growing against it. To minimize additional root loss, we recommend that the existing sewer and drain services east of Garry Oak #984 be capped and abandoned instead of being excavated and removed. This will minimize the amount of excavation required.

- **Barrier fencing:** The areas surrounding the trees to be retained should be isolated from the construction activity by erecting protective barrier fencing. Where possible, the fencing should be erected at the perimeter of the critical root zones. The barrier fencing must be a minimum of 4 feet in height, of solid frame construction that is attached to wooden or metal posts. A solid board or rail must run between the posts at the top and the bottom of the fencing. This solid frame can then be covered with plywood, or flexible snow fencing. The fencing must be erected prior to the start of any construction activity on site (i.e. demolition, excavation, construction), and remain in place through completion of the project. Signs should be posted around the protection zone to declare it off limits to all construction related activity. The project arborist must be consulted before this fencing is removed or moved for any purpose.
