# Tree Assessment and Development Report

Prepared for 868 Old Esquimalt Rd, Esquimalt BC  
SUBMITTED  
17 March 2025

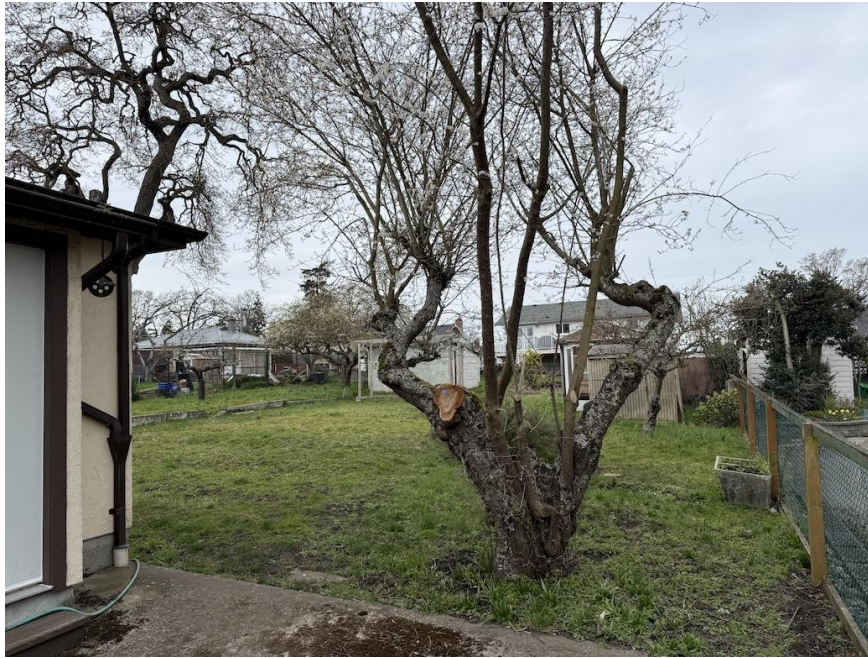
**Figure 1**

Trees #5 and #6 in the tree inventory table and tree management site plan are required to be removed due to their conflict with construction designs. Both trees are plum species with multiple stems. Severe reduction pruning to tree #5 has caused decreased tree vitality and decreased its tolerance to construction. Large pruning cuts not compartmentalized increase the tree's vulnerability to pests, pathogens, and decay (Figure 1).

*Tree #5*

*Note.* Severe reduction pruning of a major limb is evident.

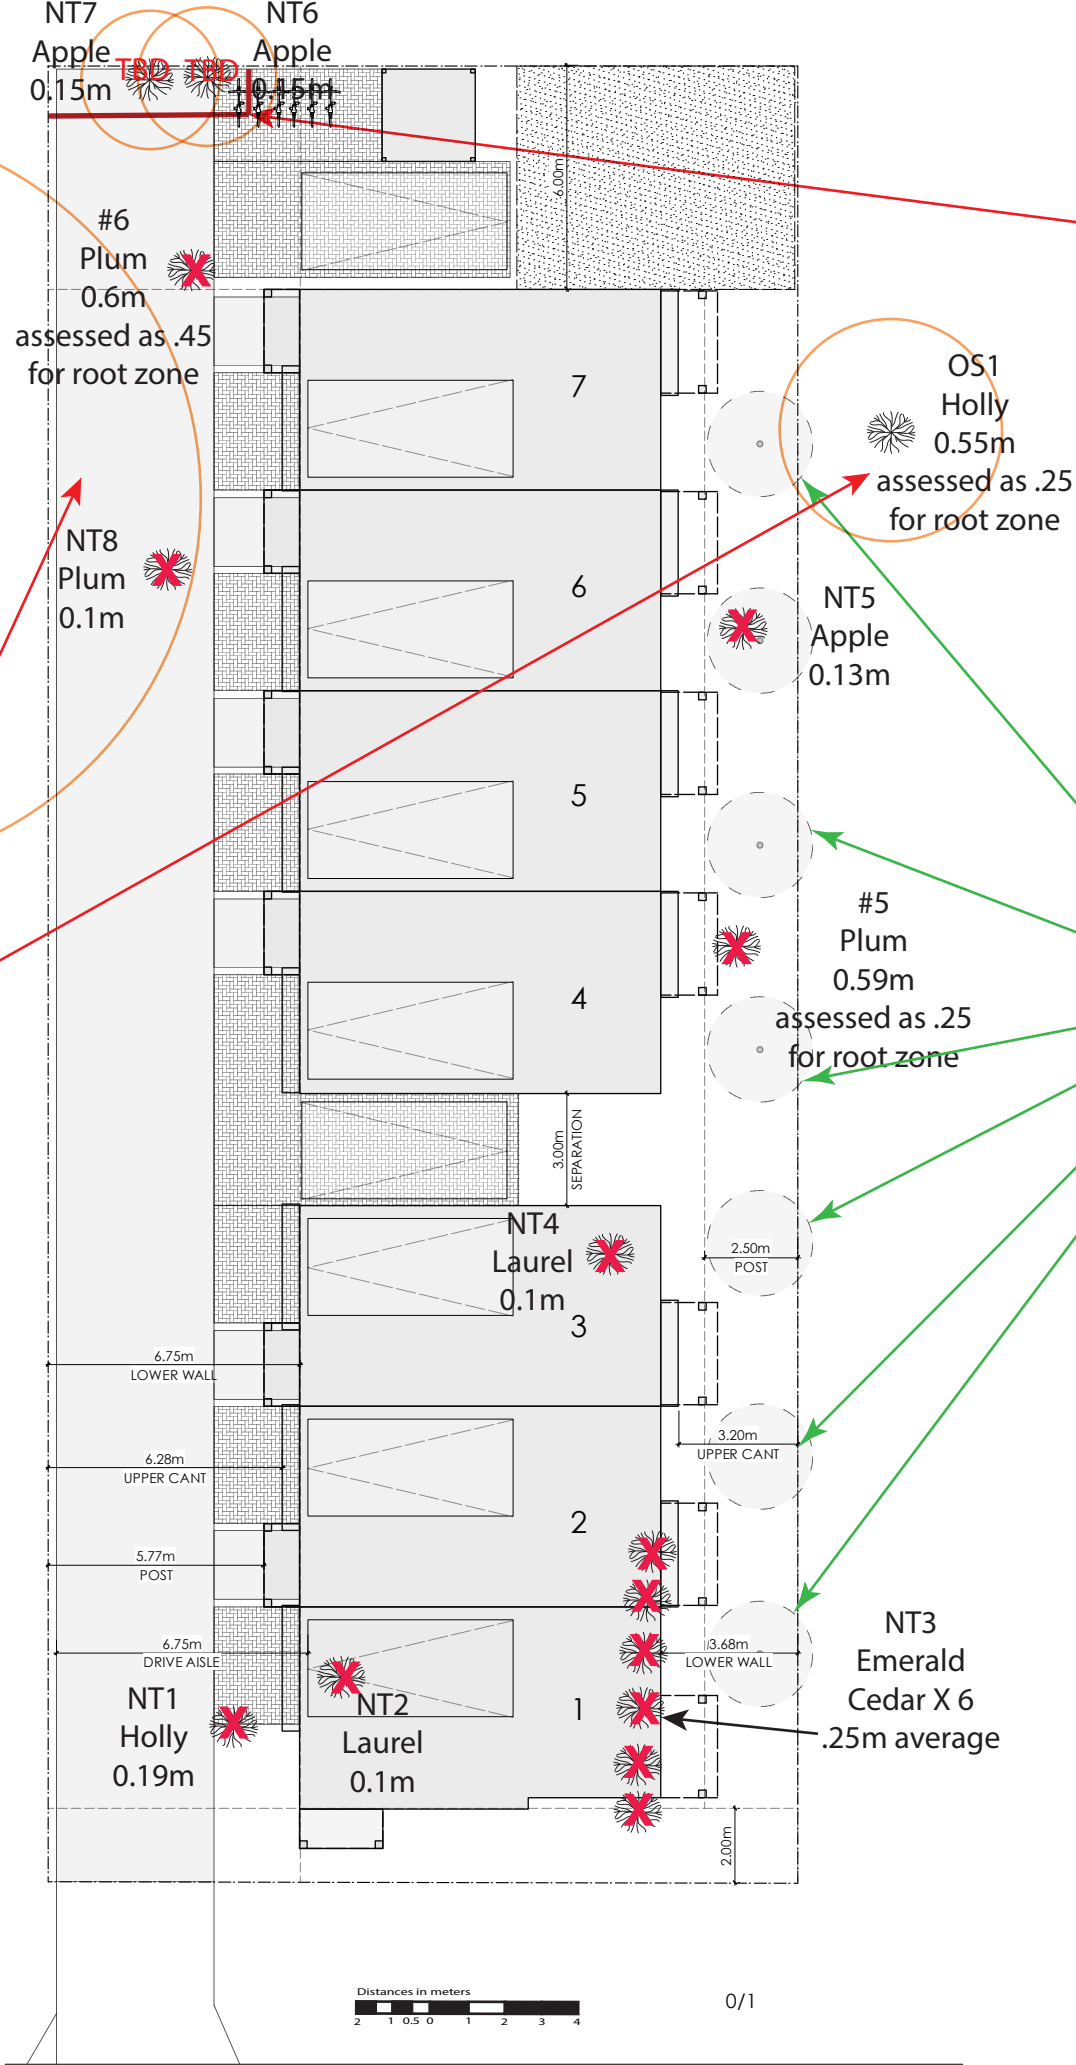
# TREE MANAGEMENT SITE PLAN

Meaningful root loss not expected for off site by law protected trees. Arborist direction required for excavations(and root pruning (if required). Protection signage on property line fence.

If trees to be retained, 10-20 cm surface excavations to large root horizon (>5cm) for permeable surface such as pavers 1.5m from property line. Arborist direction Recomend. Optional protection fence.

In the case of trees OS1 and OS2, arborist supervision is required for excavations occurring within either trees PRZ. *See Tree Management Site Plan.*

Existing fencing along the east and west property lines can be utilized as tree protection fencing for trees OS1 and OS2. The establishment of clearly marked tree protection zones is advised. These zones should be delineated with appropriate signage to ensure that construction access is restricted, and any entry into these areas is subject to the prior approval of an arborist. Further details and specifications regarding the tree protection zones are provided in the attached site plan.

The introduction of organic mulch, like a wood chip material, is recommended to be applied at a thickness of 20 cm in all PRZ's that are proximal to construction activities. Organic mulch will act as a compression material where machinery for excavations will be required to operate within tree PRZ's. Other protective measures to avoid surface compaction may also be applied by the project arborist's direction.
