## Capital Tree Service Inc.

Arborist Report  
903 Admirals Rd,  
Esquimalt BC V9A 2P1  
September 9, 2025

Prepared for:  
Ramtar Developments  
Prepared by:  
Capital Tree Service Inc.

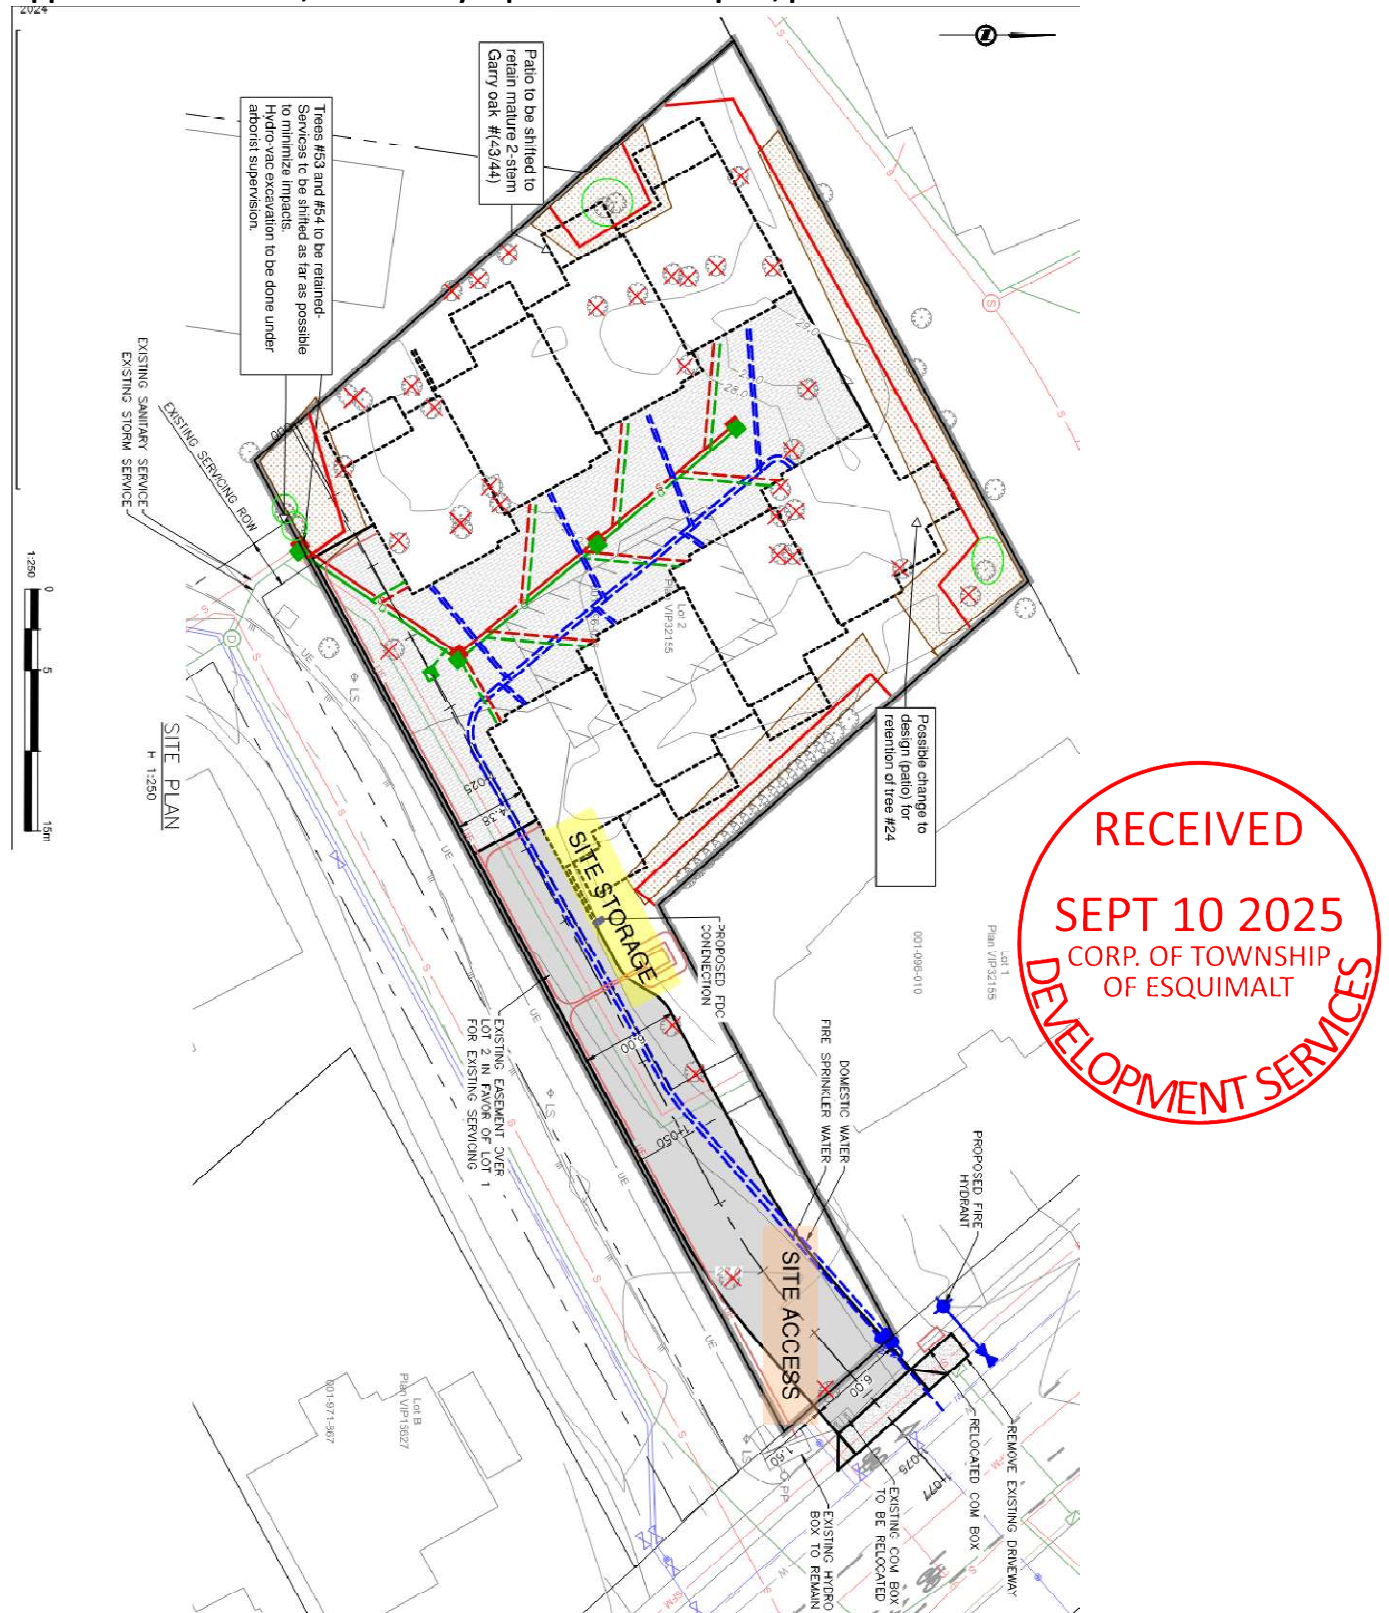
**Figure 1. Site Plan.** Red lines indicate Tree Protection Fencing. See Appendix C for Tree Protection Fencing specifications. Hatched brown indicated anti-compaction required.

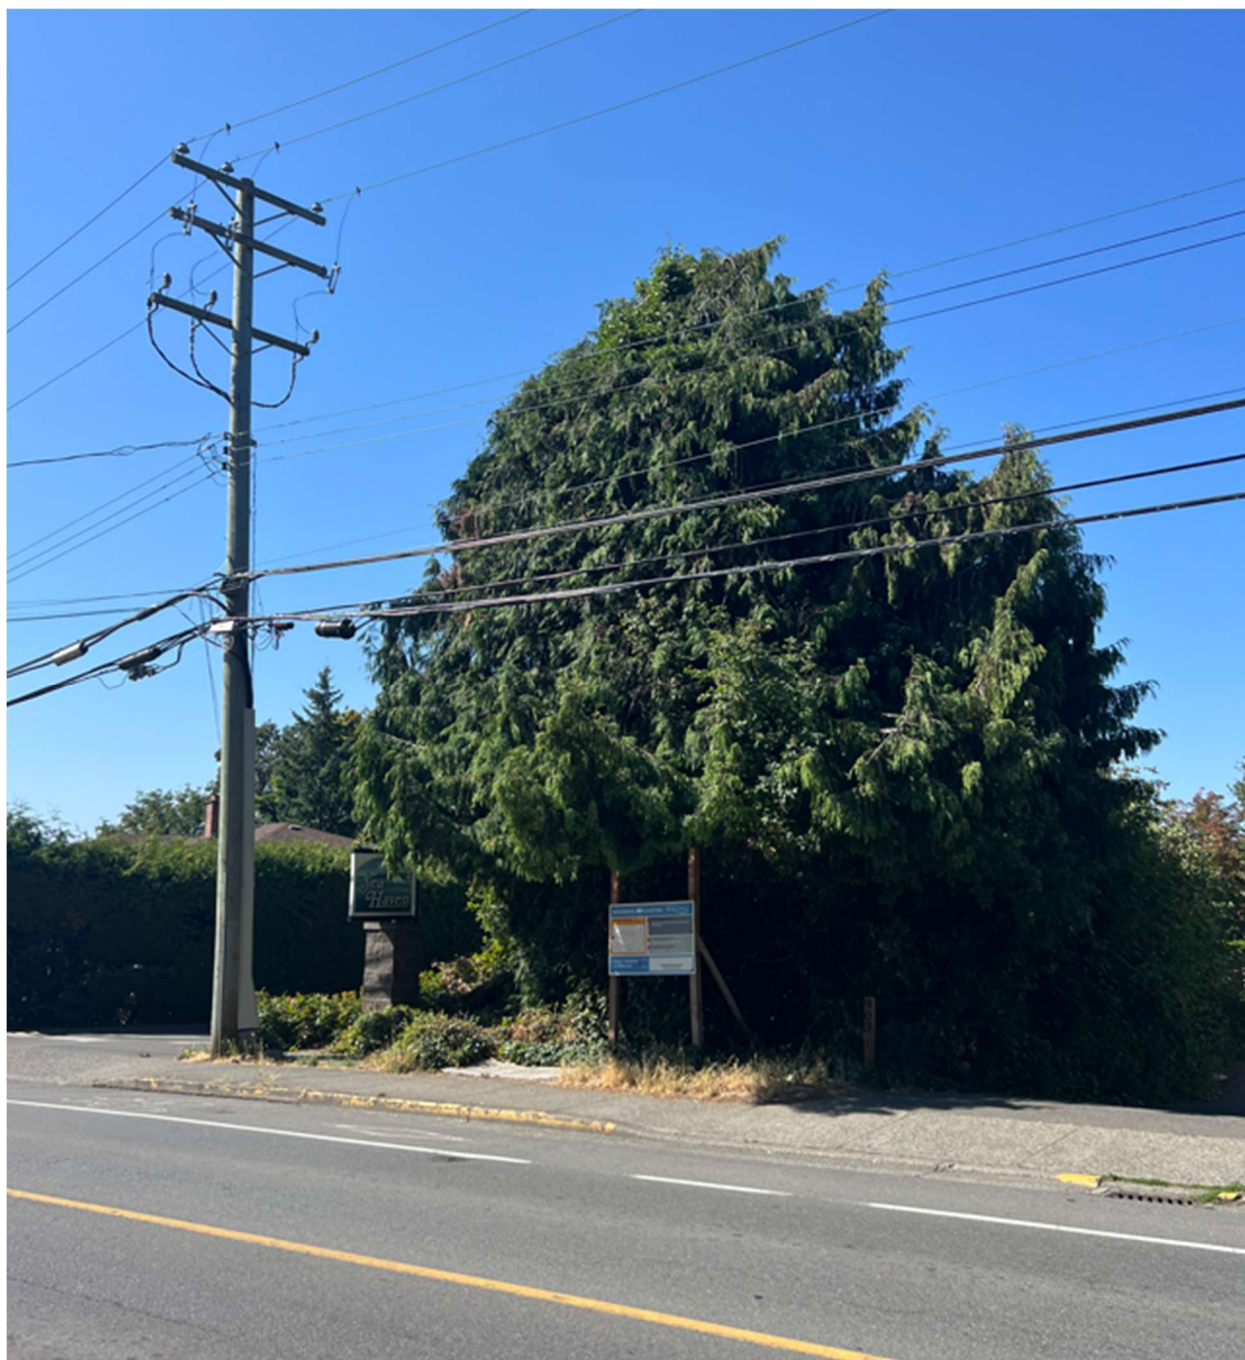
**Figure 3. Streetview of 903 Admirals. Tree #61 above development sign.**

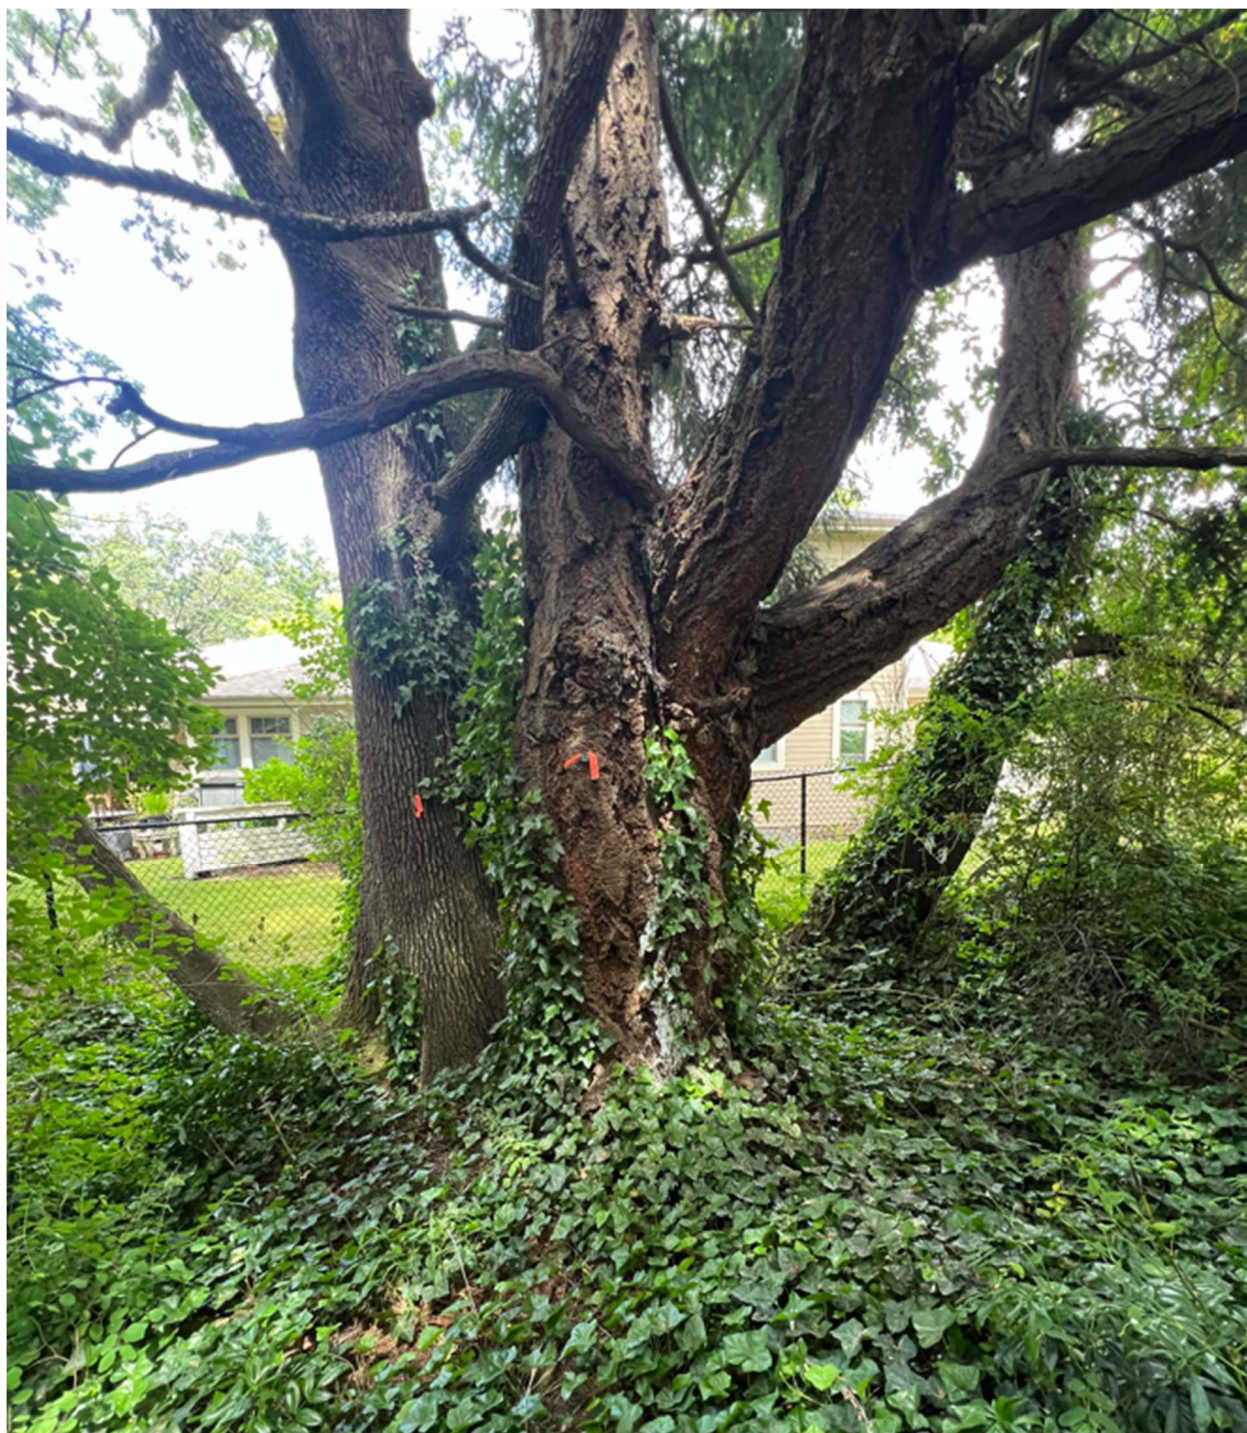
Tree #24, a mature Garry oak in the north-east corner will be retained. The careful removal of nearby tree #23, a Douglas fir with myriad structural deficiencies will be required as several branches from the Oak have intertwined and fused with the Douglas fir. Once the Douglas fir is removed, pruning on the Oak to reduce the canopy to eliminate conflicts with the new building can occur. Deadwood removal and any other maintenance/health pruning may also be done at this time. The remaining stump from tree #23 shall remain in place as it likely has intertwined roots with tree #24. A slight design change may be required shifting the patio from the proposed unit from the north to the east side of the unit- this may be assessed after preliminary site preparation including removal of all other surrounding trees.

| Capital Tree Service Inc. | | | | | | | | |
|---|---|---|---|---|---|---|---|---|
| 23 | Douglas fir | 94 | 11 | 7 | F-P/P | Yes | Remove | Resinosis. Included bark. Embedded branches from neighbouring Oak. Ivy surrounding base to 2.5m. Multi-dominant in crown. Broken top. Previous crown reduction or failures. Poor aspect ratios. Height: 12m |
| 24 | Garry oak | 99 | 12 | 8 | F-P/P | Yes | Retain | Co-dominant at 0.3m, 73+26 dbhs. Ivy around base/ to 3m. Sunken area on basal stem. Deadwood up to 10cm. Some Narrow angles of attachment in canopy. Branches intertwining Douglas fir neighbour #23. |

**Figure 4. View of Northeast corner of property. Trees 24, 23, 25 in frame.**

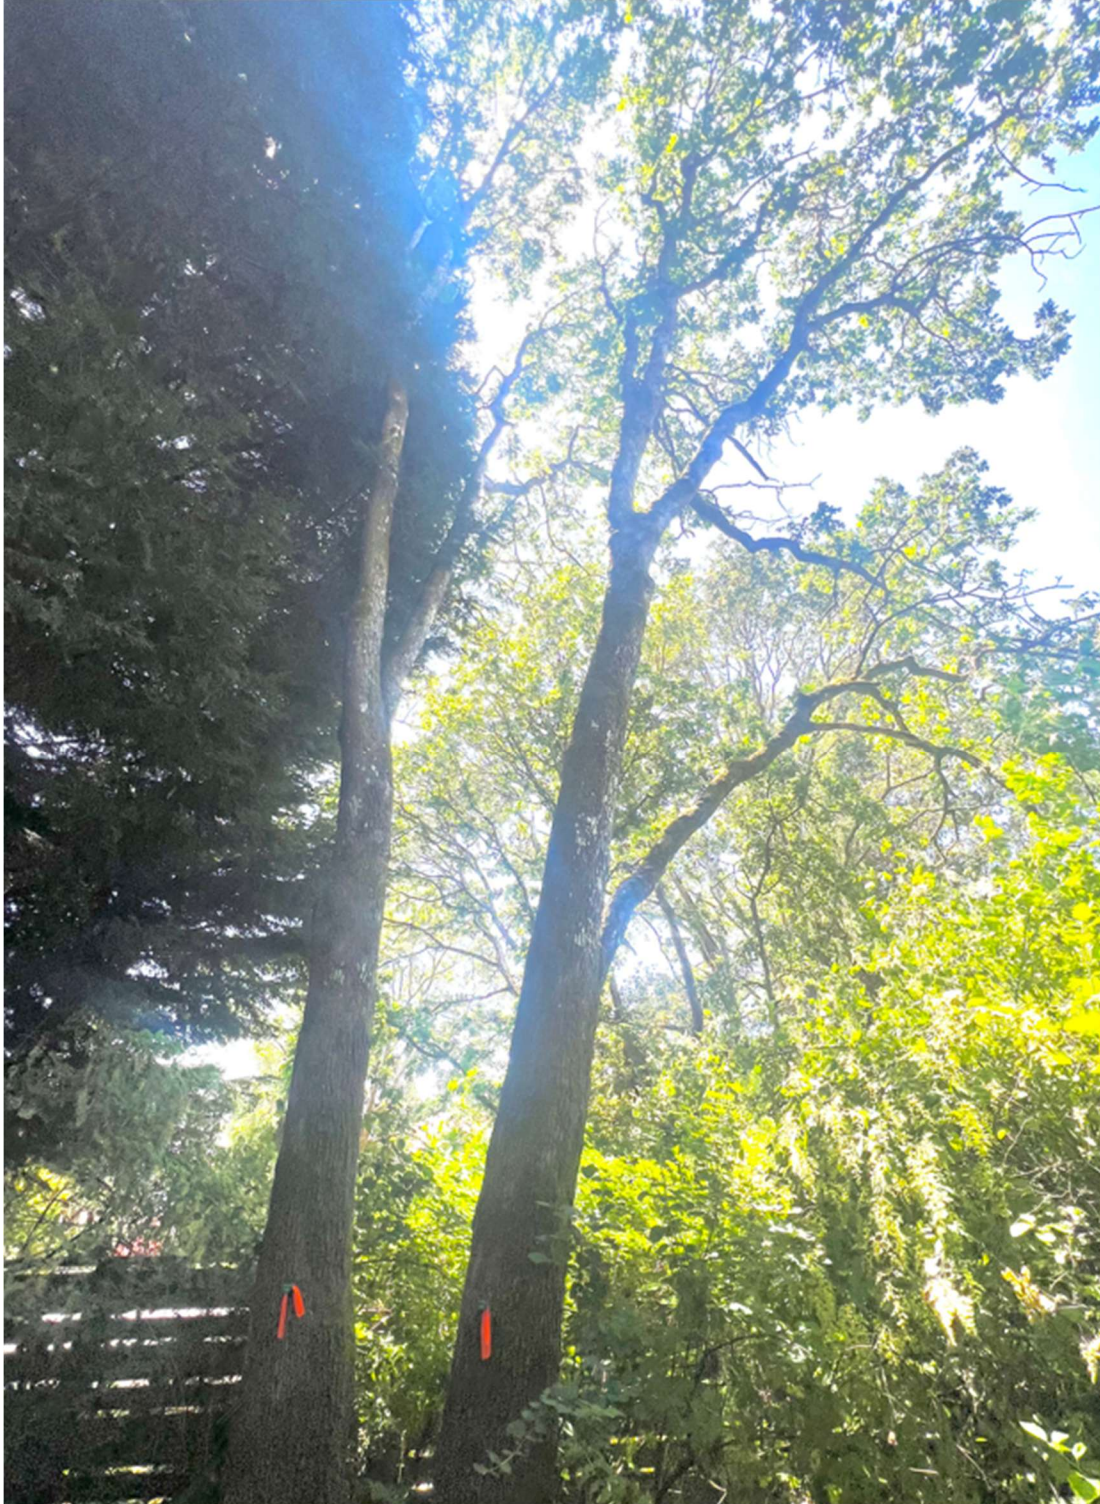
**Figure 5. Tree 43/44**

Tree #43/44, a mature two-stem Garry oak will be retained. Additional assessment after the removal of surrounding trees and preliminary site preparation has occurred may confirm if a cable installation is necessary to address the co-dominant structure. The patio design has been

| 43/44 | Garry oak | 35 | 4 | 5 | F/P | Yes | Retain | Co-dominant stem with #44. Poor live crown ratio. Narrow angles of attachment in canopy. 5cm+ Deadwood. Raised canopy. Uneven canopy. Possible decay at Co-dominant union. |
| | | 37 | 4 | 5 | F/P | | | Co-dominant stem with #43. Poor live crown ratio. Narrow angles of attachment in canopy. 5cm+ Deadwood. Raised canopy. Uneven canopy. Possible decay at Co-dominant union. |

altered to allow for the retention of this tree. Patio installation of this patio, all other patios, and hardscaping within the PRZs of retained trees is to adhere to the following procedure.

1. Remove top layer of organics with a mini excavator under arborist supervision.
2. Lay down a layer of geogrid (Combogrid 30/30).
3. Lay down base material for final surface.
4. Install final surfacing material.

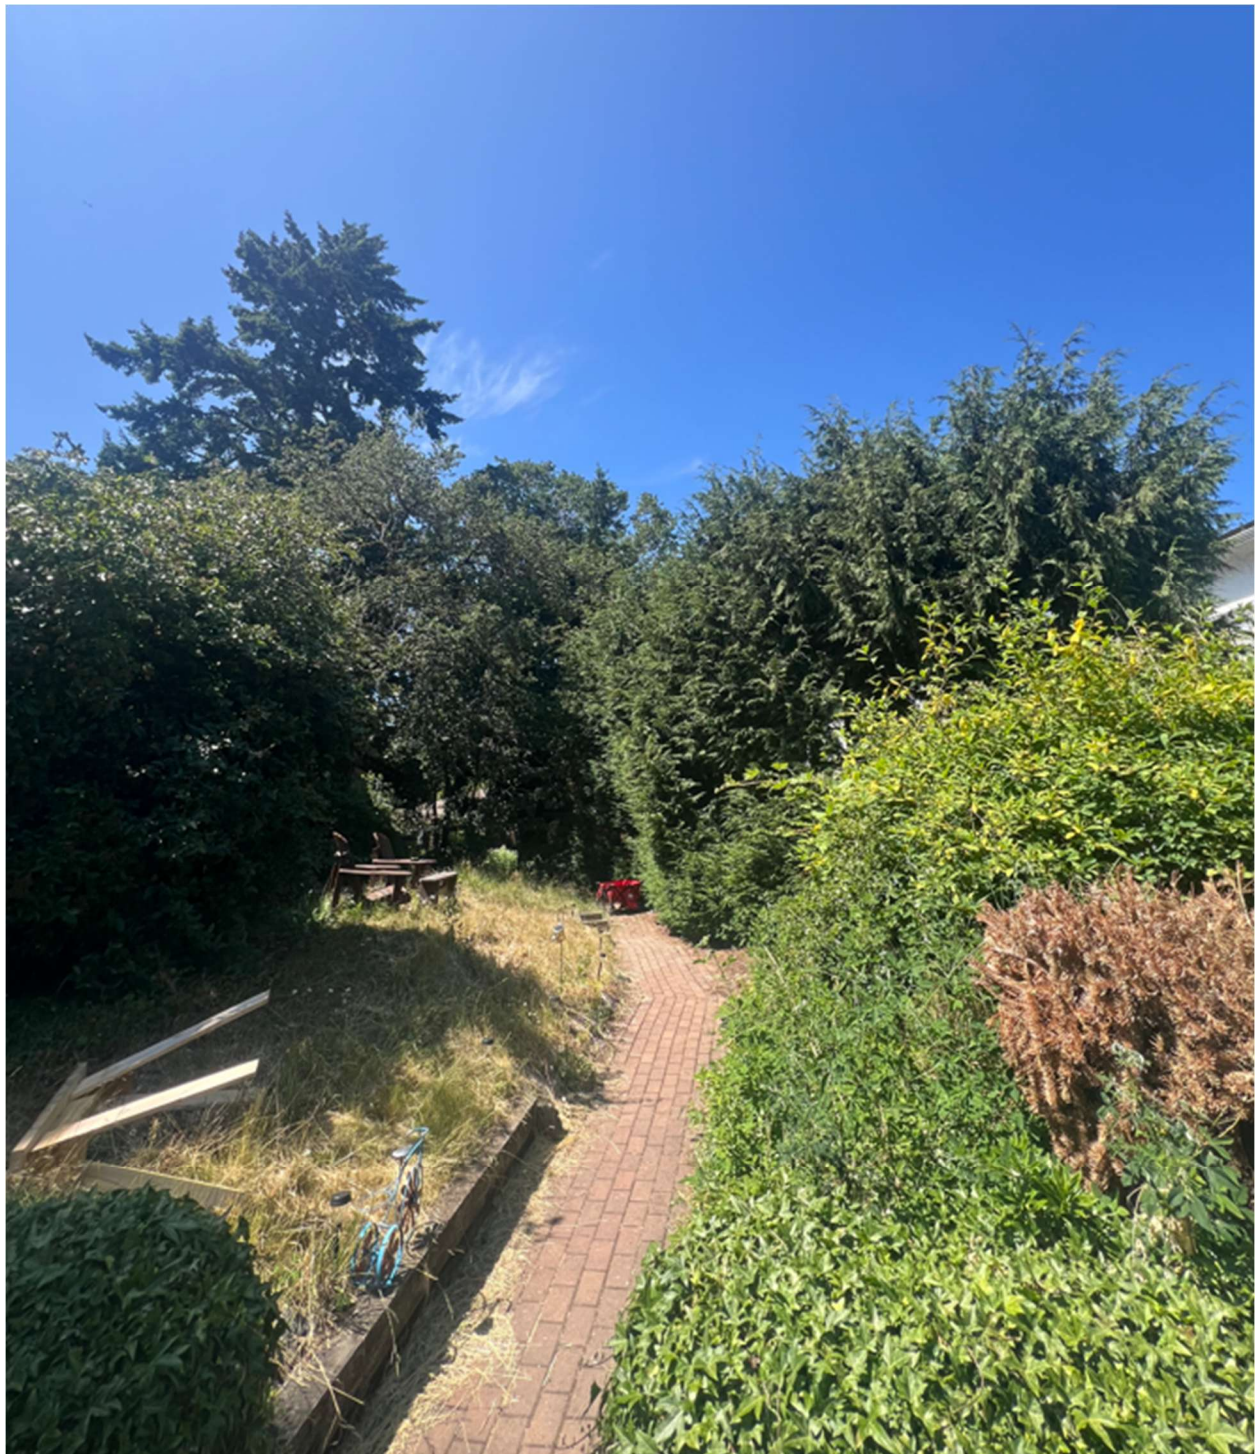
Figure 6. View from driveway looking north.

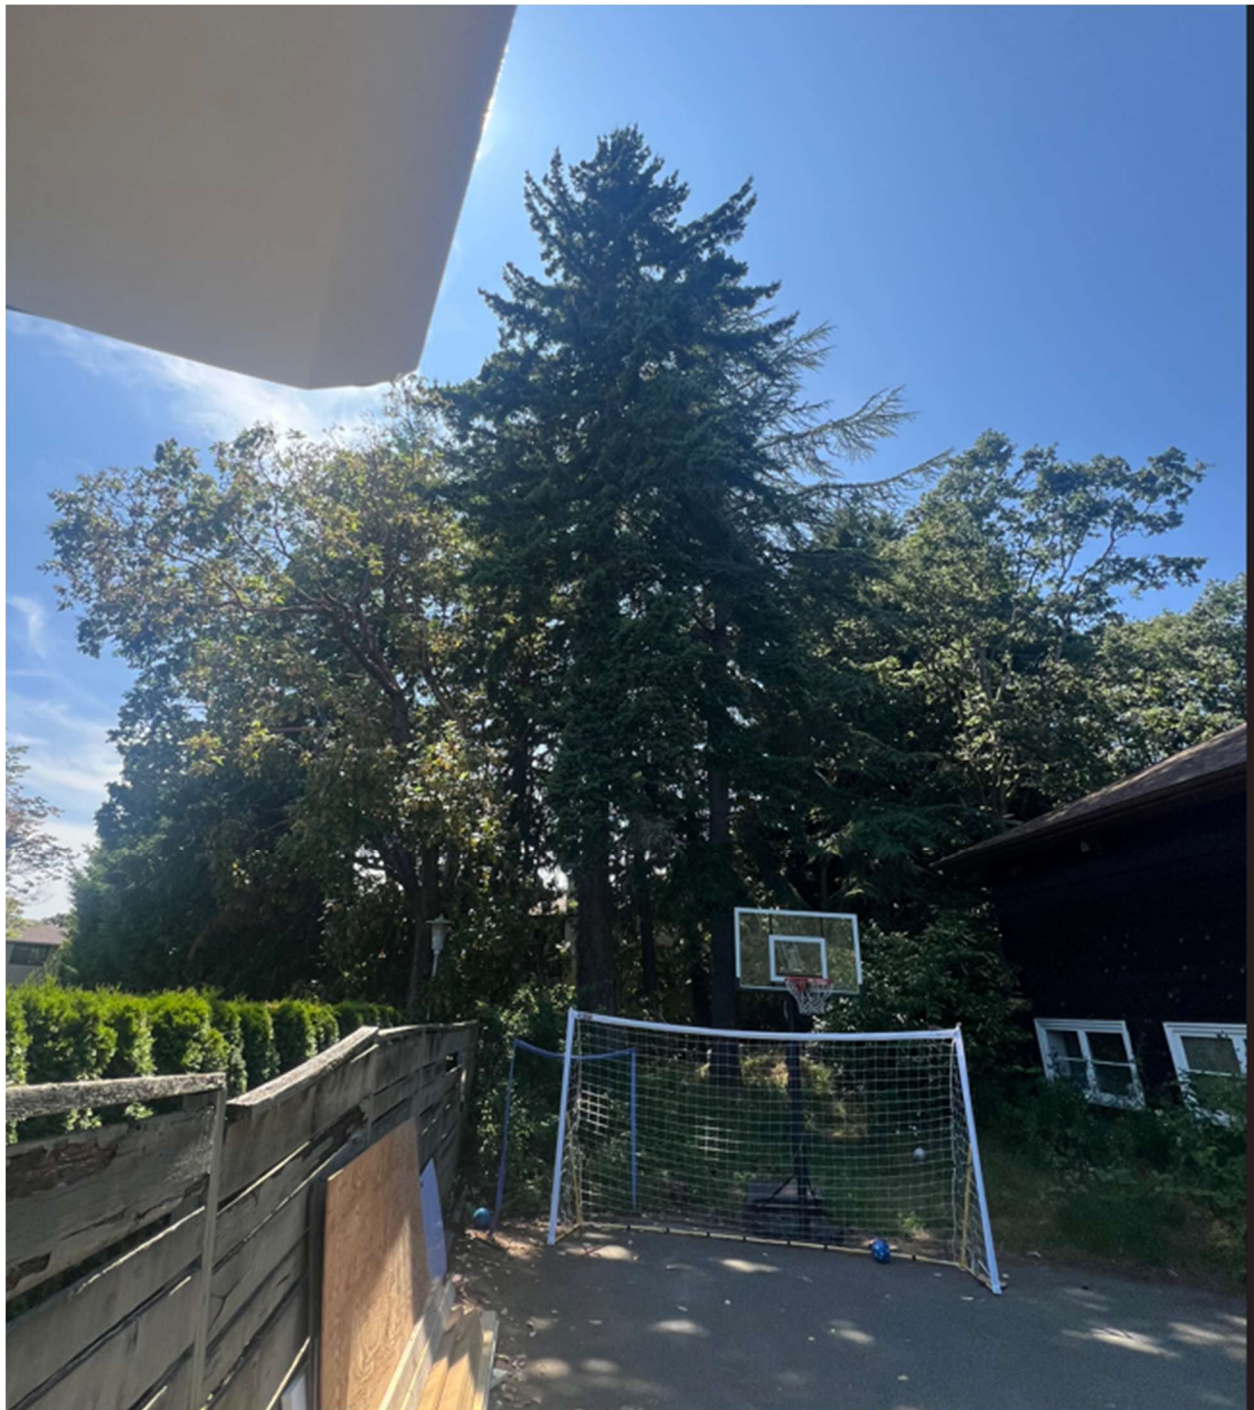
**Figure 7. View from driveway of southwest corner of property.**
