614-618 GRENVILLE AVENUE—
ESQUIMALT, BC
CONSTRUCTION IMPACT ASSESSMENT &
TREE MANAGEMENT PLAN

PREPARED BY: Talmack Urban Forestry Consultants Ltd.
Robert McRae – Consulting Arborist
ISA Certified # PN-7125A
Tree Risk Assessment Qualified
Tree Appraisal Qualified

DATE OF ISSUANCE: September 12, 2023

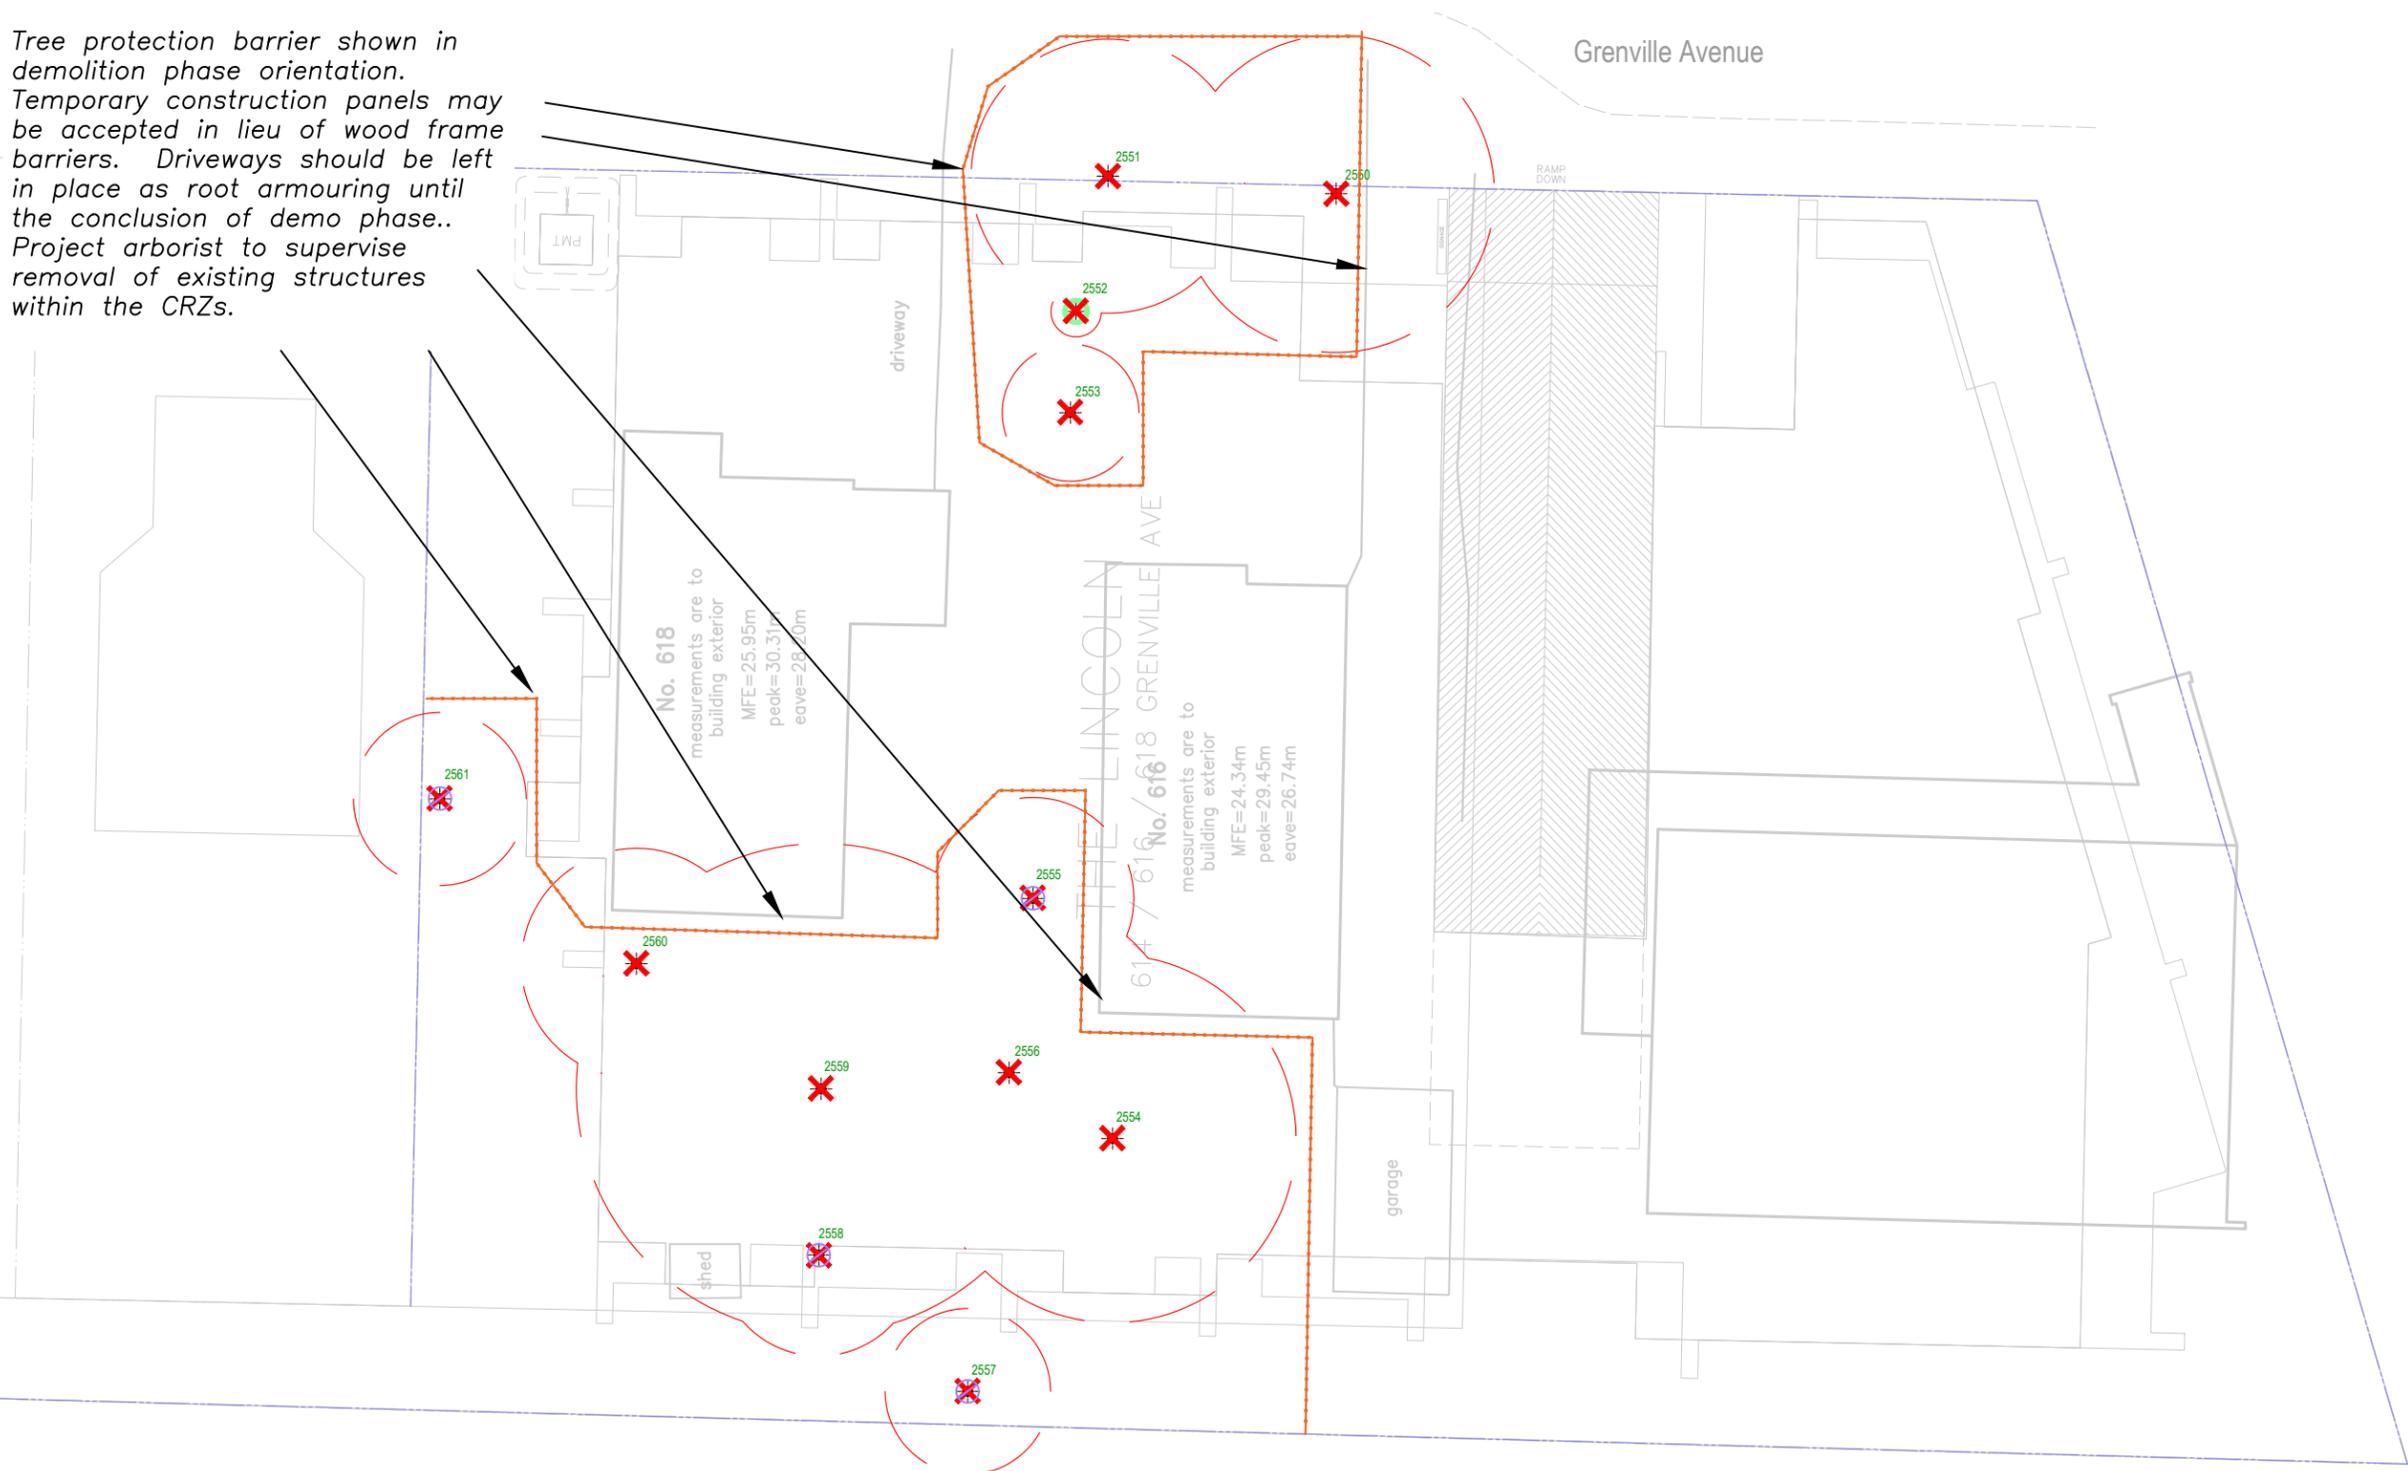
APPENDIX A – TREE MANAGEMENT PLAN

Tree protection barrier shown in demolition phase orientation. Temporary construction panels may be accepted in lieu of wood frame barriers. Driveways should be left in place as root armoring until the conclusion of demo phase.. Project arborist to supervise removal of existing structures within the CRZs.

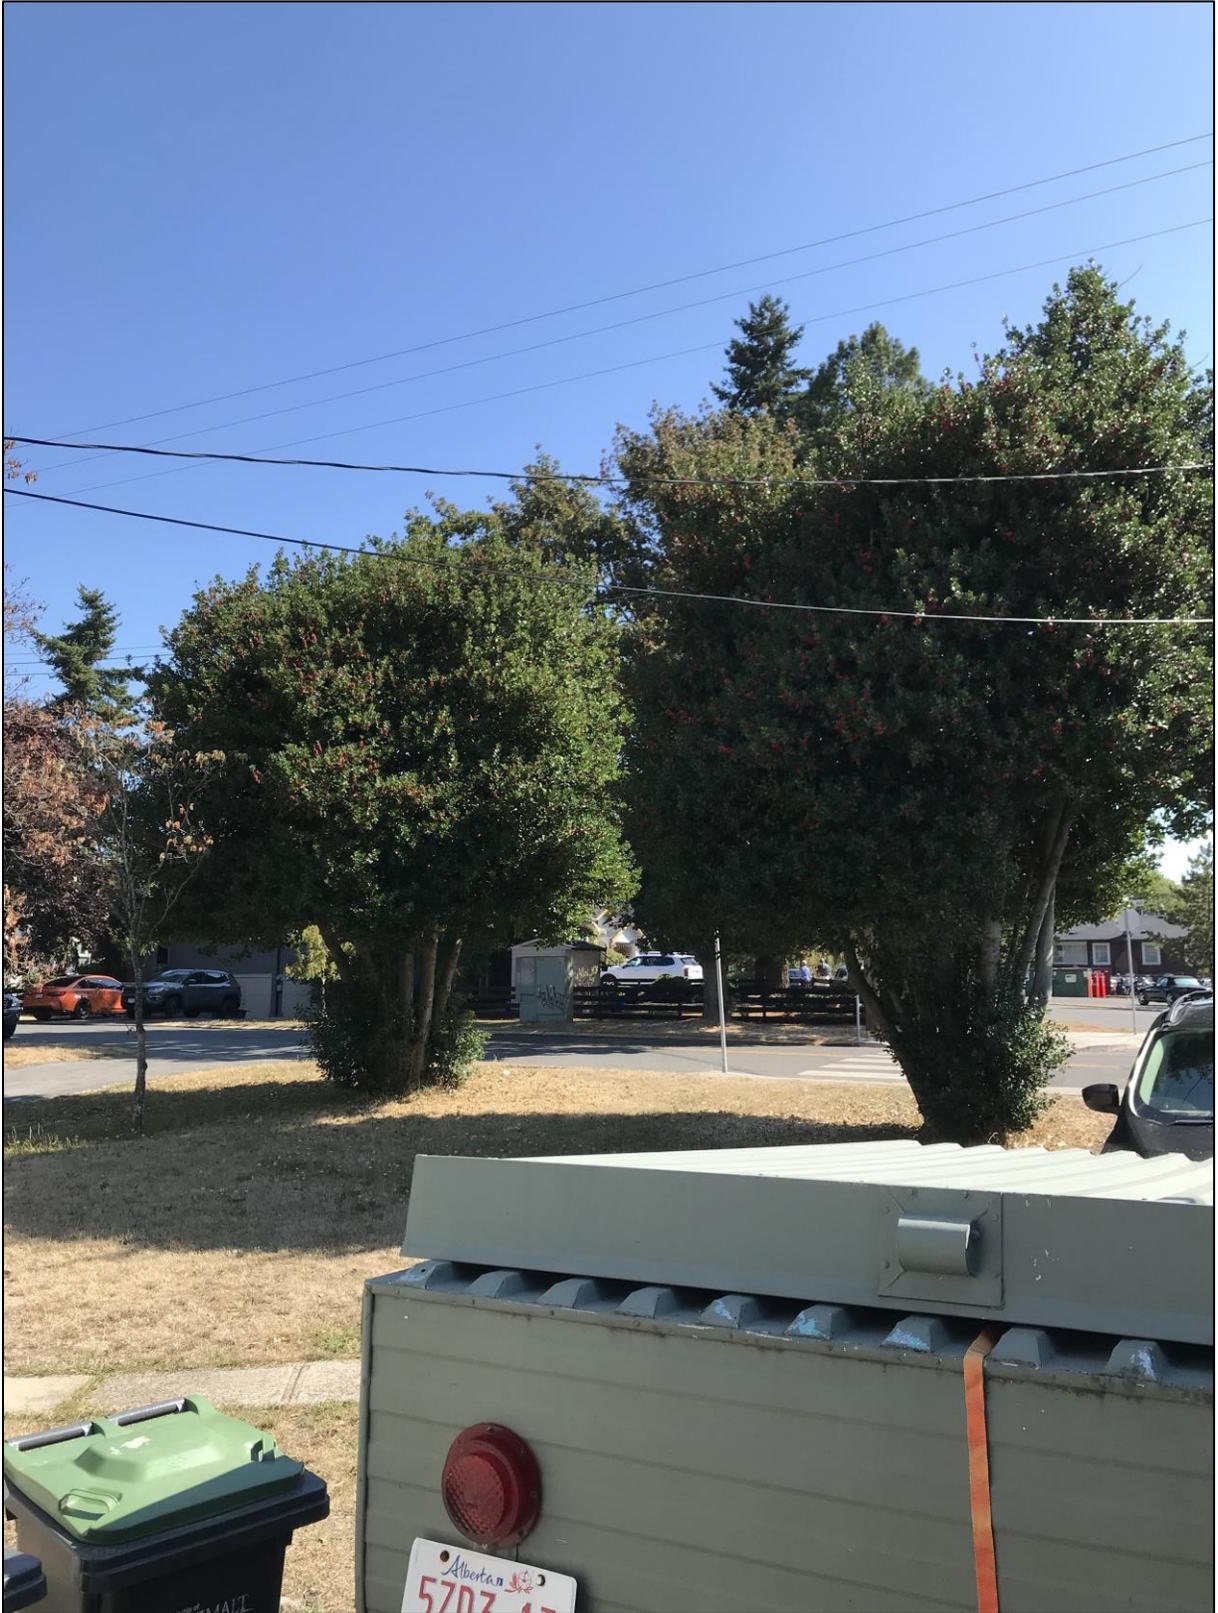
Photograph 1: English Holly #2550 & 2551 (right to left) proposed for removal.

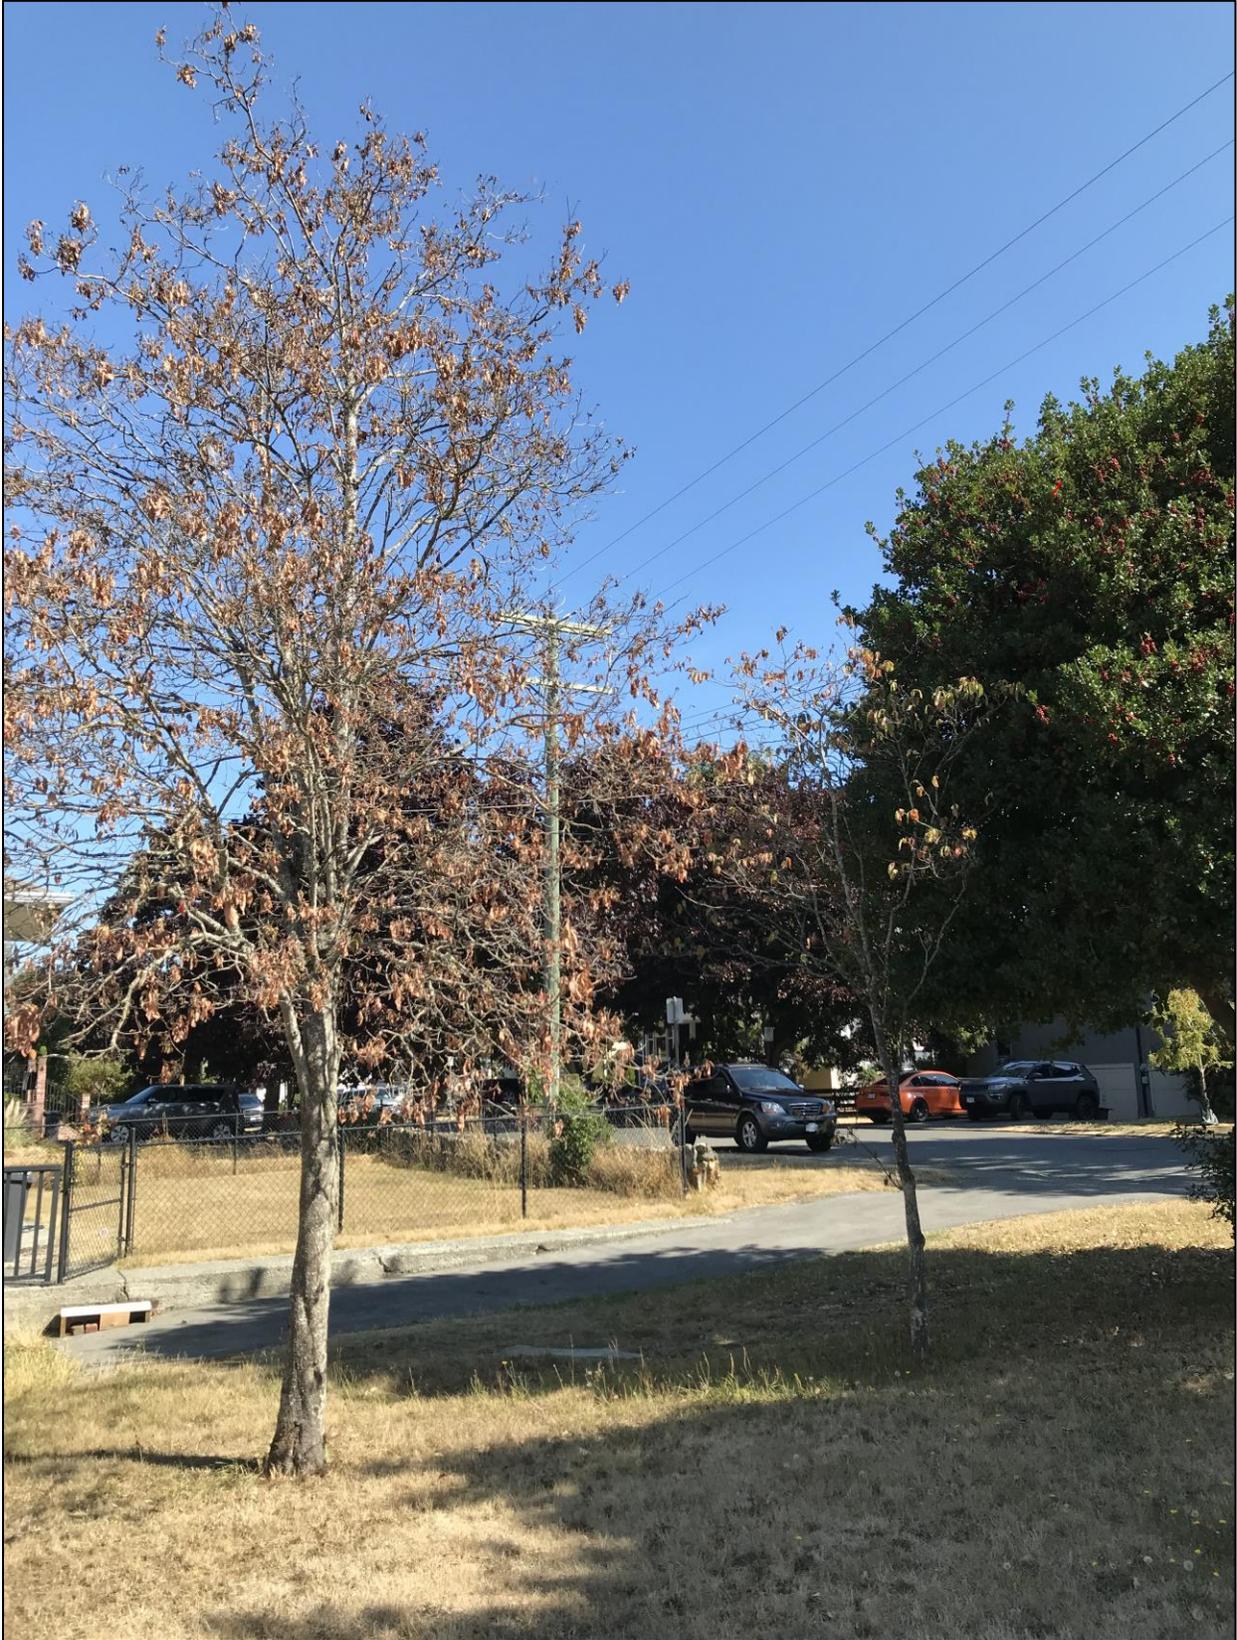
2553	Yes	On-site	Yes	Pacific Dogwood	<i>Cornus nuttallii</i>	19	4	1.9	Good	Poor	Fair	Unsuitable	Drought stress, included bark in unions.	Within footprint of proposed underground parking.	X
2554	Yes	On-site	Yes	Hedge Maple	<i>Acer campestre</i>	23,18,15	10	5.1	Moderate	Good	Fair-poor	Unsuitable	Asymmetrical crown, included bark in unions.	Within footprint of proposed underground parking.	X
2555	Yes	On-site	No	Plum	<i>Prunus spp.</i>	23	5	2.8	Moderate	Fair	Fair-poor	Unsuitable	Epicormic growth, large pruning stubs, asymmetrical crown.	Within footprint of proposed underground parking.	X
2556	Yes	On-site	Yes	Horsechestnut	<i>Aesculus hippocastanum</i>	50	11	5	Good	Good	Fair	Unsuitable	Multiple stems originating at ~2m with included bark in unions.	Within footprint of proposed underground parking.	X
2557	Yes	On-site	No	Jeffrey Pine	<i>Pinus jeffreyi</i>	23	4	2.3	Good	Good	Fair	Unsuitable	Lean south (correcting) damaging fence.	Within footprint of proposed underground parking.	X

Photograph 2: *Pacific Dogwood #2552 & 2553 (right to left) proposed for removal.*

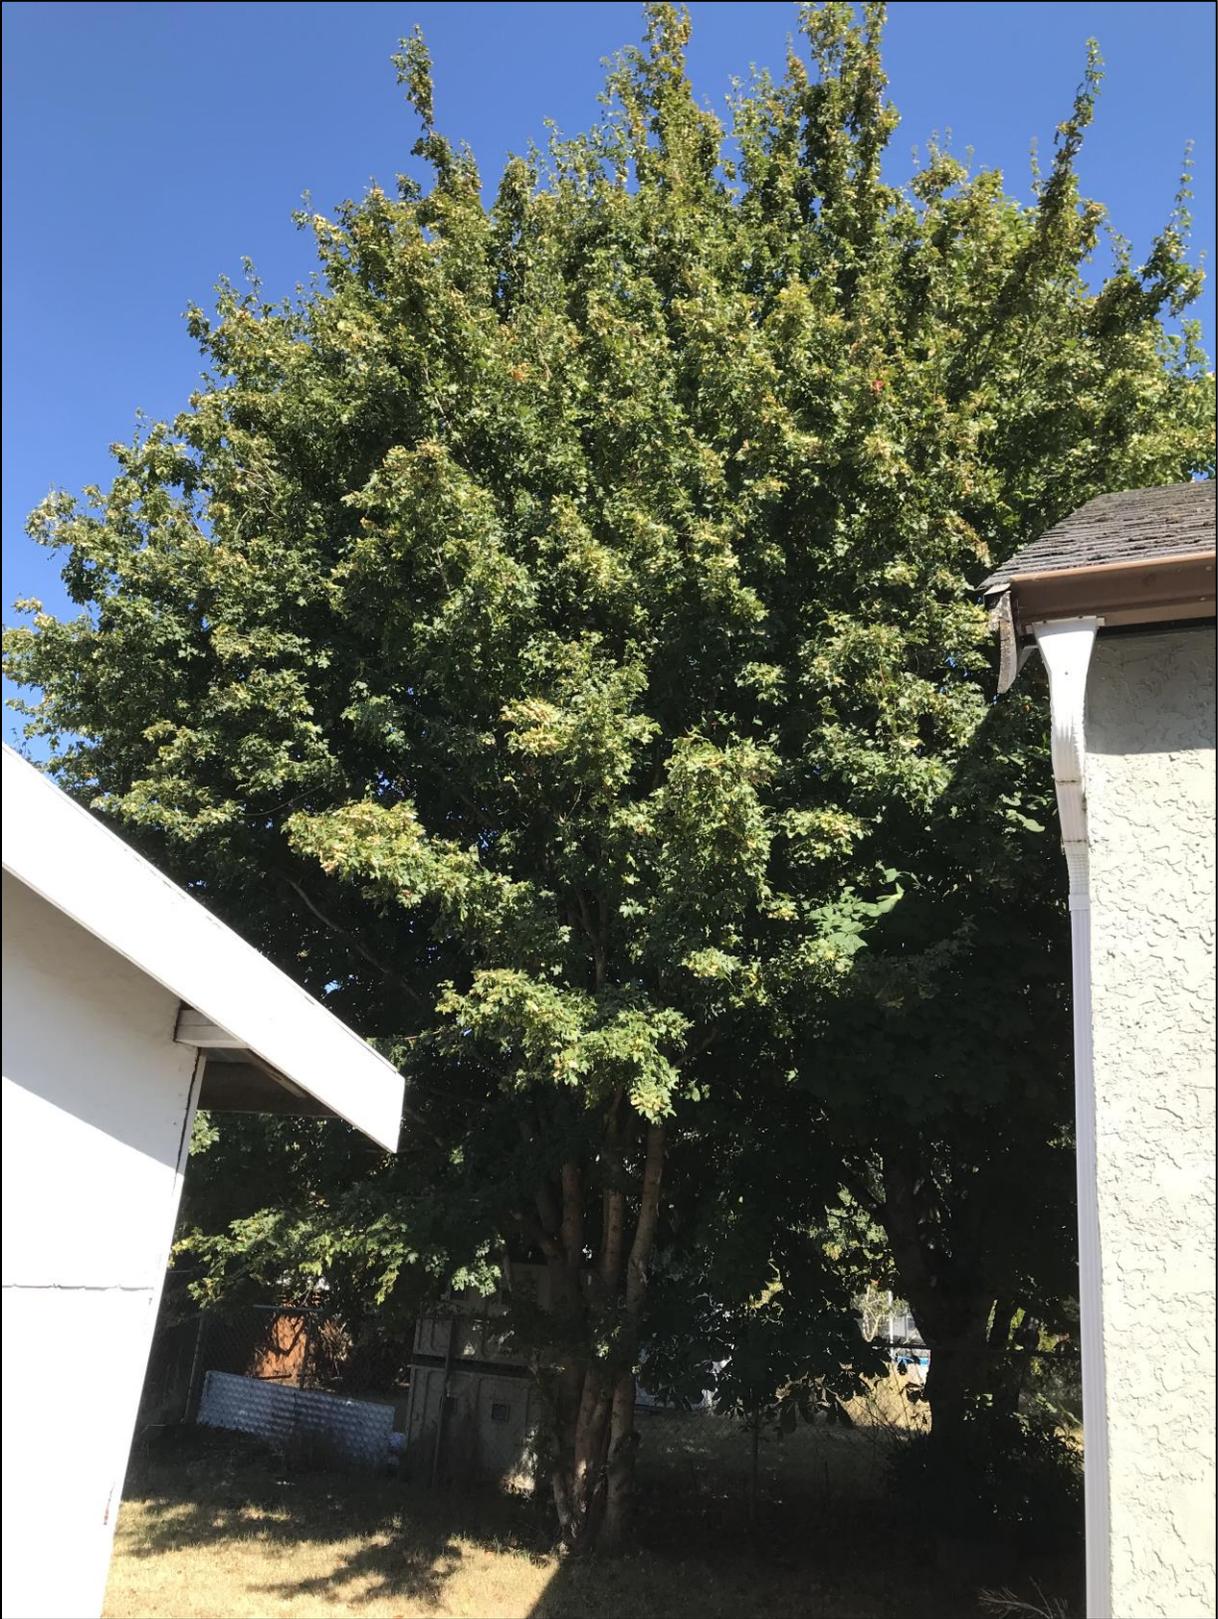
Photograph 3: *Hedge Maple #2554 proposed for removal.*

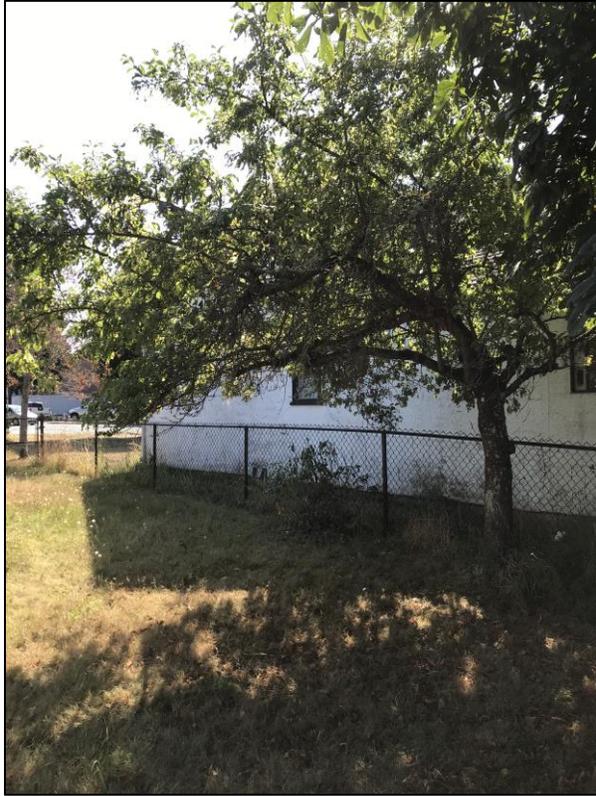
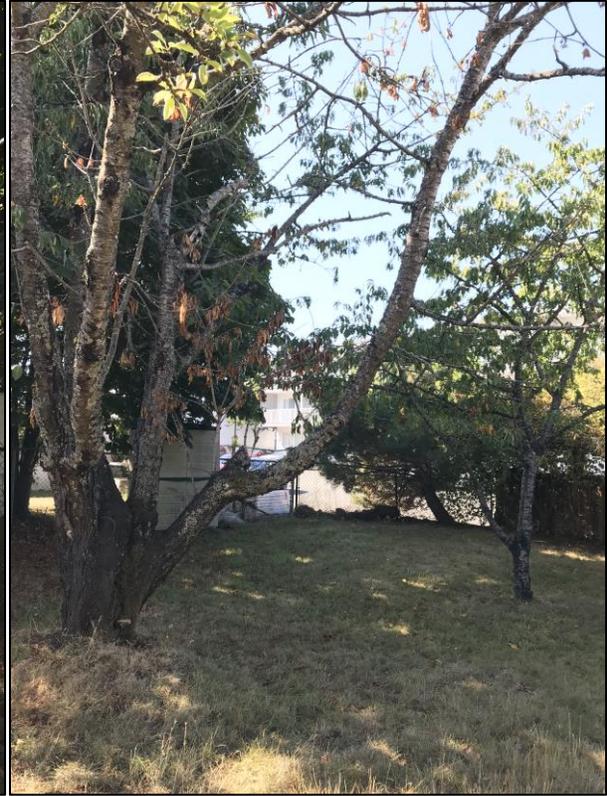
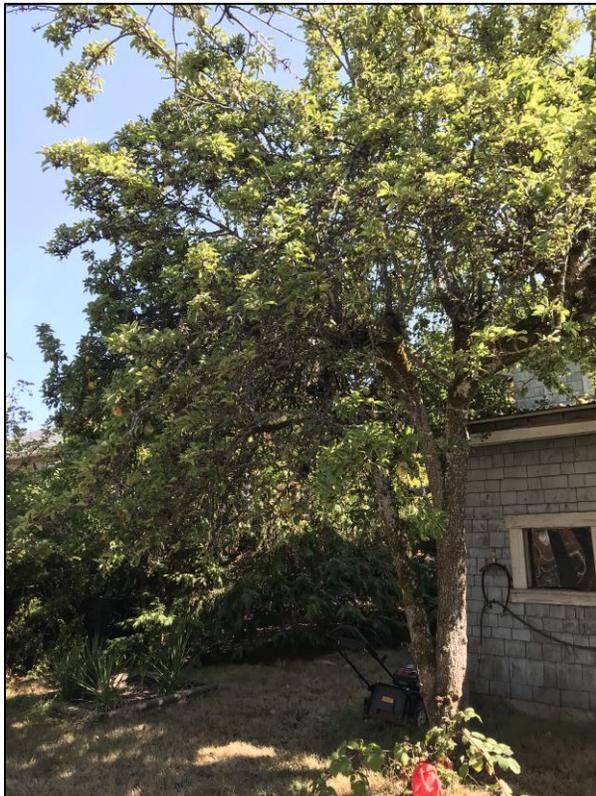
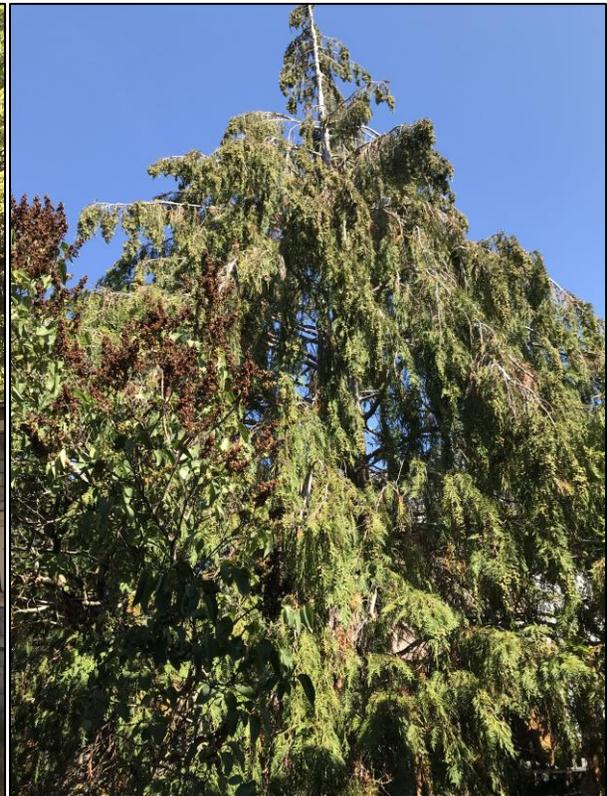
2558	Yes	On-site	No	Cherry	<i>Prunus spp.</i>	16,9,3	5	2.8	Moderate	Fair	Fair	Unsuitable	Health stress, tortrix, included bark.	Within footprint of proposed underground parking.	X
2559	Yes	On-site	Yes	Cherry	<i>Prunus spp.</i>	Multi-stem (29,24,22) largest)	10	6.8	Moderate	Poor	Poor	Unsuitable	Dieback, large dead stems (north side), columns of decay in scaffold limbs, multiple ganoderma fruiting bodies at base.	Within footprint of proposed underground parking.	X

2560	Yes	On-site	Yes	Pear	<i>Pyrus spp.</i>	23,15	7	3.2	Moderate	Fair-good	Fair	Unsuitable	Pruned for fruit production historically, included bark in primary stem union.	Within footprint of proposed underground parking.	X
2561	Yes	On-site	No	Lawson Cypress	<i>Chamaecyparis lawsoniana</i>	24	7	2.4	Good	Fair-good	Fair-good	Unsuitable	Extended limbs, sparse top.	Within footprint of proposed underground parking.	X
2562	Yes	On-site	Yes	Douglas-fir	<i>Pseudotsuga menziesii</i>	59	10	8.9	Poor	Fair-good	Fair	Conditional	Rooted adjacent to retaining wall, deflected trunk, majority of canopy removed (to trunk) on west side over parking lot, epicormic growth.		Retain
2563	Yes	On-site	Yes	Douglas-fir	<i>Pseudotsuga menziesii</i>	47	9	7.1	Poor	Fair	Poor	Conditional	Topped at ~5m with large deflected leaders (one extended south), majority of canopy removed west side over parking lot.		Retain
2564	Yes	On-site	Yes	Douglas-fir	<i>Pseudotsuga menziesii</i>	39	8	5.9	Poor	Fair	Fair-poor	Conditional	Topped with deflected leader, small deadwood		Retain

Photographs 4-7: Plum #2555 (upper left), Horsechestnut #2556 (upper right, background), Jeffrey Pine #2557 (upper right, background), Cherry #2558 & 2559 (upper right), Pear #2560 (lower left), Lawson Cypress #2561 (lower right)—proposed for removal.

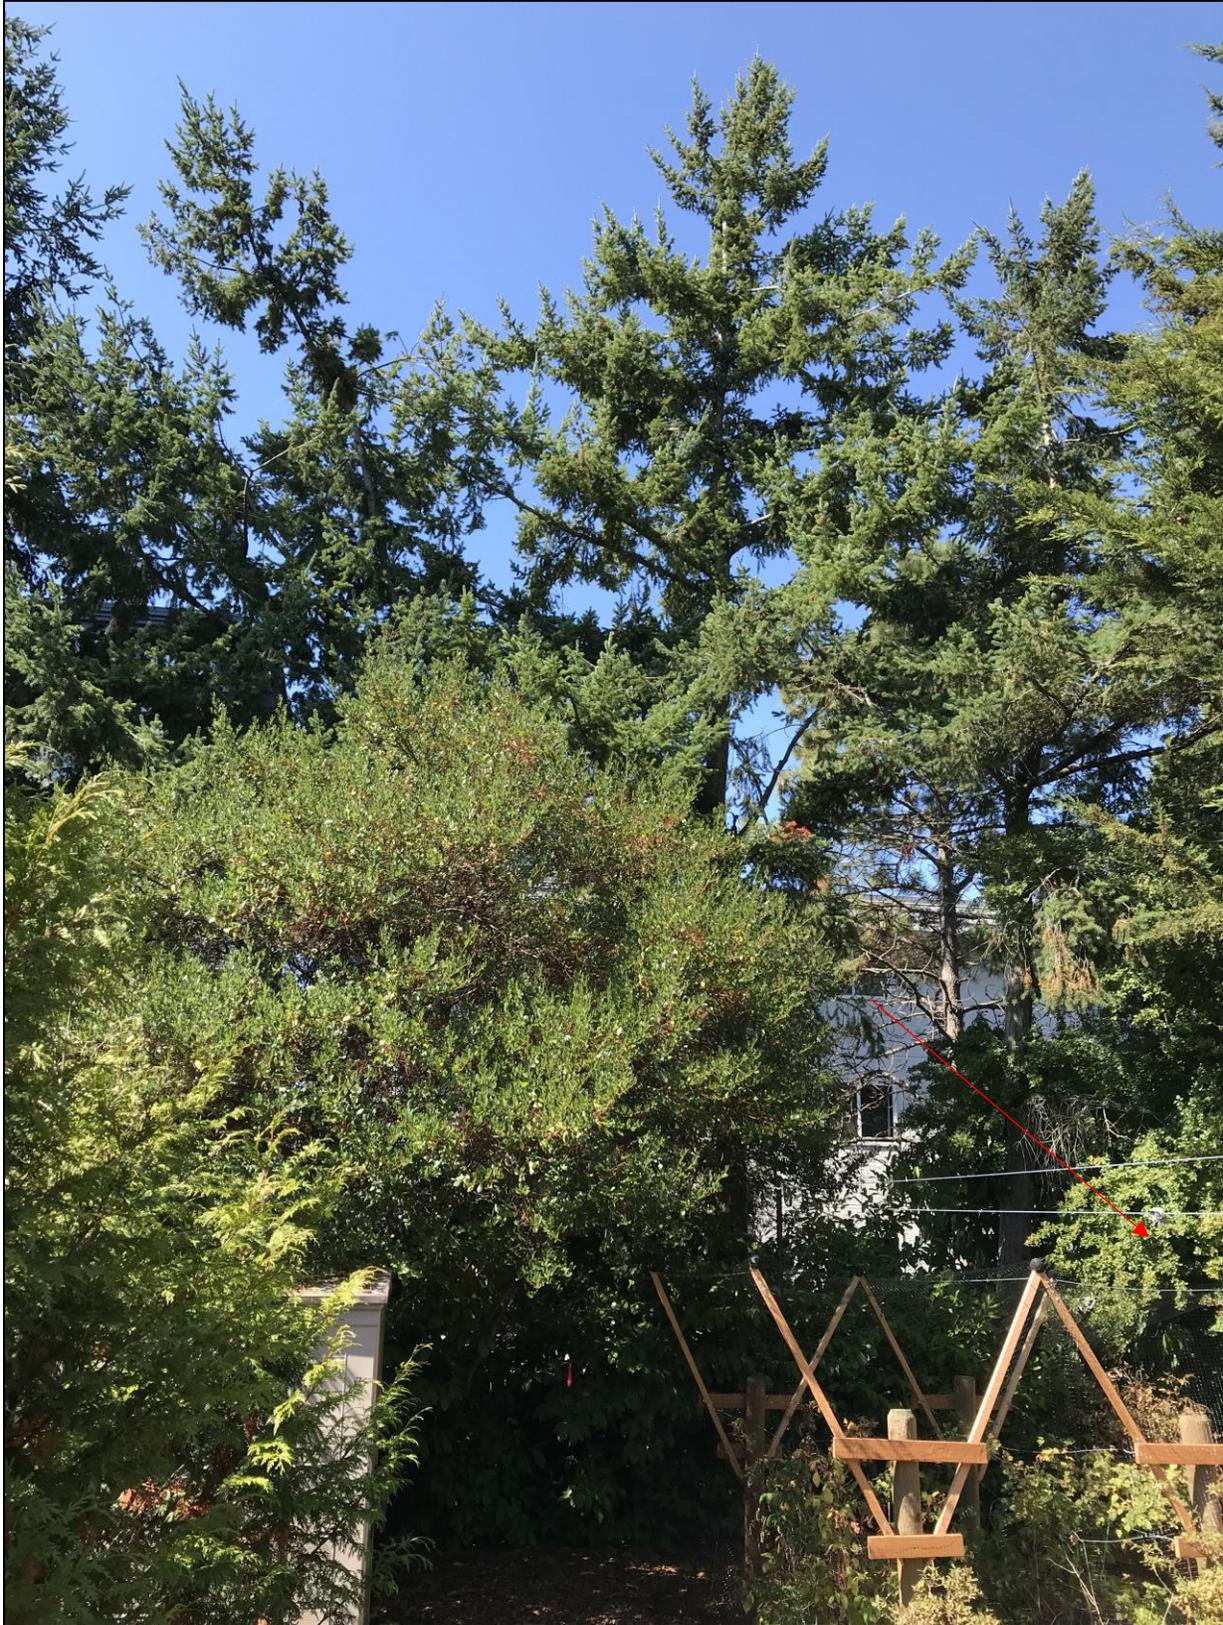
2565	Yes	On-site	Yes	Douglas-fir	<i>Pseudotsuga menziesii</i>	38	8	5.7	Poor	Fair	Fair-poor	Conditional	Topped with deflected leader, small deadwood		Retain
2566	Yes	Shared	Yes	European Hawthorn	<i>Crataegus monogyna</i>	15,14,13	6	3.1	Good	Fair	Fair-poor	Conditional	Multiple stems, extensive epicormic growth. Possibly shared between three properties. Invasive species.		Retain
NT1	Yes	On-site	Yes	Plum	<i>Prunus spp.</i>	26,17,17	6	5.6	Moderate	Fair	Fair	Suitable	Pruned for fruit production.		Retain
NT2	Yes	On-site	Yes	European Birch	<i>Betula pendula</i>	39	11	5.9	Poor	Fair-good	Fair-poor	Conditional	Topped at ~6m with new deflected leaders.		Retain
NT3	Yes	On-site	Yes	European Birch	<i>Betula pendula</i>	33	10	5	Poor	Fair-good	Fair-poor	Conditional	Topped at ~6m with new deflected leaders.		Retain
NT4	Yes	Off-site	Yes	Plum	<i>Prunus spp.</i>	~20,12,6	9	3.7	Moderate	Fair	Fair-poor	Conditional	Multiple stems, extensive epicormic growth.		Retain

Photograph 8: *Douglas-firs #2562-2565 (left to right), European Hawthorn #2566 (red arrow); canopy of Leyland Cypress NT8 visible (right frame).*
