1100-1108 Esquimalt Road and 610-612 Lampson Street, Esquimalt

Construction Impact Assessment & Tree Preservation Plan

DATE OF ISSUANCE: February 21, 2019
Updated: August 28, 2020

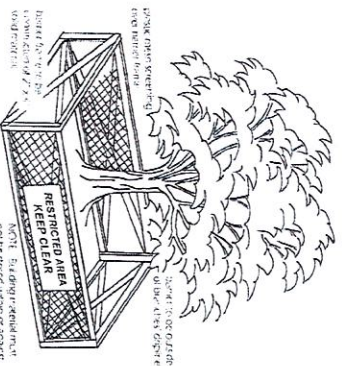
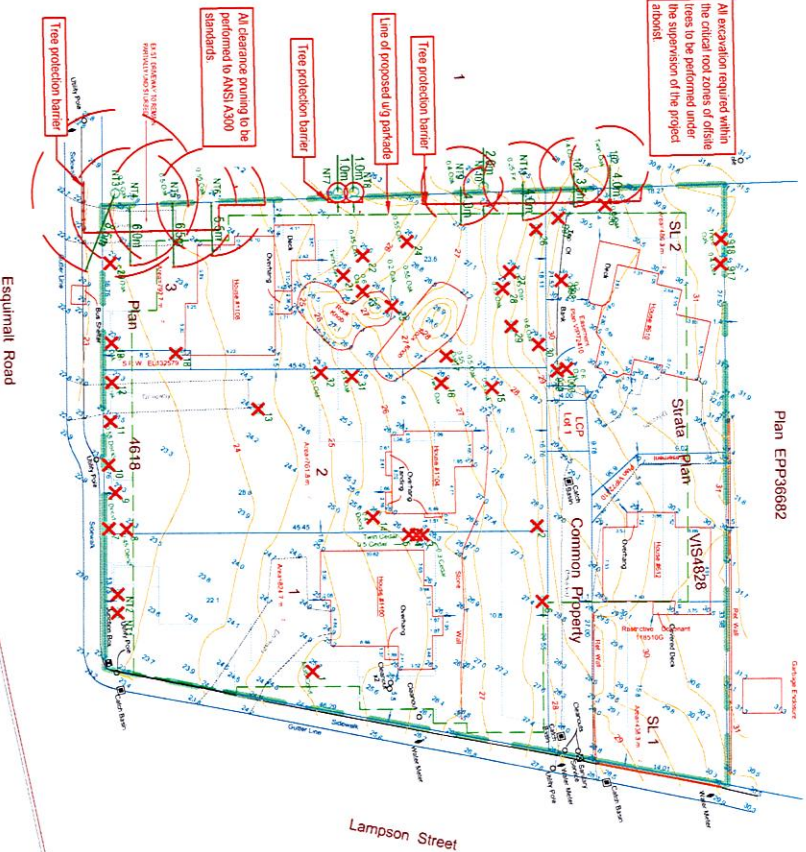
Sketch T1

- Barrier fencing must be erected around trees NT3-NT11 as shown on the attached tree management plan (Sketch T1) following removal of the existing driveway slab to minimize soil compaction and to avoid damaging critical roots. The existing shrubbery at the base of the trees will provide a natural barrier to construction equipment accidentally damaging their trunks until the fencing is erected.

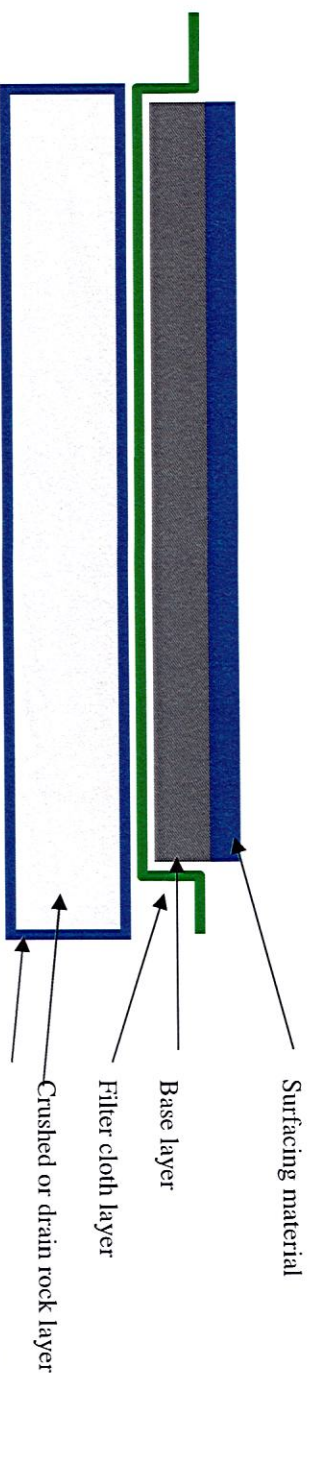
Diagram – Site Specific Driveway, Parking and Walkway

If the new paved surfaces within the CRZ of tree to be retained require excavation down to bearing soil and roots are encountered in this area, this could impact their health and structural stability. If tree retention is desired, a raised and permeable paved surface should be constructed in the areas within the critical root zone of the trees. The “paved surfaces above root systems” diagram and specifications is attached.

1. Excavation for construction of the driveway/parking/walkway areas must remove only the top layer of sod and not result in root loss
2. A layer of medium weight felted Geotextile fabric (Nilex 4535, or similar) is to be installed over the entire area of the critical root zone that is to be covered by the paved surface. Cover this Geotextile fabric with a layer of woven Amoco 2002 or Tensar BX 1200. Each piece of fabric must overlap the adjoining piece by approximately 30-cm.

3. A 10cm layer of torpedo rock or 20-mm clean crushed drain rock, is to be used to cover the Geotextile fabric (depth dependent on desired finished grade).

4. A layer of felted filter fabric is to be installed over the crushed rock layer to prevent fine particles of sand and soil from infiltrating this layer.

5. The bedding or base layer and permeable surfacing can be installed directly on top of the Geotextile fabric.
6. Two-dimensional (such as CombiGrid 30/30 or similar) or three-dimensional geo-grid reinforcements can be installed in combination with, or instead of, the geotextile fabric specified in the attached diagram.

7. Ultimately, a geotechnical engineer should be consulted and in consultation with the project arborist may specify their own materials and methods that are specific to the site's soil conditions and requirements, while also avoiding root loss and reducing compaction to the sub-grade.
