820 Dunsmuir Rd, Esquimalt

Construction Impact Assessment & Tree Preservation Plan

Date of Issuance: December 12, 2019
Updated: August 24, 2021

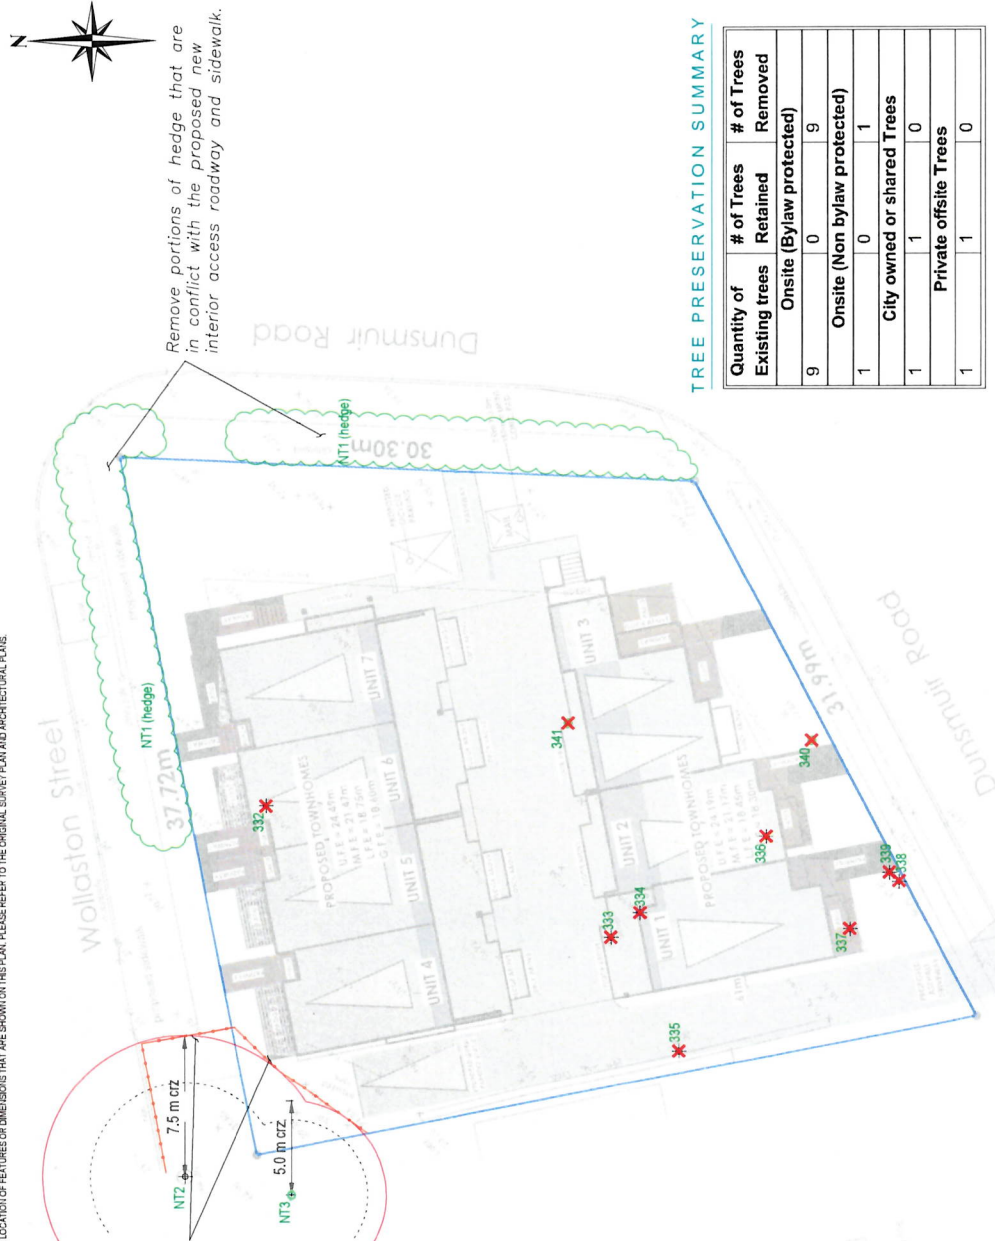
Tree Management Plan - T11
820 Dunsmuir Road
Essex, BC

Remove portions of hedge that are in conflict with the proposed new interior access roadway and sidewalk.

We recommend that an effort be made to minimize the extent of excavation outside the patio area and onto the municipal boulevard. The project arborist must supervise any excavation within the CRZ of this tree (7.5m). We do not anticipate its health or structural stability will be significantly impacted if our recommendations are followed. Barrier fencing should be erected in the locations shown on the attached tree management plan (T1).

We recommend the project arborist supervise any excavation or blasting required within the CRZ of this tree (5.0 meters) and barrier fencing be erected in the locations shown on the attached tree management plan (T1).
