820 Esquimalt Road, 833-837 Old Esquimalt Road—Esquimalt, BC

Construction Impact Assessment & Tree Management Plan

April 06, 2022

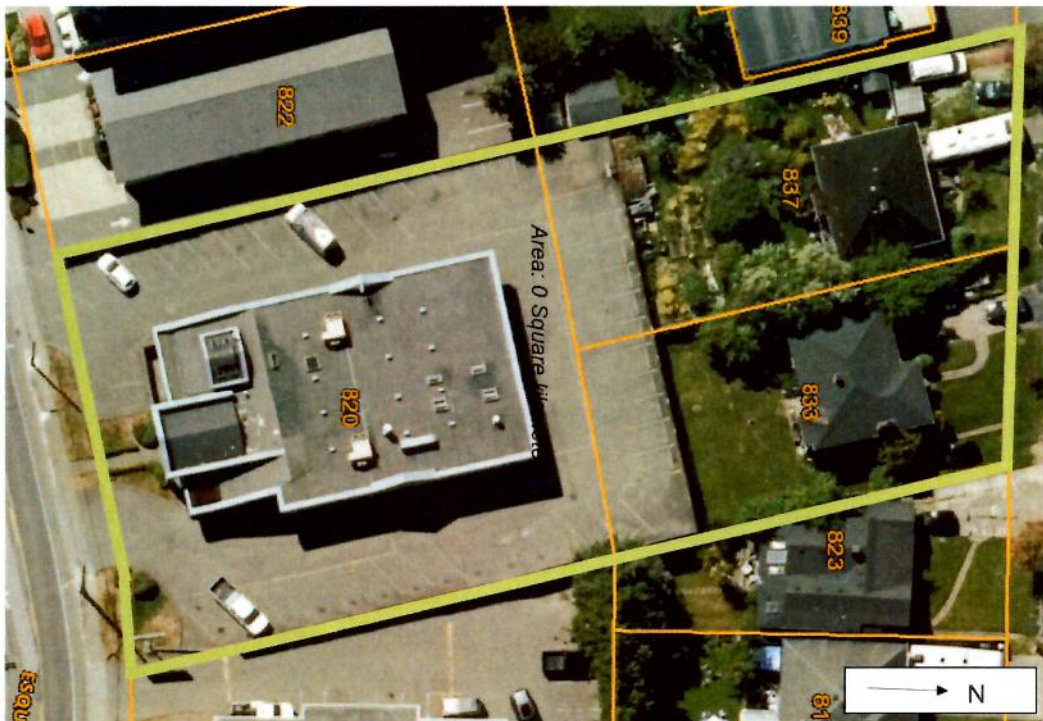
Figure 1: Site context air photo: The approximate boundary of the subject site is outlined in Green.

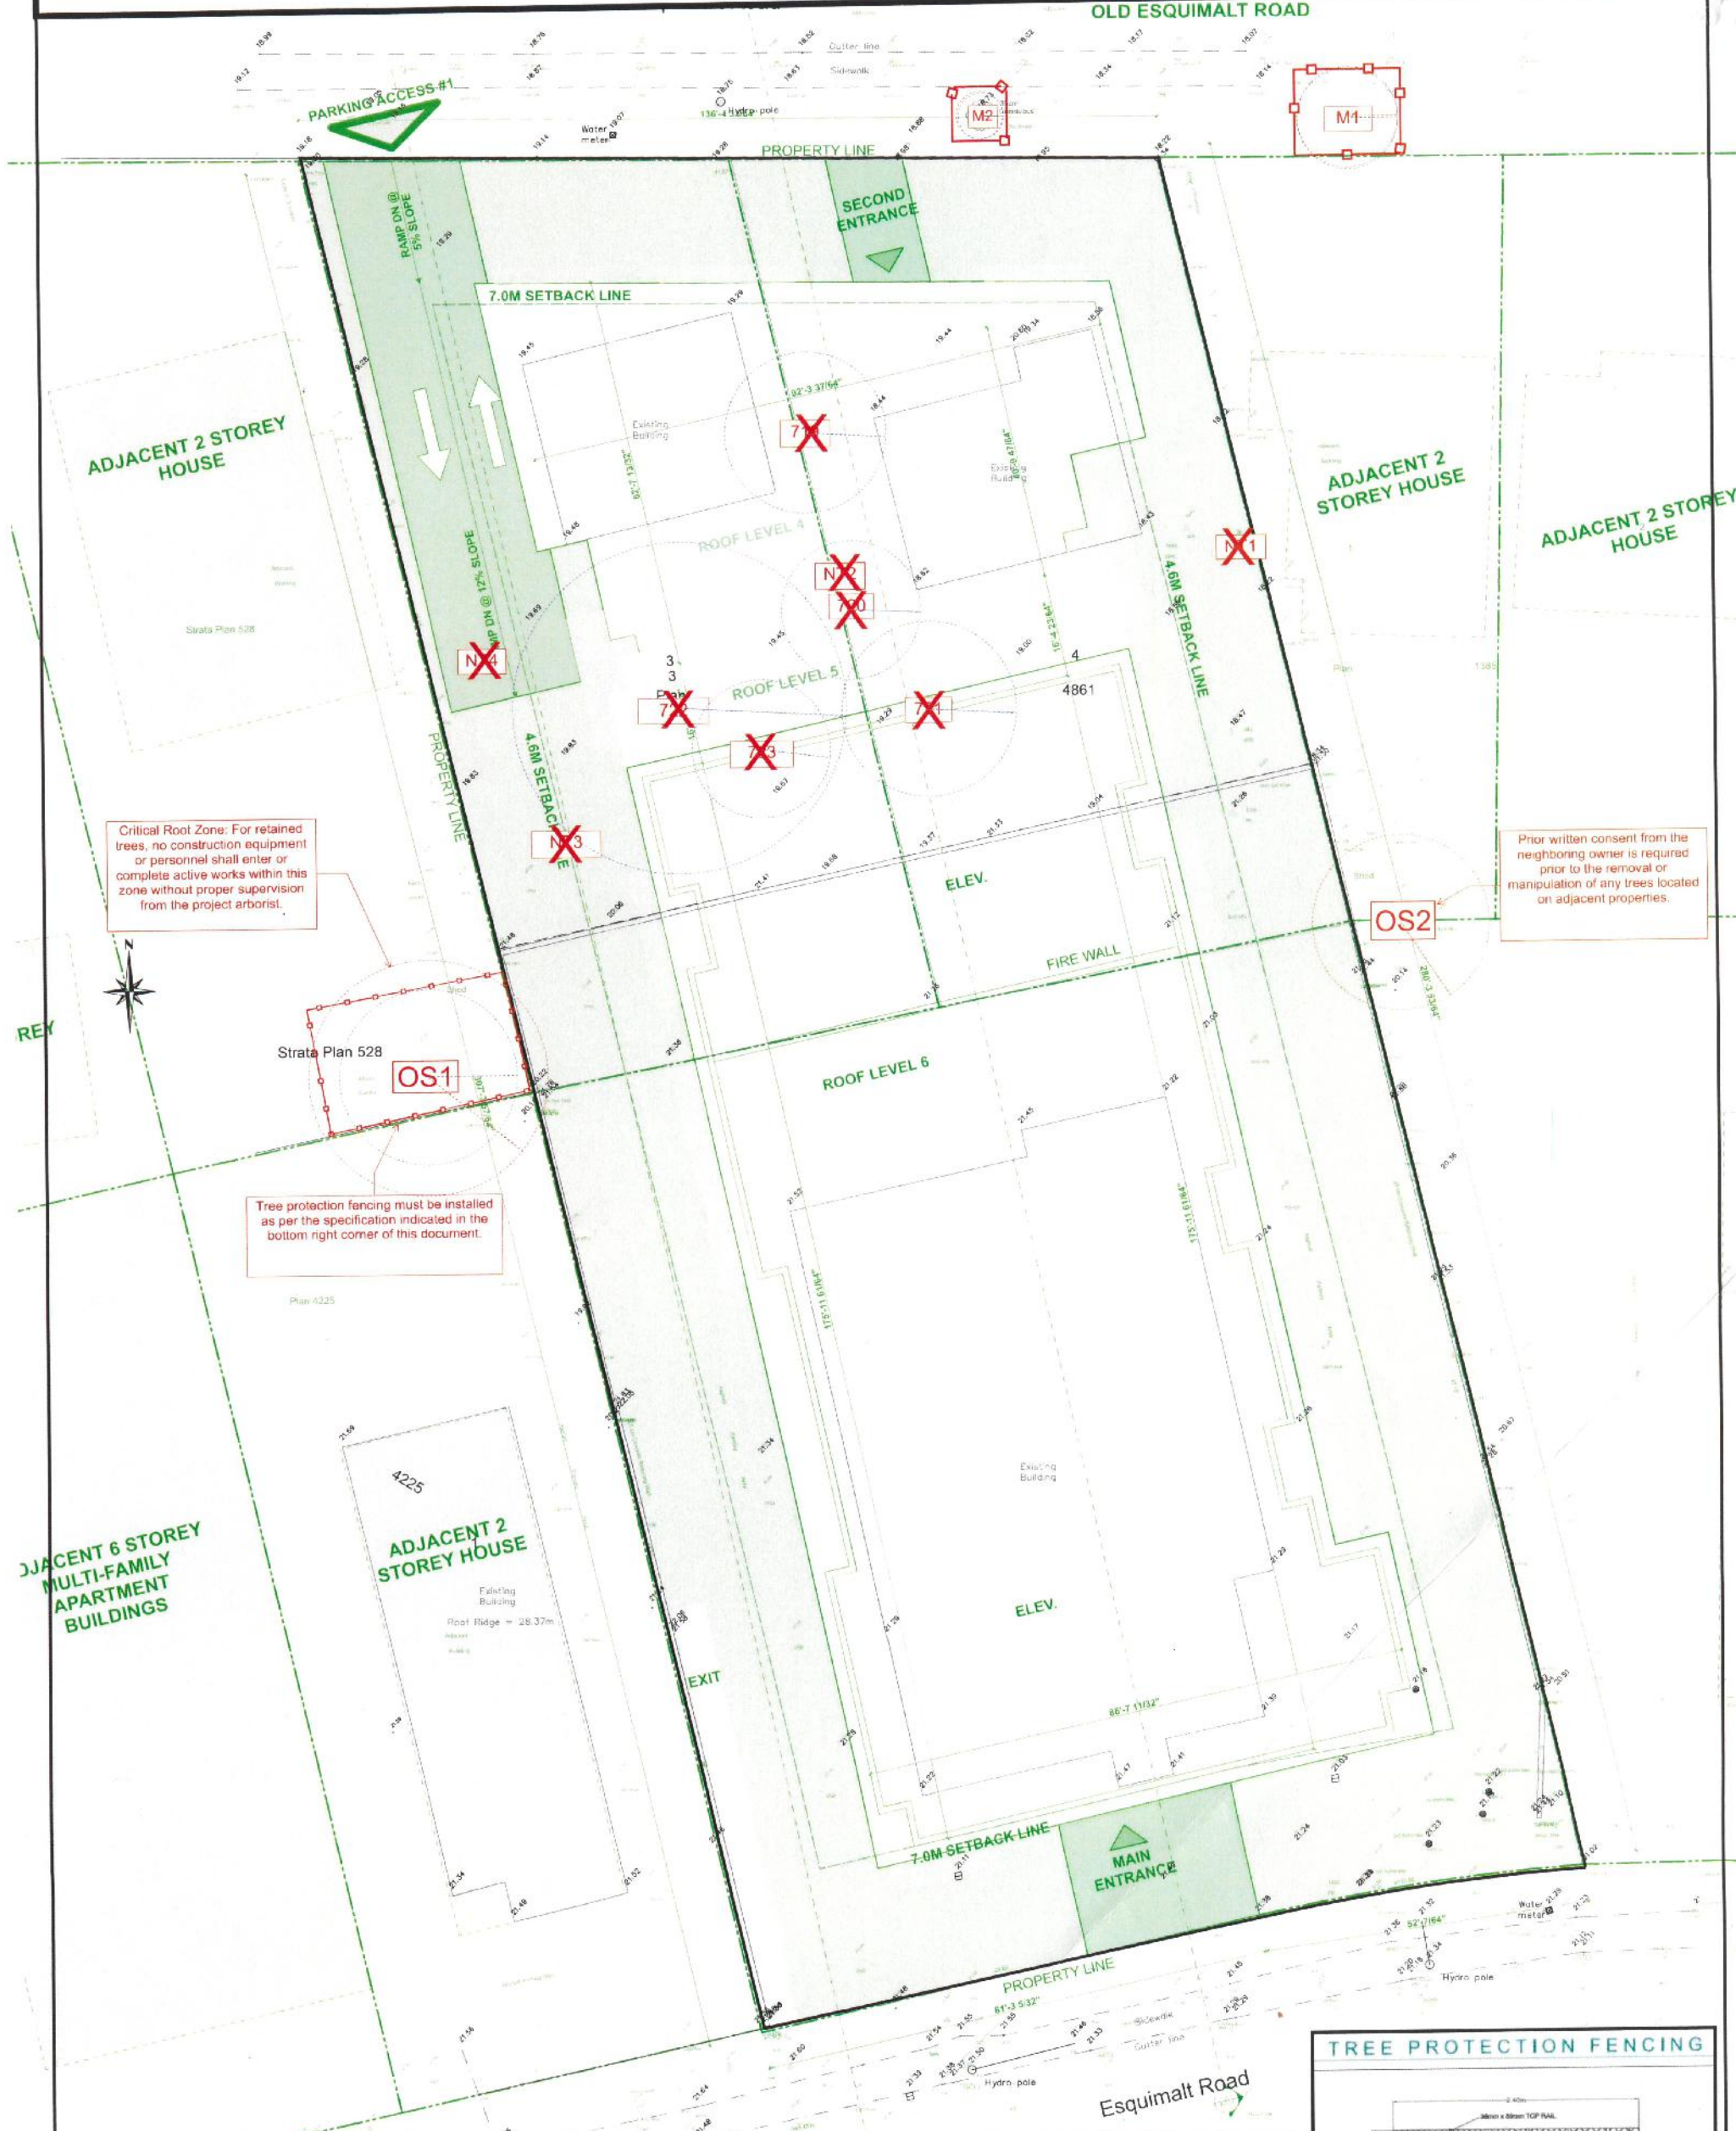
Tree Management Plan (T1) - 820 Esquimalt Road, 833-837 Old Esquimalt Road

The following municipal trees (indicated by ID #) are located where they are possible for retention providing that their critical root zones can be adequately protected during construction. The project arborist must be onsite to supervise any excavation or fill placement required within the critical root zone (shown on the tree management plan (T1) in *Appendix A*):

Due to the proximity to the proposed development and its health and structure, the retention status of M2 is "to be determined (TBD)" based on the proposed positioning of onsite works and construction practices. Currently, M2 is scheduled to be retained and protected until the proposed development is approved and such information can be confirmed.

Due to the proximity to the proposed development and their health and structure, the retention statuses of OS1 & OS2 are "to be determined (TBD)" based on the proposed positioning of onsite works and construction practices.

All on-site trees are proposed for removal and replacement due to the position of the building envelope and the subsequent excavation, drive-way installation, and final grading to establish landscaping. The following outlines which trees are considered onsite bylaw protected trees and those that are considered non-bylaw protected:

Tree Protection Barrier: The areas, surrounding the trees to be retained (M1, M2, OS1, and OS2) should be isolated from the construction activity by erecting protective barrier fencing (see *Appendix A* for municipal barrier specifications). Where possible, the fencing should be erected at the perimeter of the critical root zone. The barrier fencing to be erected must be a minimum of 4 feet in height, of solid frame construction that is attached to wooden or metal posts. A solid board or rail must run between the posts at the top and the bottom of the fencing. This solid frame can then be covered with flexible snow fencing. The fencing must be erected prior to the start of any construction activity on site (i.e., demolition, excavation, construction), and remain in place through completion of the project. Signs should be posted around the protection zone to declare it off limits to all construction related activity. The project arborist must be consulted before this fencing is removed or moved for any purpose.

Critical Root Zone: For retained trees, no construction equipment or personnel shall enter or complete active works within this zone without proper supervision from the project arborist.

Tree protection fencing must be installed as per the specification indicated in the bottom right corner of this document.
