GYE + ASSOCIATES
Consultants in Urban Forestry and Arboriculture

Arborist Report for Development

Site Address: 861 + 865 Esquimalt Road
Esquimalt, BC

Date of Report: June 24, 2022
Revised March 14, 2024

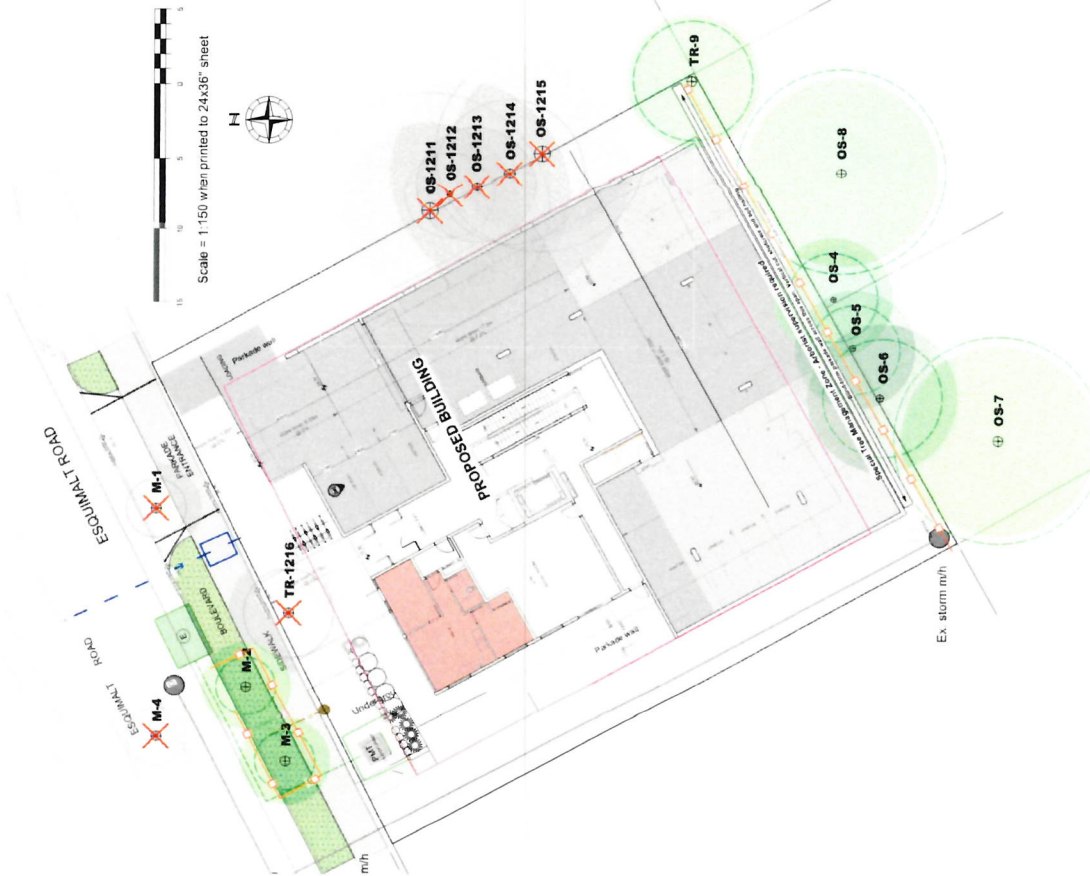
- Five Lawson cypress trees, (tags OS-1211, 1212, 1213, 1214, and 1215) are located along the east boundary of Lot 861. These trees are located atop a 0.75 m- high retaining wall that is in poor condition. The roots of these trees are causing extensive damage to one of the two paved driveways accessing the back of Lot 861. There is also significant aerial encroachment of the crowns of these trees into Lot 861.

Large surficial roots from the Leyland cypress trees are cracking and heaving the adjacent asphalt driveway access into existing Lot 861. The crowns of the trees extend well into the proposed building footprint and are not amenable to crown reduction pruning of the magnitude required. The distance from the base of the trees to the edge of the building excavation, assuming vertical shoring, is only 1.6 m, which is inside of the critical root plate radius and close to the zone of rapid root taper. Excavation this close to the trees will destabilize the trees, with the likelihood of failure and impact *very likely* with consequences ranging from *significant* to *severe*, depending upon which of several high-value targets are struck.² For these reasons, all five of these trees are recommended for removal and replacement.

All but one of the remaining trees to be preserved are located on the two adjoining lots to the south of the site. These include two mature Garry oaks (OS-7 and 8), which are located a safe distance back from the boundary, and two established Western Red cedars (OS-5 and 6) and a small Flowering cherry (OS-4). A small plum (TR-9) located at the south-west corner of the site. These latter four trees all grow very close to a concrete retaining wall that divides the proposed development site from the two adjoining properties. The wall manages a grade change up to the site of approximately 1.5 m measured at the intersection of the three property boundaries. If this retaining wall has been properly constructed with a footing on a competent subgrade, there is a good chance that it will have prevented any migration of tree roots into the proposed site. If this supposition holds true, it will dramatically reduce any potential impacts arising from the proposed development to these trees. For this reason, the project intends to maintain and protect this retaining wall *in situ* if possible. To this end, it is recommended that the existing grade north of the wall be maintained or restored once the parkade wall has been constructed (see below).

- Tree Protection
- a) Tree protection fencing shall be installed to the City of Esquimalt standards at the locations indicated on this drawing **2000L**1. Demolition or building permit being issued.

- d) Requests to temporarily remove or move tree fencing must be reviewed by the project arborist for approval.
- Soil arbouring. If it is not possible to fence the entire PHZ, the unprotected portion of the PHZ shall be arbouring with 3/4" plywood or a temporary cover of geo-textile and 200mm of road base, moderately compacted with a plate compactor. (See drawing for recommended soil arbouring locations.)

- b) The vertical face of excavated cuts within or adjacent to TPAs shall be securely covered with steel sheet piling reinforced with wire mesh.
- Mulching and irrigation of vulnerable trees. Off-site trees OS-4, OS-5 and OS-6 and Municipal Tree M-1 shall require immediate care during the dry season (April 1 - Nov 1).

- Replacement trees
- a) The project arborist shall be present to oversee the replacement of trees. Four protected boundary trees and two protected municipal trees (see Tree Inventory Table) shall be replaced with trees of similar or greater size and species. The replacement trees shall be planted in the same location as the original trees. The replacement trees shall be planted in the same location as the original trees. The replacement trees shall be planted in the same location as the original trees.
