Capital Tree Service Inc.

Arborist Report

903 Admirals Rd,

September 9, 2025

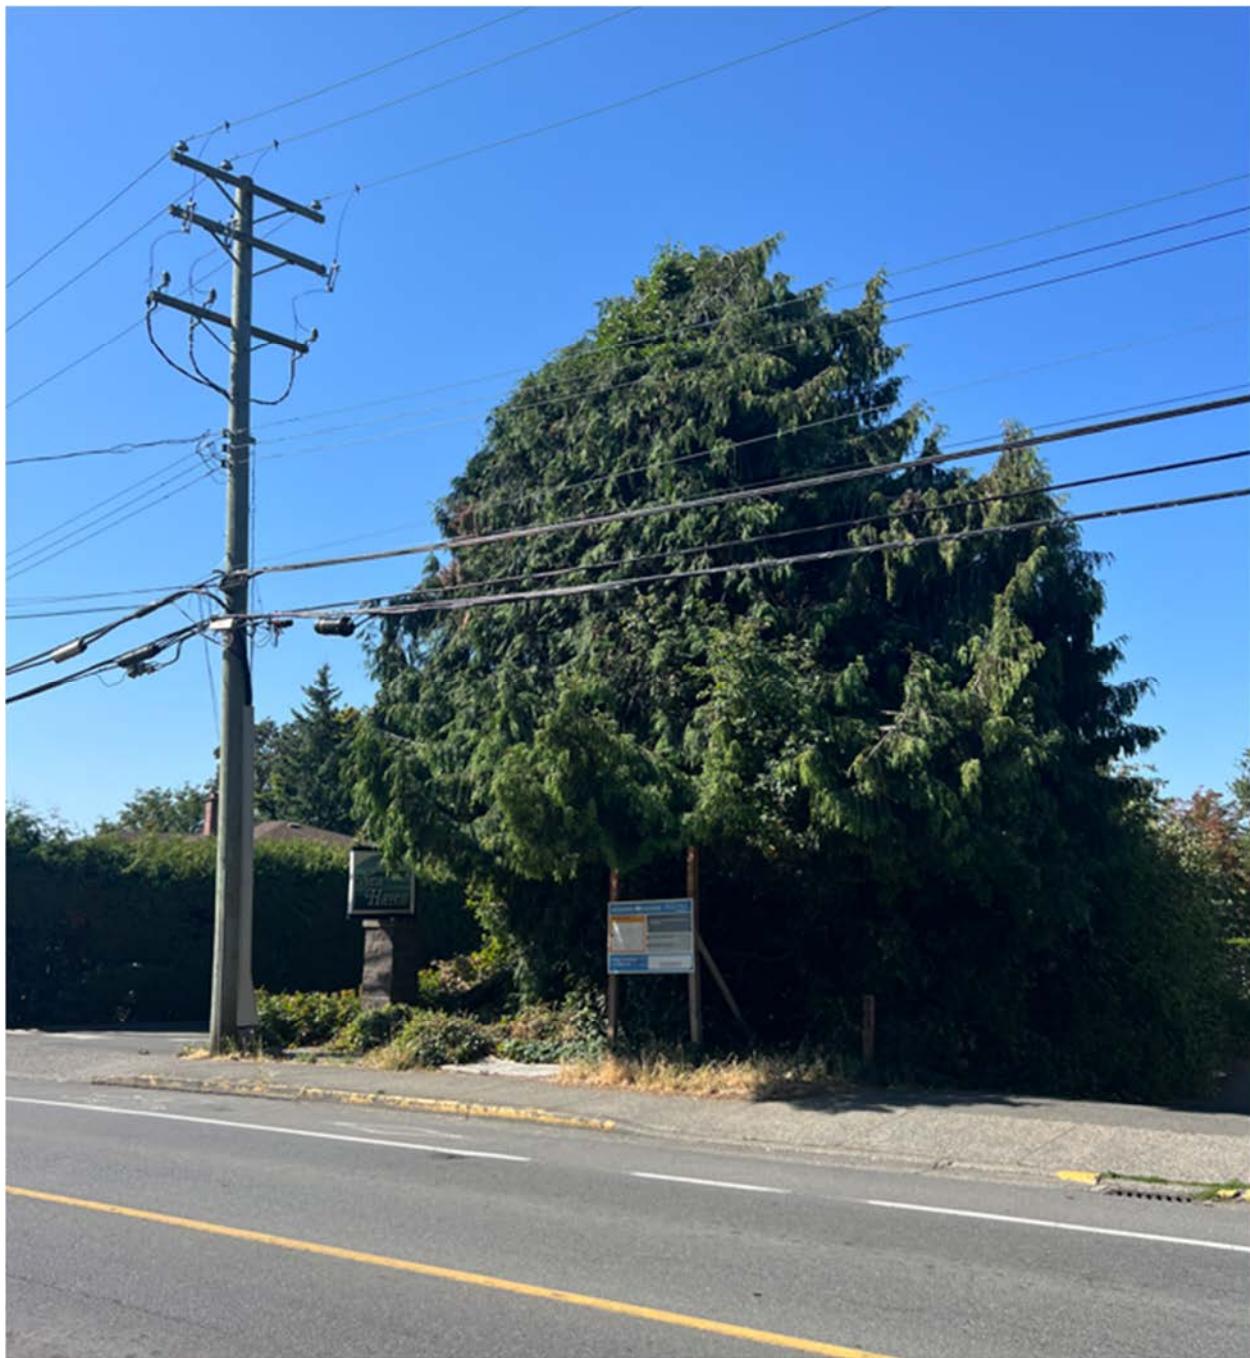
Figure 3. Streetview of 903 Admirals. Tree #61 above development sign.

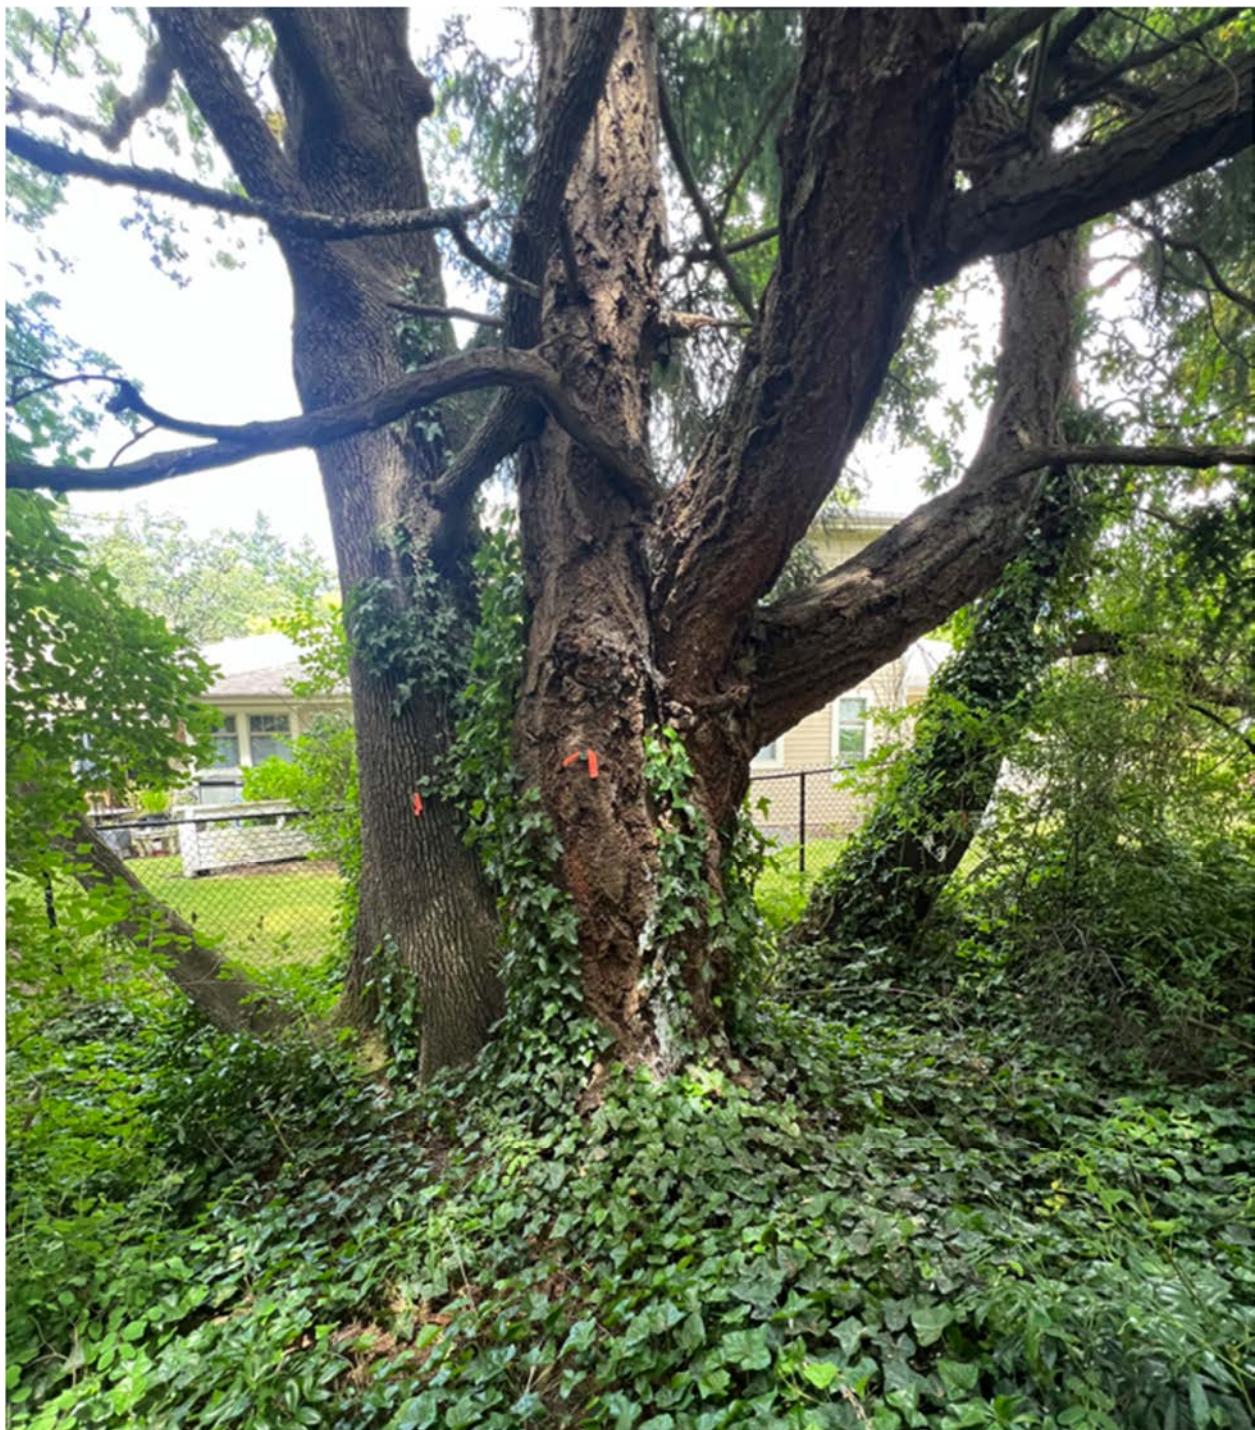
Tree #24, a mature Garry oak in the north-east corner will be retained. The careful removal of nearby tree #23, a Douglas fir with myriad structural deficiencies will be required as several branches from the Oak have intertwined and fused with the Douglas fir. Once the Douglas fir is removed, pruning on the Oak to reduce the canopy to eliminate conflicts with the new building can occur. Deadwood removal and any other maintenance/health pruning may also be done at this time. The remaining stump from tree #23 shall remain in place as it likely has intertwined roots with tree #24. A slight design change may be required shifting the patio from the proposed unit from the north to the east side of the unit- this may be assessed after preliminary site preparation including removal of all other surrounding trees.

Figure 4. View of Northeast corner of property. Trees 24, 23, 25 in frame.

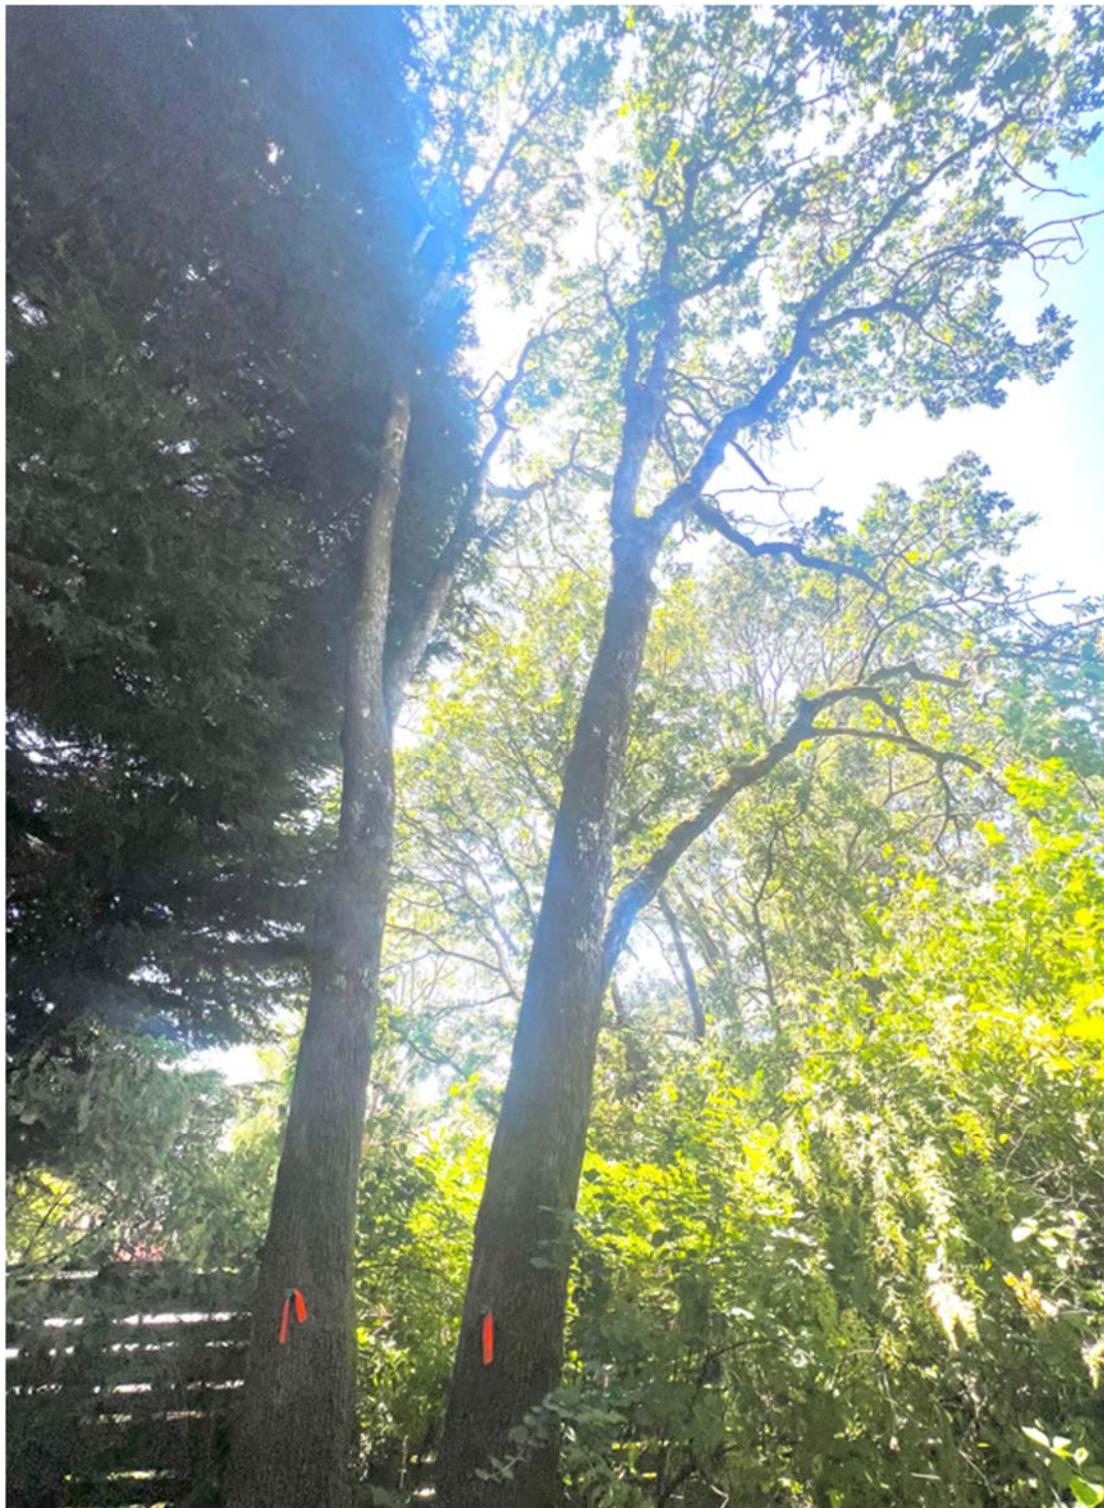
Figure 5. Tree 43/44

Tree #43/44, a mature two-stem Garry oak will be retained. Additional assessment after the removal of surrounding trees and preliminary site preparation has occurred may confirm if a cable installation is necessary to address the co-dominant structure. The patio design has been

42	Garry oak	19	2	5	F/P	Yes	Remove	Phototropic lean. Uneven canopy. Poor live crown ratio. 5cm+ Deadwood.
43/44	Garry oak	35	4	5	F/P	Yes	Retain	Co-dominant stem with #44. Poor live crown ratio. Narrow angles of attachment in canopy. 5cm+ Deadwood. Raised canopy. Uneven canopy. Possible decay at Co-dominant union.
		37	4	5	F/P			Co-dominant stem with #43. Poor live crown ratio. Narrow angles of attachment in canopy. 5cm+ Deadwood. Raised canopy. Uneven canopy. Possible decay at Co-dominant union.
45	Lawson cypress	72	9	9	F/P	Yes	Remove	Multi-dominant top. Narrow angles of attachment in canopy. Uneven canopy due to neighboring trees. Good foliar colour.
46	Lawson cypress	74	9	9	F/P	Yes	Remove	Multi-dominant top. Narrow angles of attachment in canopy. Uneven canopy due to neighboring trees. Good foliar colour.
47	Lawson cypress	35	4	6	F/P	Yes	Remove	Multi-dominant top. Narrow angles of attachment in canopy. Uneven canopy due to neighboring trees. Good foliar colour.

altered to allow for the retention of this tree. Patio installation of this patio, all other patios, and hardscaping within the PRZs of retained trees is to adhere to the following procedure.

1. Remove top layer of organics with a mini excavator under arborist supervision.
2. Lay down a layer of geogrid (Combigrad 30/30).
3. Lay down base material for final surface.
4. Install final surfacing material.
