# Arborist Report for Development

Site Address: 861 + 865 Esquimalt Road Esquimalt, BC

Date of Report: June 24, 2022 Revision-1 March 14, 2024 Revision-2 September 17, 2024

PROJECT
761 - 865 Esquimalt Rd,
Esquimalt, BC
SHET TITLE
TITLE MANAGEMENT Plan for
RZ & DPA

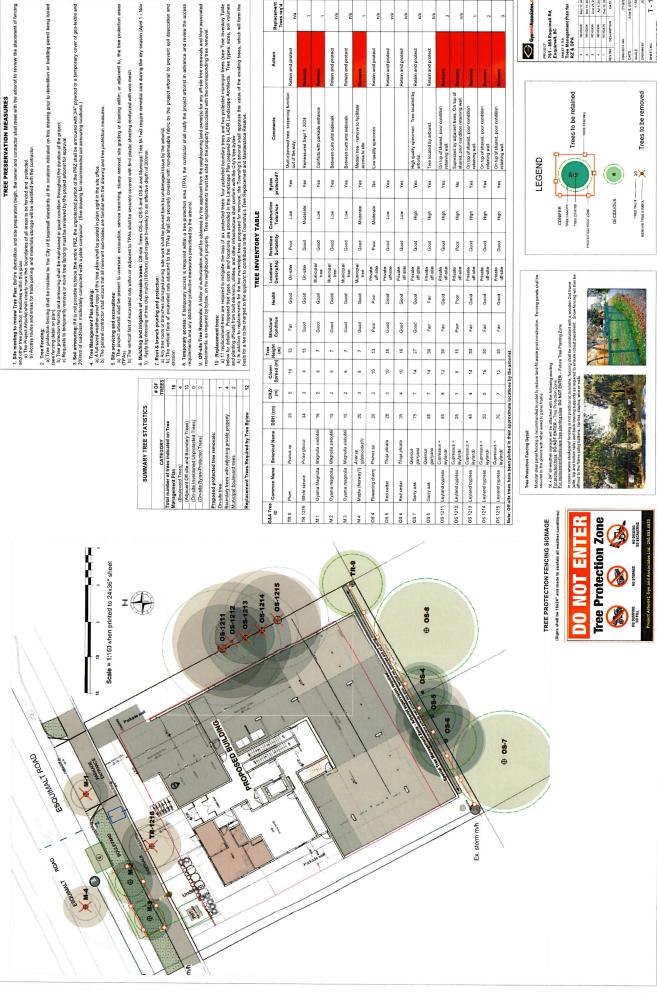
I emporary access: if emporary access is required within a tree protection area (FPA), the contractor shall notify the project arboinst in advance and review the accelerates and any additional protective measures prescribed by the arboinst.

Off-eile Tree Removals: A letter of achtoclastion shall be obtained by the applicant from the neighbouring land owner(s) for any off-eile tree removals and their assertings are required by bylaw, on the neighbour's property. Thes replacements must be either on the property associated with the corresponding tee removal.

TREE INVENTORY TABLE	ENTORY	TABLE				
A Tree	Common Name	A Tree Common Name Botanical Name DBH (cm)	DBH (cm)	CRZr (m)	Crown Tree Spread (m) Height	Tree Height (m)	Structural	Health	Location/ F Ownership	Retention Suitability	Construction	Bylaw protected?	Comments	Action	Replacement Trees reg'd
6	Plum	Prunus sp.	35	2	10	13	Fair	Good	On-site	Poor	Low	Yes	Multi-stemmed tree; screening function; out of the way.	Retain and protect	r/a
1216	White spruce	Picea glauca	34	ю	00	5	Good	Good	On-site	Good	Moderate	Yes	Remeasured Sept 1, 2024	Remove	-

-	Oyama Magnolia	Oyama Magnolia Magnolia sieboldii	16	2	9	7	Good	Good	Municipal	Good	Low	Yes	Conflicts with parkade entrance	Remove	-
2	Oyama magnolia	Oyama magnolia Magnolia sleboldii	15	2	9	7	Good	Good	Municipal	Good	Low	Yes	Between curb and sidewalk	Retain and protect	n/a
62	Oyama magnolia	Oyama magnolia Magnolia sieboldii	15	2	ø	7	Good	Good	Municipal	Good	Low	Yes	Between curb and sidewalk	Retain and protect	n/a
	Maple (Norway?)	Acer sp. (platinoides?)	20	3	60	7	Good	Good	Municipal	Good	Moderate	Yes	Median tree - remove to facilitate access to site	Remove	-
4	Flowering cherry	Prunus sp.	20	33	10	13	Poor	Poor	Private off-site	Poor	Moderate	o <sub>N</sub>	Low quality specimen	Retain and protect	r/a
9	Red cedar	Thuja plicata	28	69	10	16	Good	Good	Private off-site	Good	Low	Yes		Retain and protect	n/a
9	Red cedar	Thuja plicata	35	4	10	16	Good	Good	Private off-site	Good	Low	Yes		Retain and protect	n∕a

7	Garry oak	Quercus	75	7	14	27	Good	Good	Private off-site	Good	High	Yes	High quality specimen. Tree located by arborist.	Retain and protect	υ/a
80	Garry oak	Quercus	99	7	14	30	Fair	Fair	Private off-site	Good	High	Yes	Tree located by arborist.	Retain and protect	υ/a
1211	Leyland cypress	Cupressus × feylandii	85	œ	12	30	Fair	Good	Private off-site	Good	High	Yes	On top of shared, poor condition retaining wall.	Remove	m
1212	1212 Leyland cypress	Cupressus × leylandii	25	6	80	15	Poor	Poor	Private off-site	Poor	High	ž	Supressed by adjacent trees, On top of shared, poor condition retaining wall.	Remove	n/a
1213	Leyland cypress	Cupressus × leylandii	45	4	14	30	Fair	Good	Private off-site	Good	High	Yes	On top of shared, poor condition retaining wall.	Remove	-
1214	Leyland cypress	Cupressus × leylandii	90	2	16	30	Fair	Good	Private off-site	Good	High	Yes	On top of shared, poor condition retaining wall.	Ramove	2

1215	1215 Leyland cypress	Cupressus × leyfandii	7.0	7	12	30	Fair	Good	Private off-site	Good	Hgh	Yes	On top of shared, poor condition retaining wall.	Ramove	n
te: Off-	site trees have be	te; Off-site trees have been plotted in their approximate locations by the arborist.	approximate	location	s by the arb	orist.
