Arborist Report

Site
685 Admirals Road
Victoria BC

September 16, 2018

RE: Proposed Development Project 685 Admirals Road, Esquimalt B.C. - Demolition & Construction

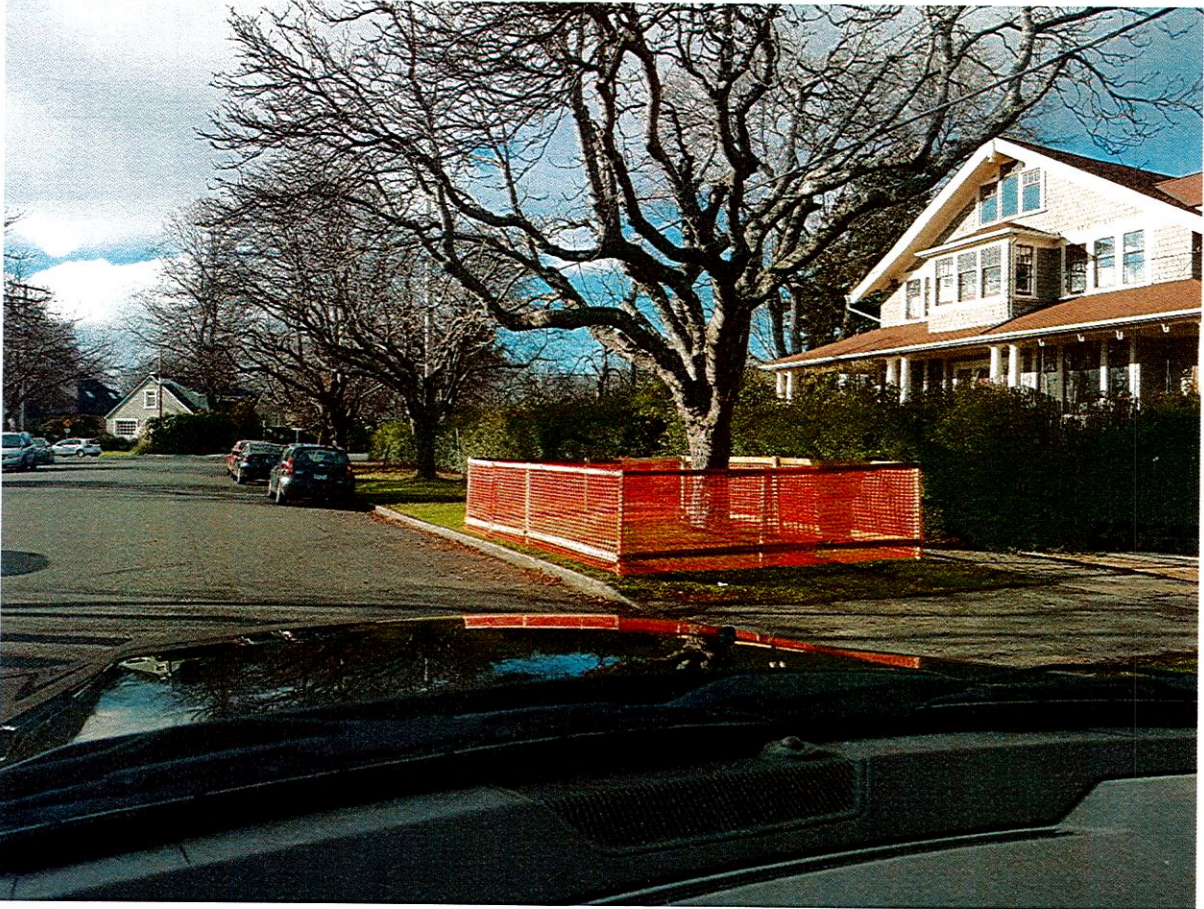
Photo #1 – Fencing Construction

In this photo you can observed a typical Tree Protection Fence. This type of construction is considered to be square with right angles.

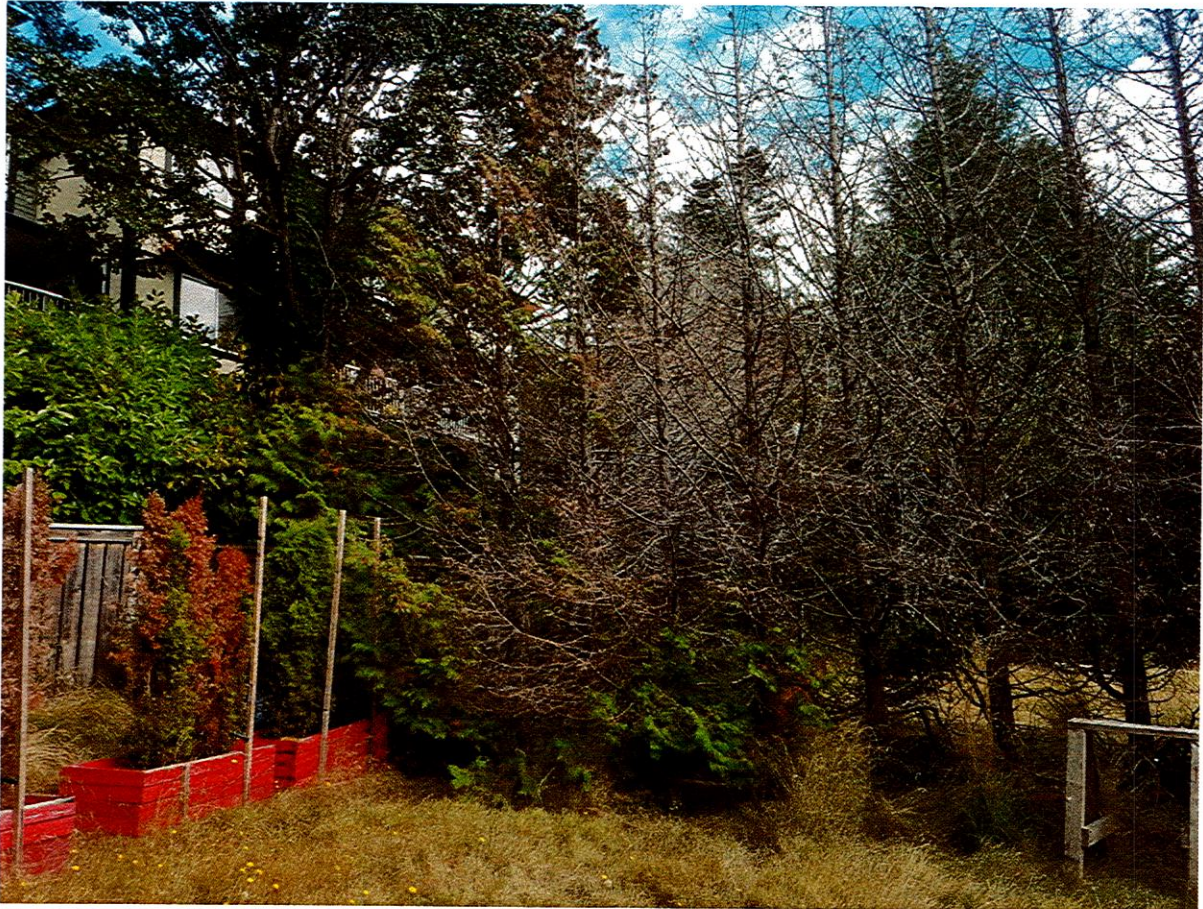
Photo #2 – Center of Lot – Dead Cedars

Thirty three (33) cedar trees are dead on the property.

In this photo you can see a number of the dead cedar trees. Positioned approximately in the center of the lot and along the eastern property line these trees will require removal from the site.

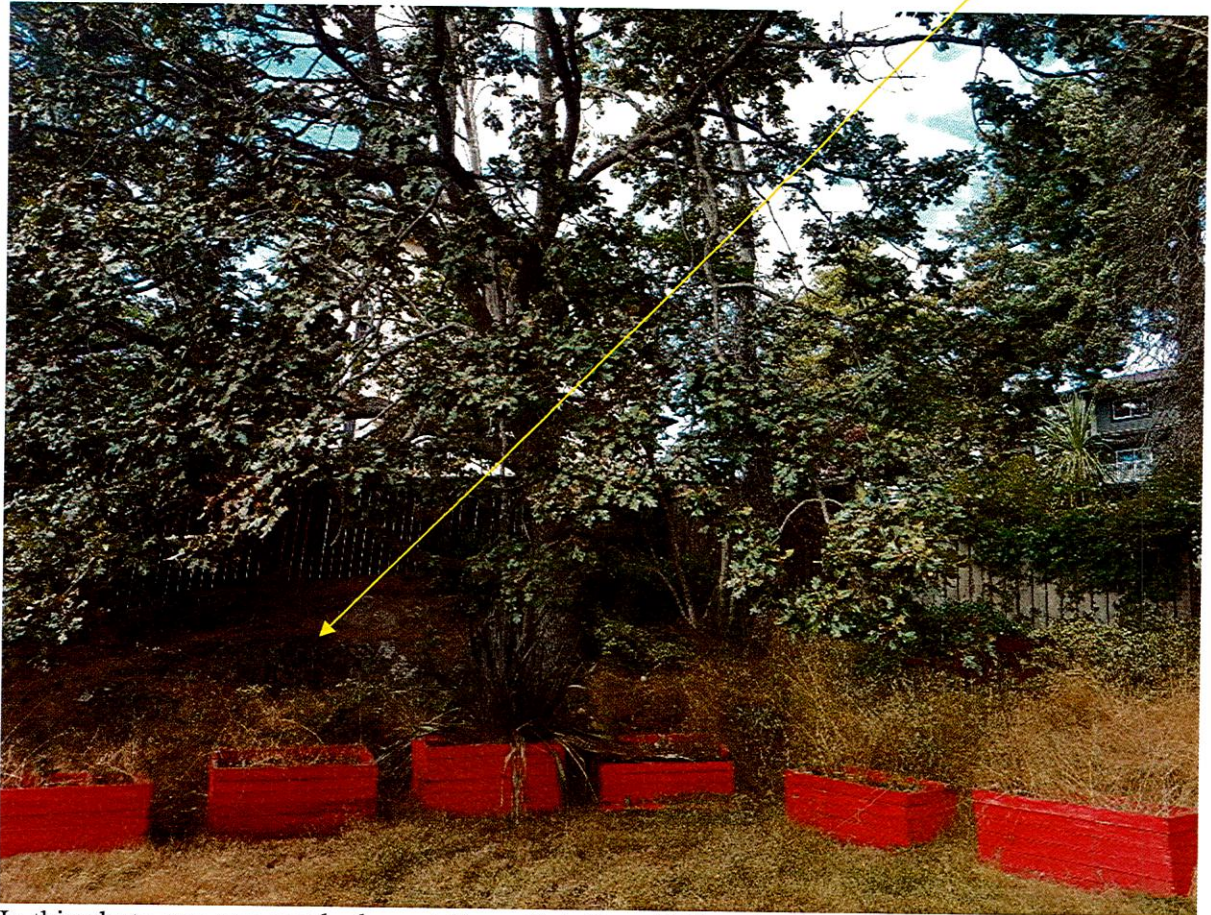
Photo # 3 – N/E Corner, Oak trees

The two (2) Garry oaks on the property are located in the North West corner of the property. Native bedrock may have to be blasted, negatively affect tree root zones.

In this photo you can see the largest Garry Oak Tree #251 setback approximately 3 metres from the north property line. Under the current proposal the tree will be located within the buildings footprint.

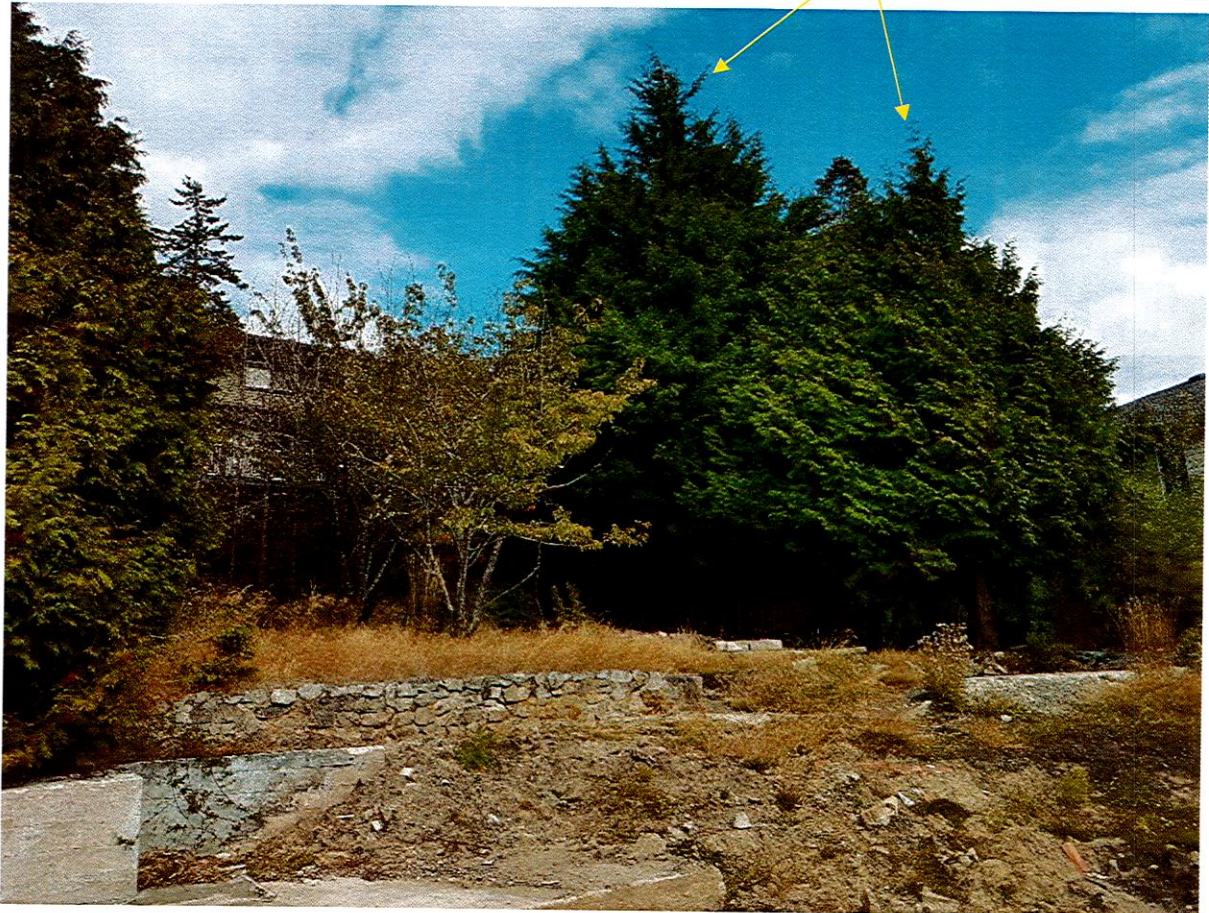
Photo #4 – South East Corner of Lot

The cedars and cypress trees are positioned along the inside of the southwest property lines.

In this photo you can see the large cypress and row of six (6) cedar trees along the south property line. Reduced grade changes will significantly damage each tree CRZ. Under the current proposal tree removal will be required to stabilize the setback along this side of the project.

259	L Cypress	67	16	7	F/F		Remove tree, heavy impacts due to excavation/grade change
260	W Cedar	24	12	3	F/F		Remove 6 cedar trees positioned along southern property line. Excavation impacts.
261	PI Plum	40	5	4	F/P		Remove, tree is infected with "ganoderma" pathogen, extensive basal stem decay.
262	B Cypress	70	12	7	F/F		Remove tree, sustancail impacts from reduced grade and development.
N/T	BI Maple	55	17	6	F/F	X	Private tree on north side of property line. Protect tree at fence-line, prune to elevate.
