# Tyn-Y-Coed, 820 Dunsmuir Road, Esquimalt BUILDING CONDITION ASSESSMENT

November 19<sup>th</sup>, 2020 # 1089.001

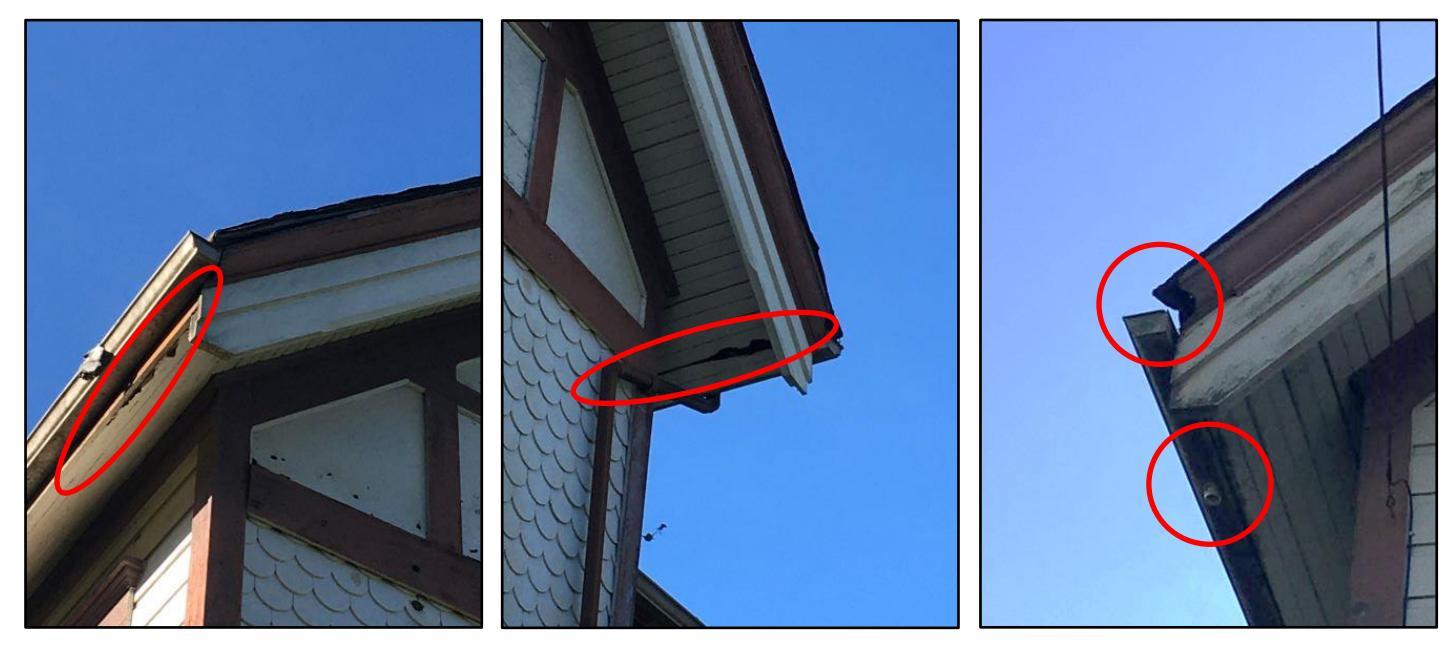
Photographs 4-6 – Soffit and trim deterioration along with a missing downspout

Despite being well beyond its expected services life, the roof cladding appeared to be providing adequate protection with no noted or observed leaks. However, the shingles were degranulating and the edges were starting to curl. The single-slope roofs were supporting organic growth and debris making the observation of their condition difficult. Deterioration of the gable trim and wood soffits was observed, suggesting previous or current moisture ingress along these areas of the roof. The north-west addition did not have soffit cladding, exposing the OSB roofing sheathing.

Based on the observations, it is recommended that the shingles and membranes be renewed in the very near future to avoid eventual damage to the roof structure and interior space. It is also recommended that the wood soffits and trim be restored prior to the shingle renewal to ensure adequate support of the assembly and the prevention of further deterioration. The gutters will also require renewal and based on their displacement in a number of locations, it is expected that the fascia board will require full renewal.

Recommended maintenance work in the interim should include debris removal from the roof and gutters as well as making sure the rainwater leader assembly is firmly affixed in place and connected. It is also recommended that organic growth be cut back from the building perimeter to eliminate the opportunity for it to penetrate the building assemblies including the roof.

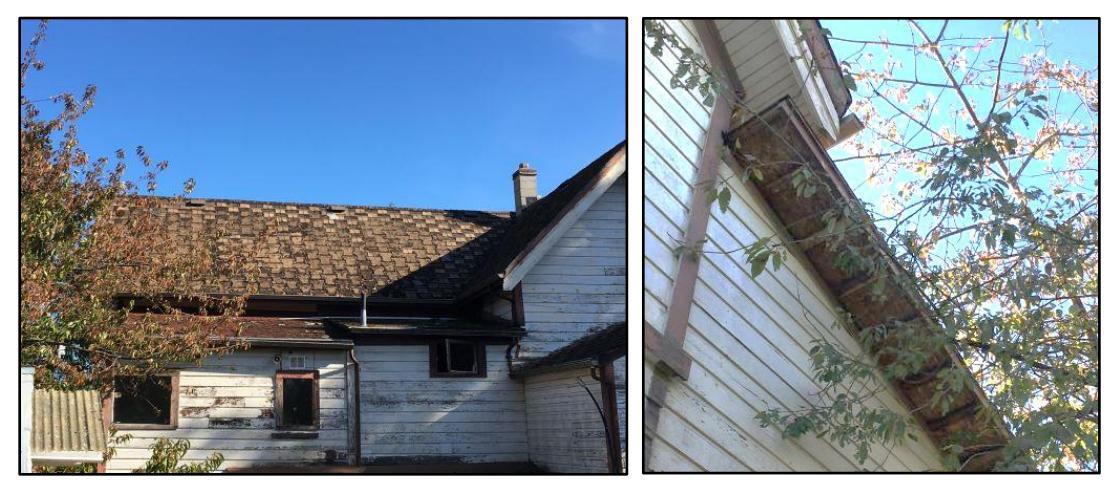
Photographs 7-8 – The upper and lower sloped roofs and the exposed OSB soffit.

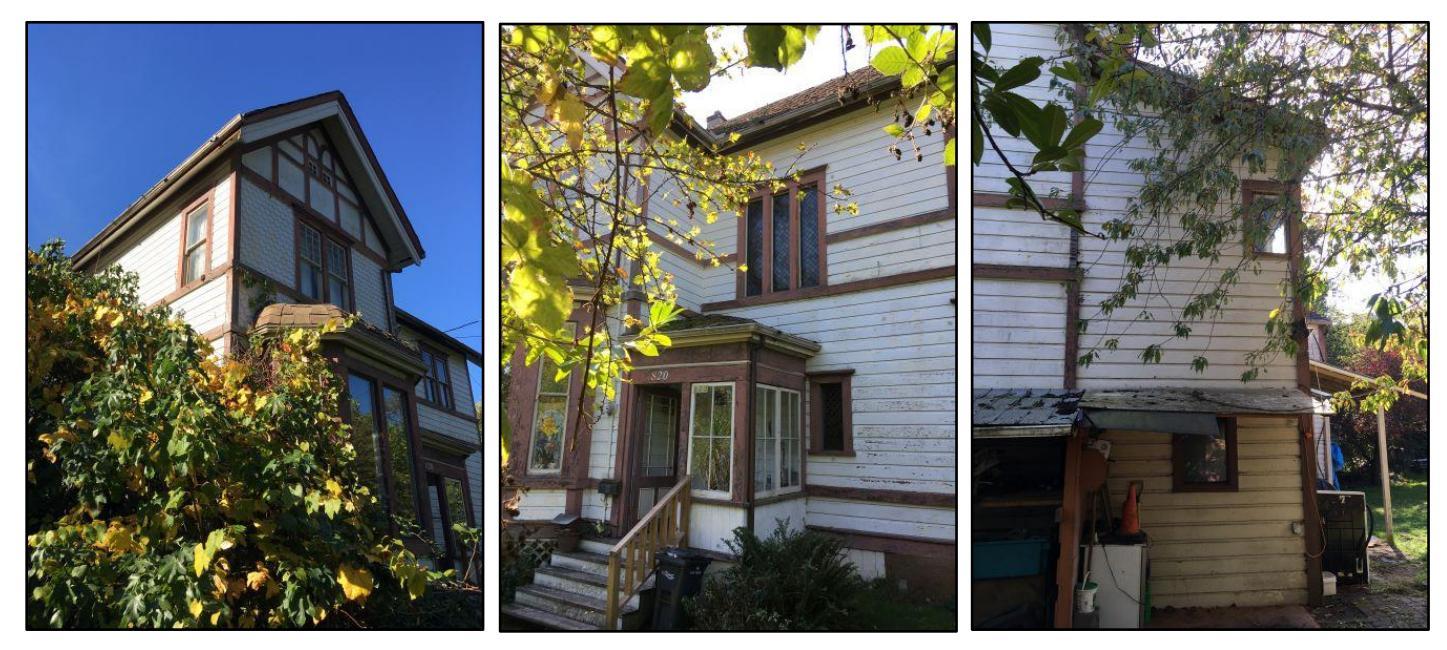
Photographs 9-11 – The upper south east corner showing the wood siding, shingles and trimmed stucco finish, The east elevation showing the worn paint on the siding, The north elevation showing the north addition

The paint finish on the wood siding and trim is deteriorating on all elevations with extensive flaking and bare wood evident on most of the wood trim. Trim deterioration was also observed, most particularly around the doors and windows. There is a portion of wall siding on the south elevation that is largely unpainted. The linearity of the paint discontinuity suggests that an extension or exterior assembly may have been removed from this portion of wall. It is now generally covered by a tree.

The original wood cladding and trim detailing generally appear to be intact from what can be observed from on-site conditions and historic photographs. Despite the condition of the paint and trim detailing, the wall assemblies also appear to be in fair condition with no observed signs of structural/cladding failure or moisture ingress through the assembly. The west additions do add an inconsistency to the wood finishes that may be allowing undetected moisture ingress. However, to prevent the imminent onset of cladding deterioration, it is recommended that the exterior paint be completely renewed including the removal of the existing paint coating where necessary and possible. The deteriorated trim elements should also be renewed and reinstated where necessary.

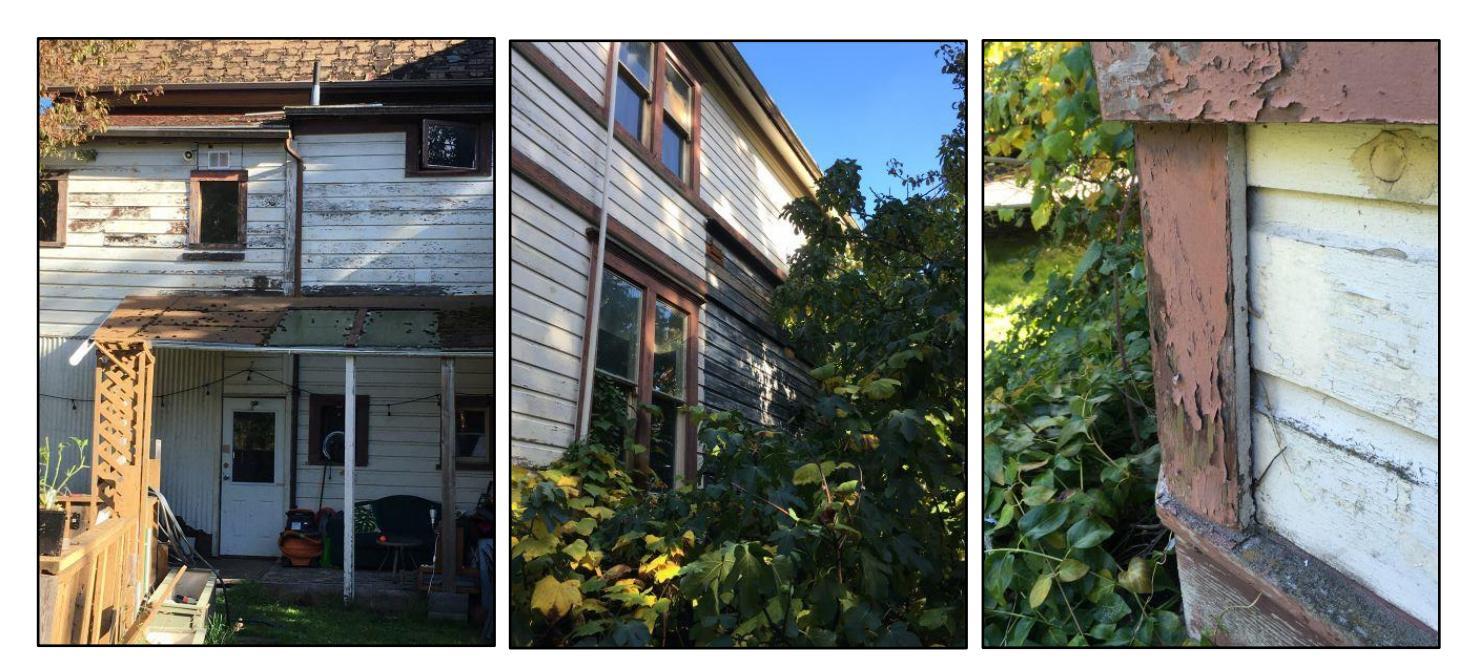
Photographs 12-14 – The west elevation showing the worn paint on the siding and the corrugated panels, The south elevation showing the bare area of wood siding, An example of extensive paint flaking on the wood trim

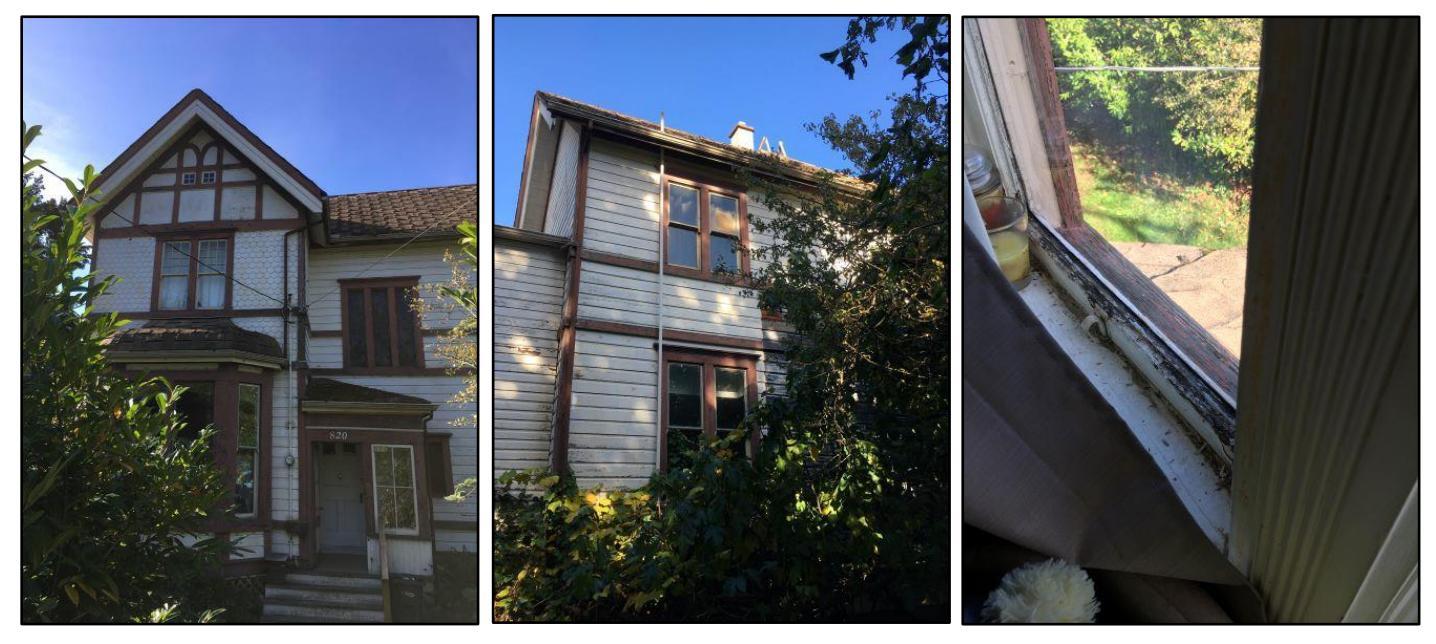
Photograph 15-17 – East elevation - double 4 lite windows in the attic, 12 over 1 double hung windows over the bay, typical 1 over 1 glazing to the right of the contemporary thermal panes in the bay, stained glass windows above and beside the entrance alcove and a 4 lite 'storm' window pane in the alcove, South elevation - typical 1 over 1 double hung windows, Interior - deteriorating window sash

The original windows on the south and east elevations generally appeared to be in fair to good condition with no obvious signs of window failure. The two central windows in the bay window have however, been replaced with fixed thermal panes. Deterioration typical to the age and exposure of the wooden frames was observed on both the interior and exterior sides. The operability of the windows was not affirmed but many of them were visibly lacking the necessary hardware. The interior trim and sills were typically observed to be intact and in fair to good condition while the exterior trim, as noted, is deteriorating.

The original windows are generally in fair condition and performing as can be expected. The windows on the west elevation are functioning as best as can be expected given their fabrication. It is recommended that the original windows be restored to conserve their integrity and appearance while the west windows should be replaced. The thermal performance of all of the windows as well as the building as a whole would be improved with the installation of storm window assemblies.

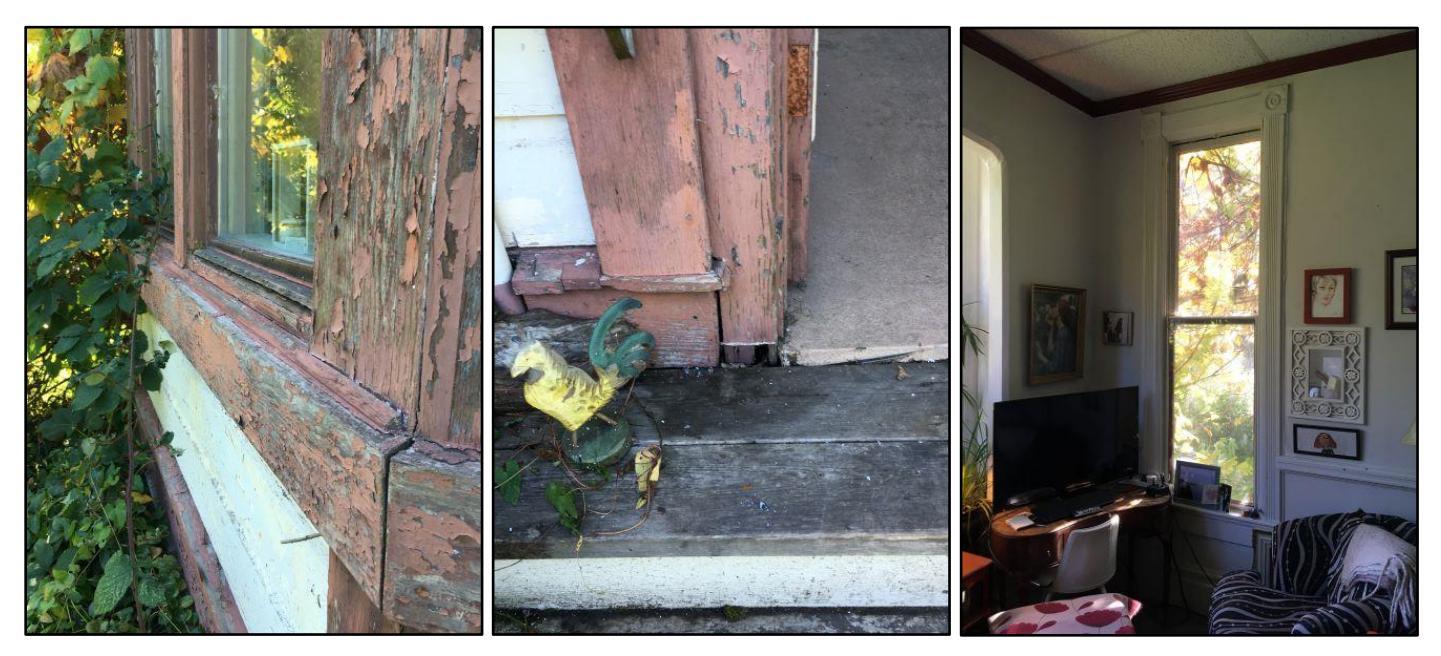
Photograph 18-20 – Deteriorating, exterior trim around the bay windows and entrance alcove door frame, Intact, original interior wood trim.

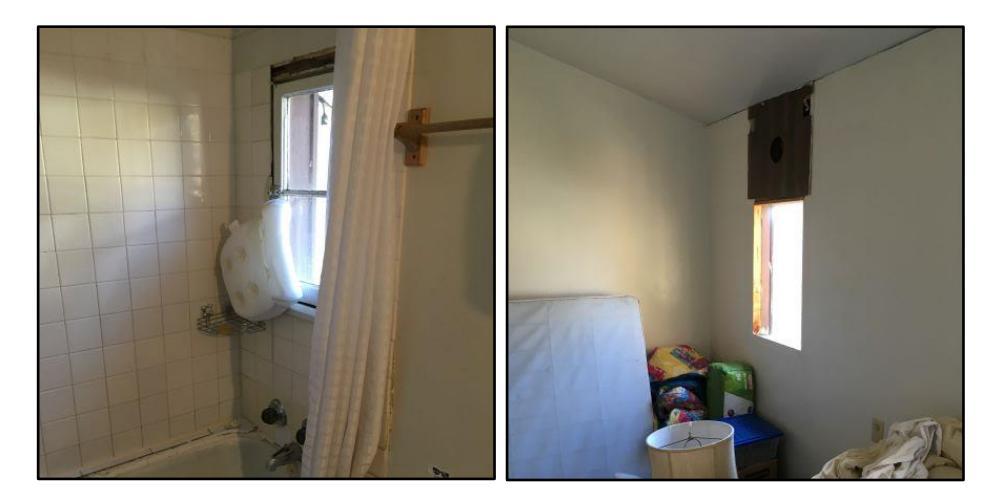
The windows on the west elevation additions are a variety of glazed assemblies with some of them fixed and others operable. Typically trimmed with wood on the exterior, a number of the windows were observed to be unfinished to the interior including a window set in a shower area where the lack of finishing trim in this extreme environment may be having an impact on the integrity of the wall assembly.

Photograph 21-22 – Interior side of the west elevation windows showing no trim finish. The window in the shower is in an extreme environment.

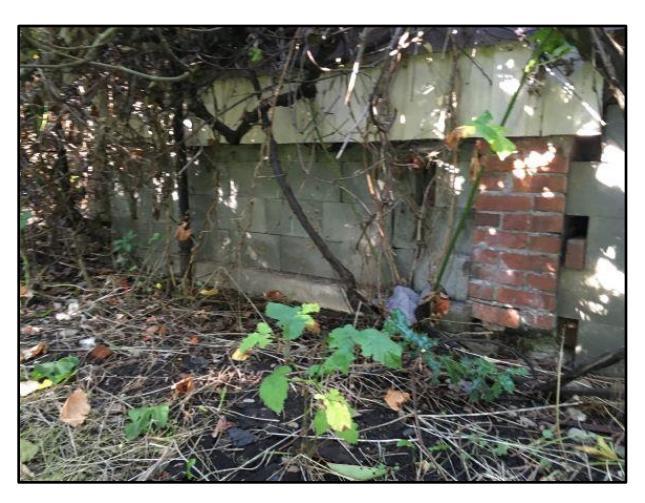
It was not possible to observe the structural foundation of the building beyond what could be seen along the south elevation. As such, it was not possible to comment on its general condition. From what could be seen, the building is at least in part supported on clay brick masonry piers and concrete block. Though the piers and concrete block appeared to be in good condition, it is expected that, should the building be conserved, a new concrete foundation meeting current code requirements would have to be constructed to adequately support the building.

Photograph 23 – Clay brick masonry pier and concrete block infill

Table 5 – Foundation Assembly Renewal Recommendations			
L	Pour a new concrete foundation to support the house.

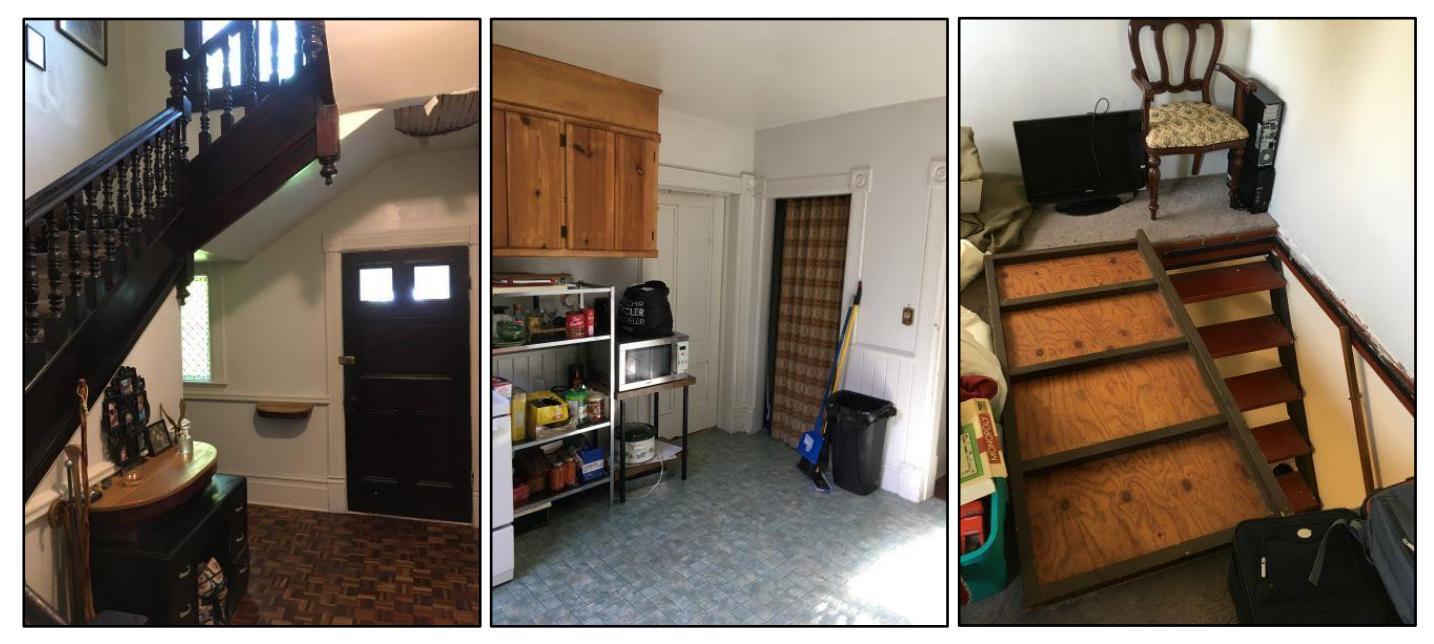
Photograph 24-26 – The original balustrade, entrance door and parquet flooring. The original kitchen wainscotting. Egress within the north addition

The north-west addition is generally used as storage space with access to the upper floor achieved through a floor door reached via stairs from the lower floor. Though generally in fair condition, the access conditions would not meet current code requirements.

The interior conditions are showing limited signs of damage and deterioration. However, the additions were generally unfinished and a lack of maintenance could be observed throughout. The additions would require significant work to bring them up to current code conditions, especially given the unknown condition of the wall assemblies. It is recommended that, should the building be conserved, the retention of the additions be carefully considered and the remaining, original portions of the building be restored.
