ENVIRONMENTAL ASSESSMENT REPORT

FOR
445 GRAFTON ST
ESQUIMALT BC, V9A 6S4

PREPARED FOR:
MAC RENO-DESIGN-BUILD
5285 WEST SAANICH RD
VICTORIA, BC, V9E 2E8

PREPARED BY:
CORVIDAE ENVIRONMENTAL CONSULTING INC.
PROJECT #2026-024
JANUARY 2026

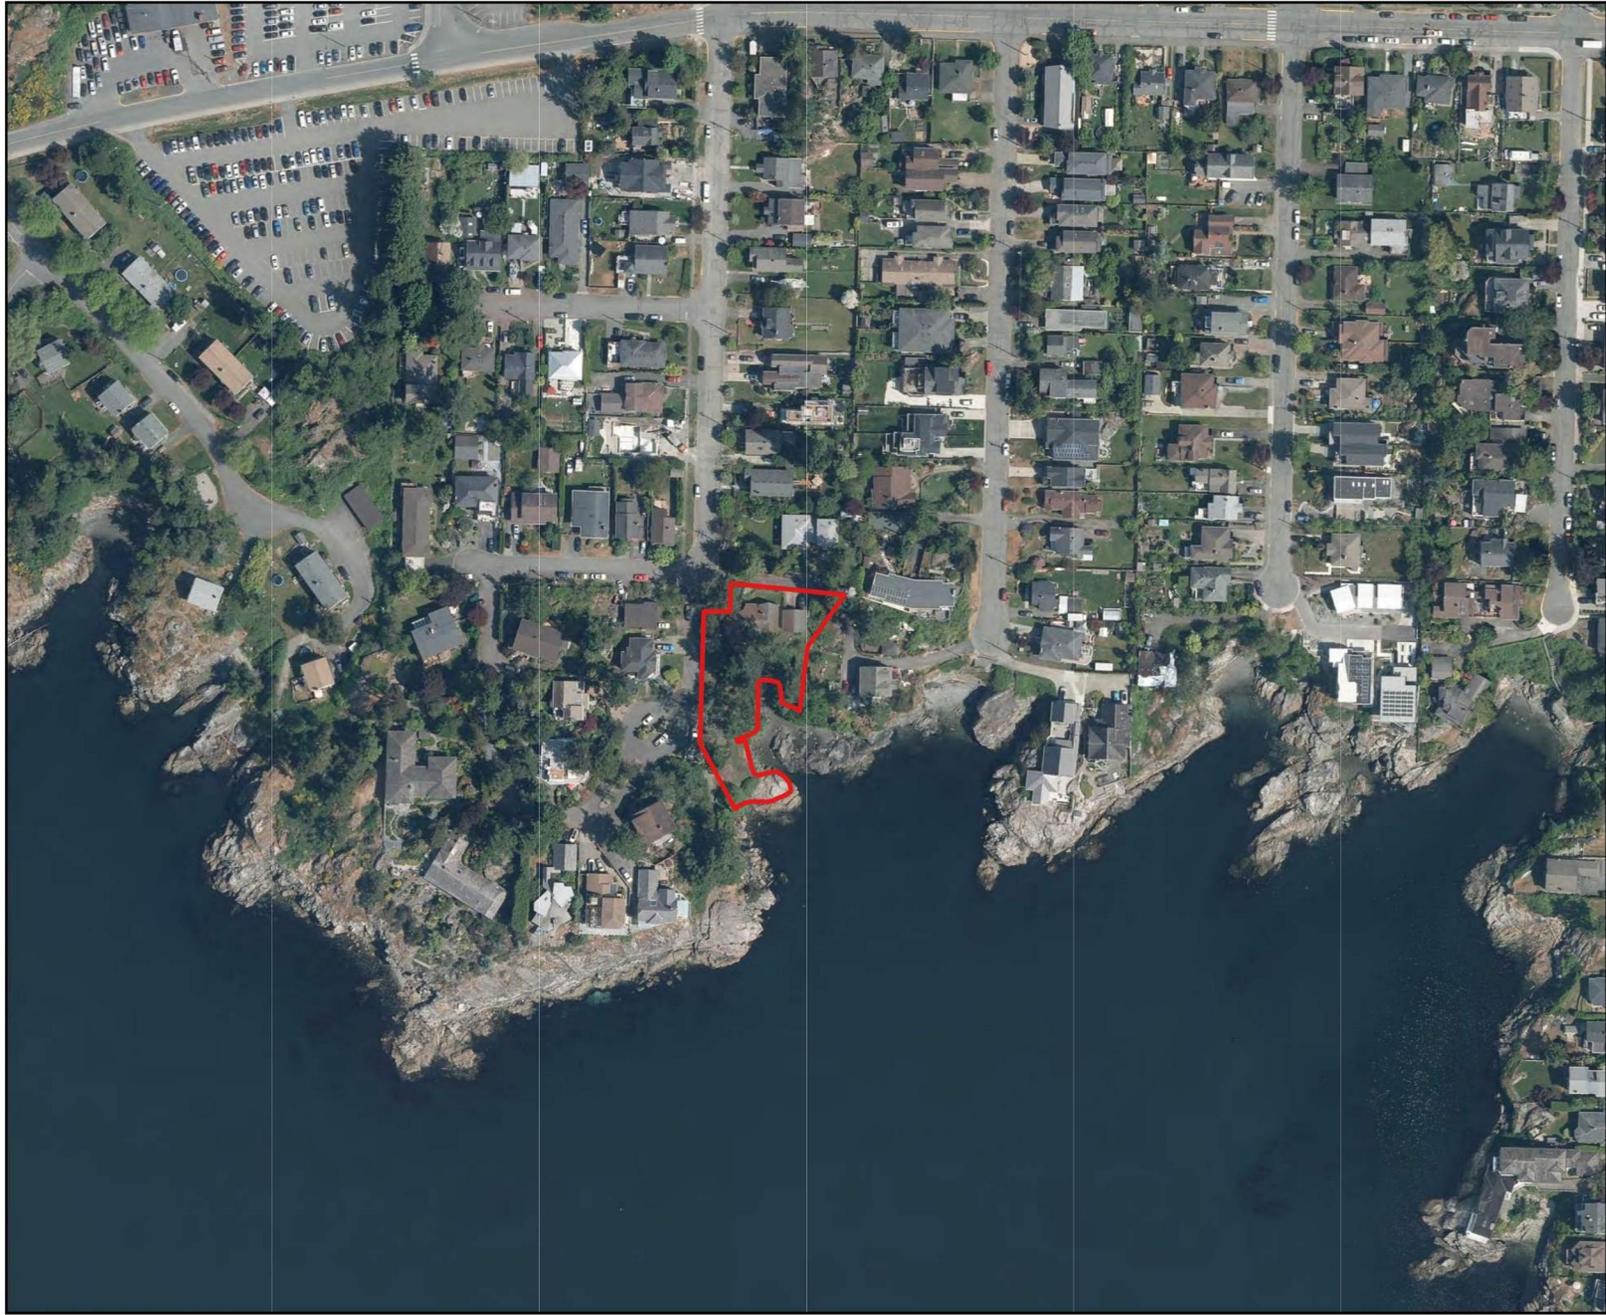
Figure #1

The Property is bound by a common property access right-of-way to the north, an RS-3 residential lot to the east, Grafton St. right-of-way to the west, and Denniston Municipal Park to the south. A portion of the southeast property boundary is waterfront bound by the Present Natural Boundary (PNB) of the Juan de Fuca Strait. Property boundaries are shown in Figure 1, designated by the red polygon.

Property Boundary and Location

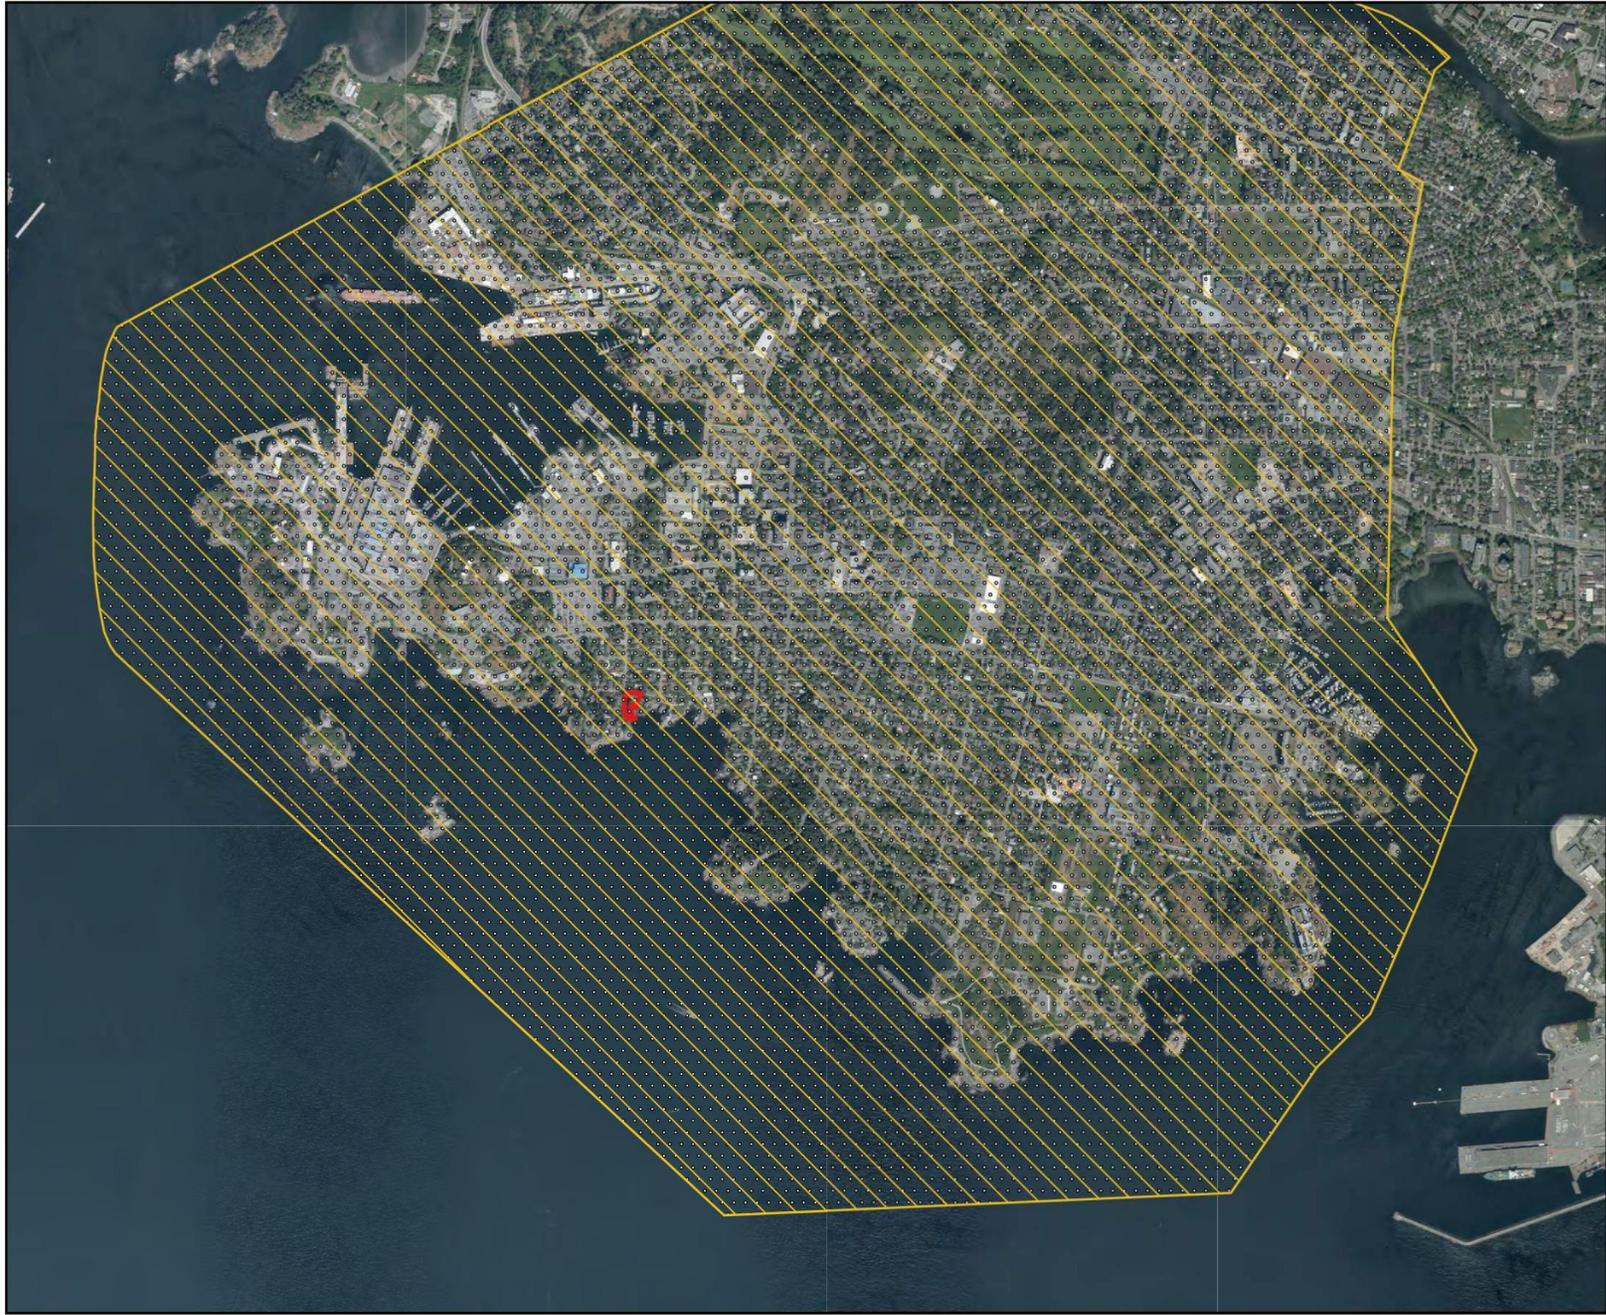
Figure #2

The DPAs overlapping the Property are shown in Figure 2.

Development Permit Areas Overlapping the Property

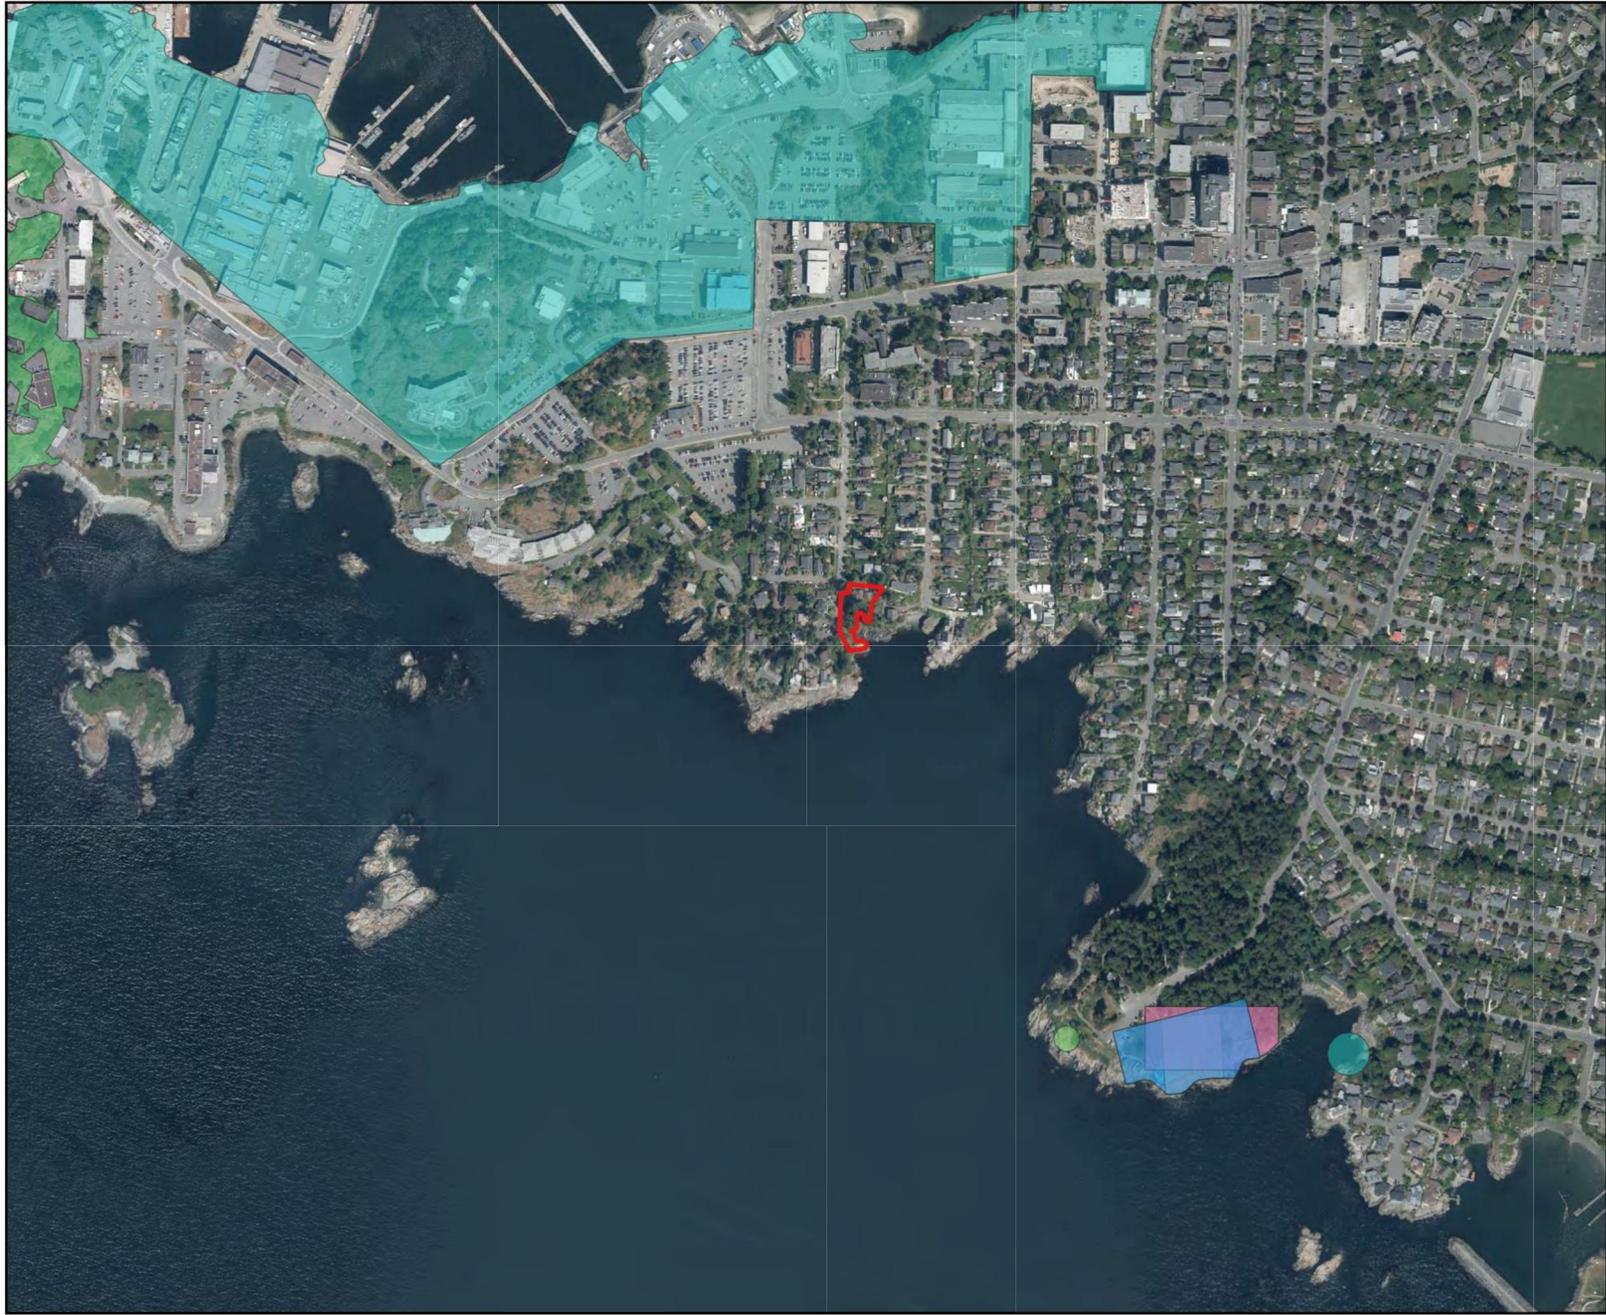
Figure #3

Sensitive Ecosystems and Species at Risk within 1 km of the Property

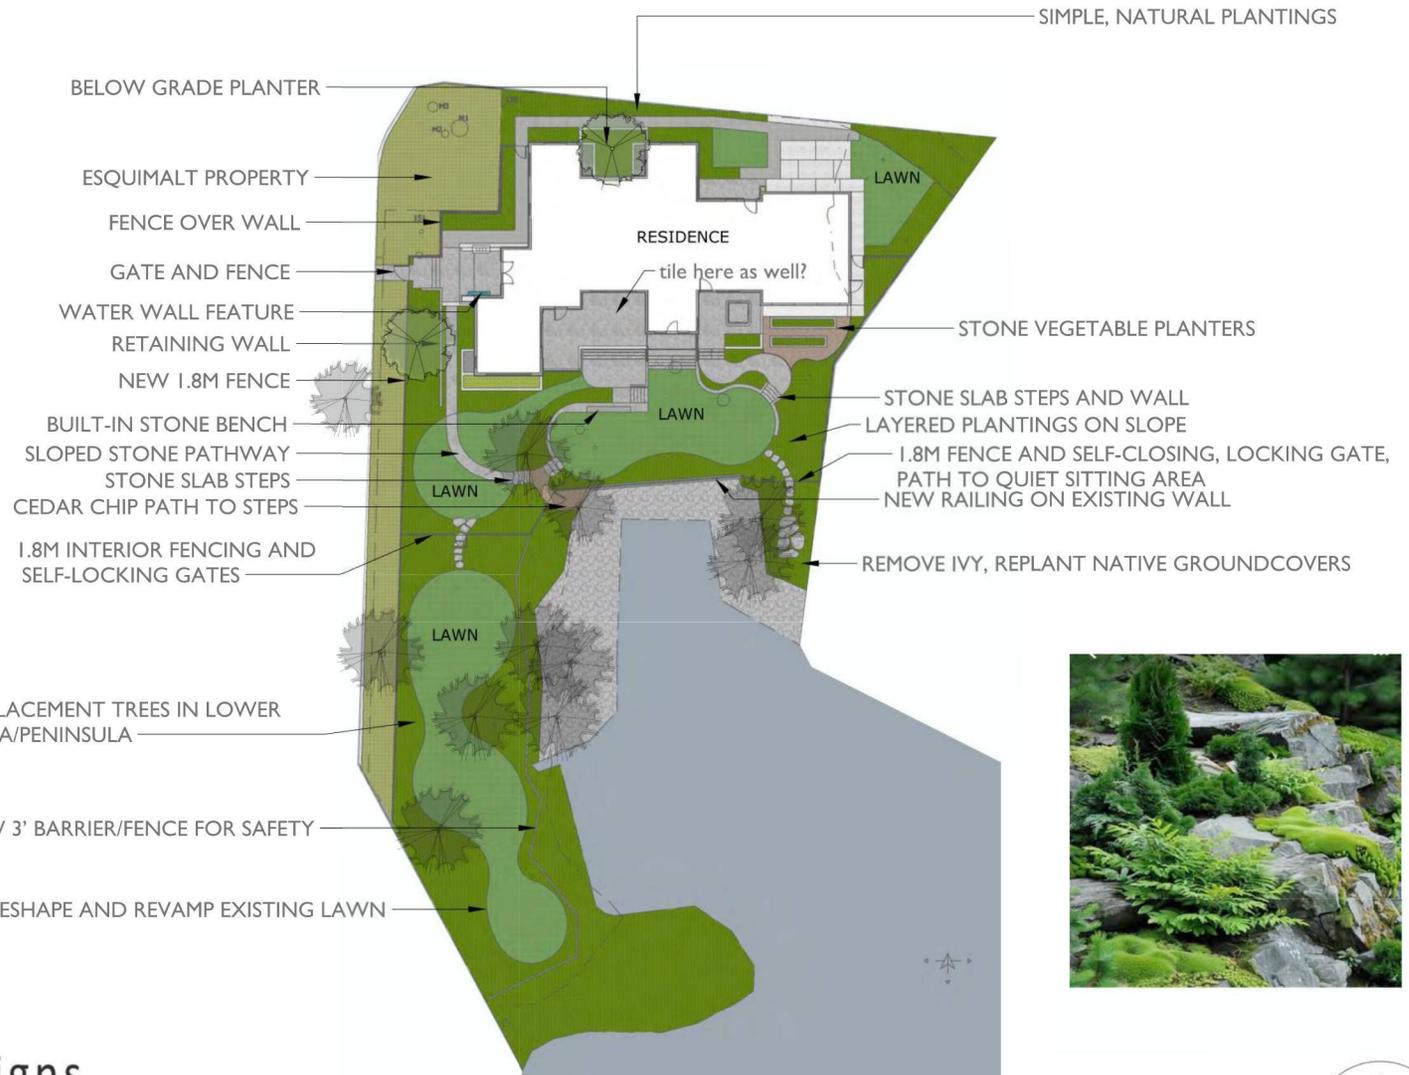
OVERALL CONCEPT

LANDSCAPE CONCEPT SKETCH, MEGAN AND TYSON GREEN
445 GRAFTON STREET, ESQUIMALT BC | SCALE 1" = 30'

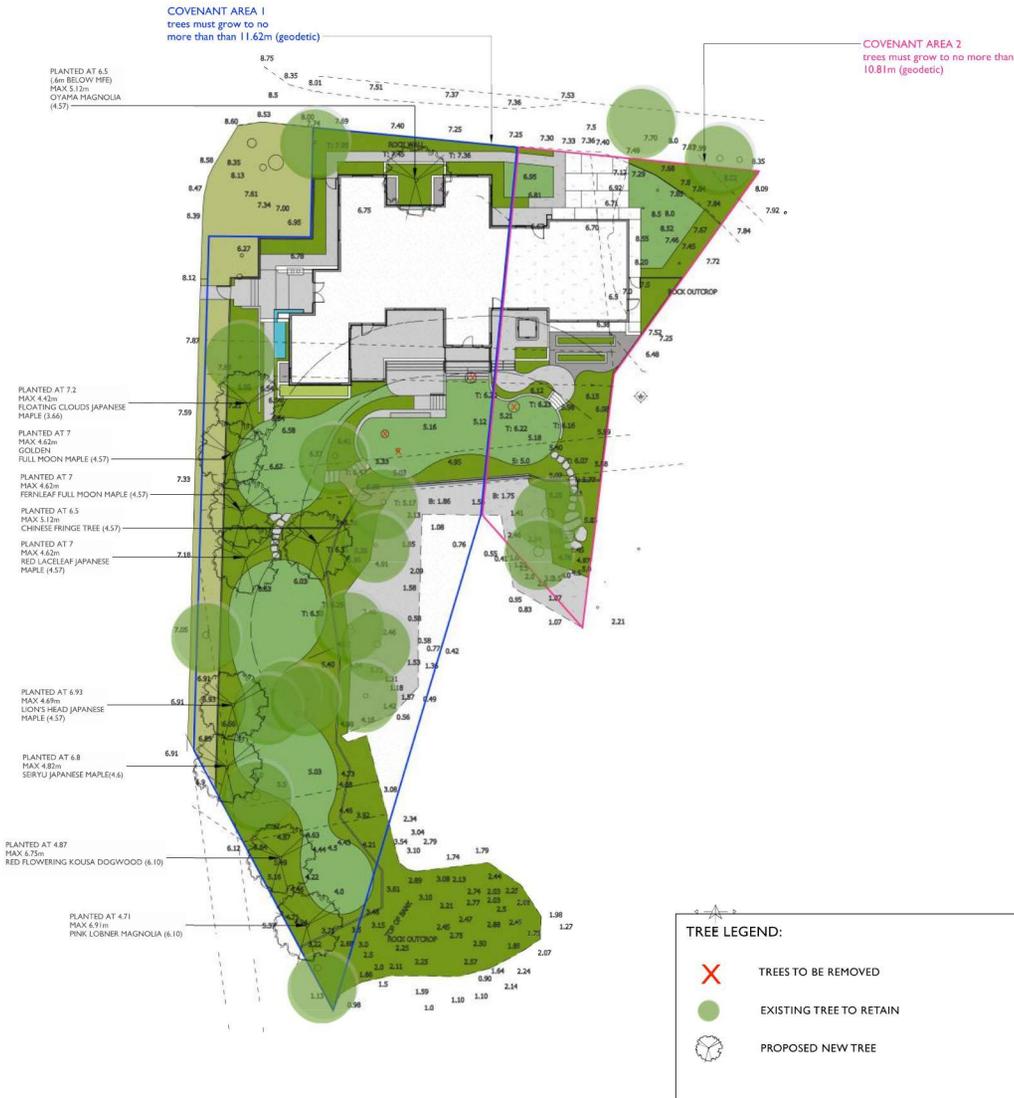
TREE RETENTION, REMOVAL AND REPLACEMENT PLAN
SCALE 1:200

445 GRAFTON STREET-REPLACEMENT TREE PLANNING

PAGE TITLE ::
PROPOSED TREE REPLACEMENT PLAN, PAGE ONE OF ONE

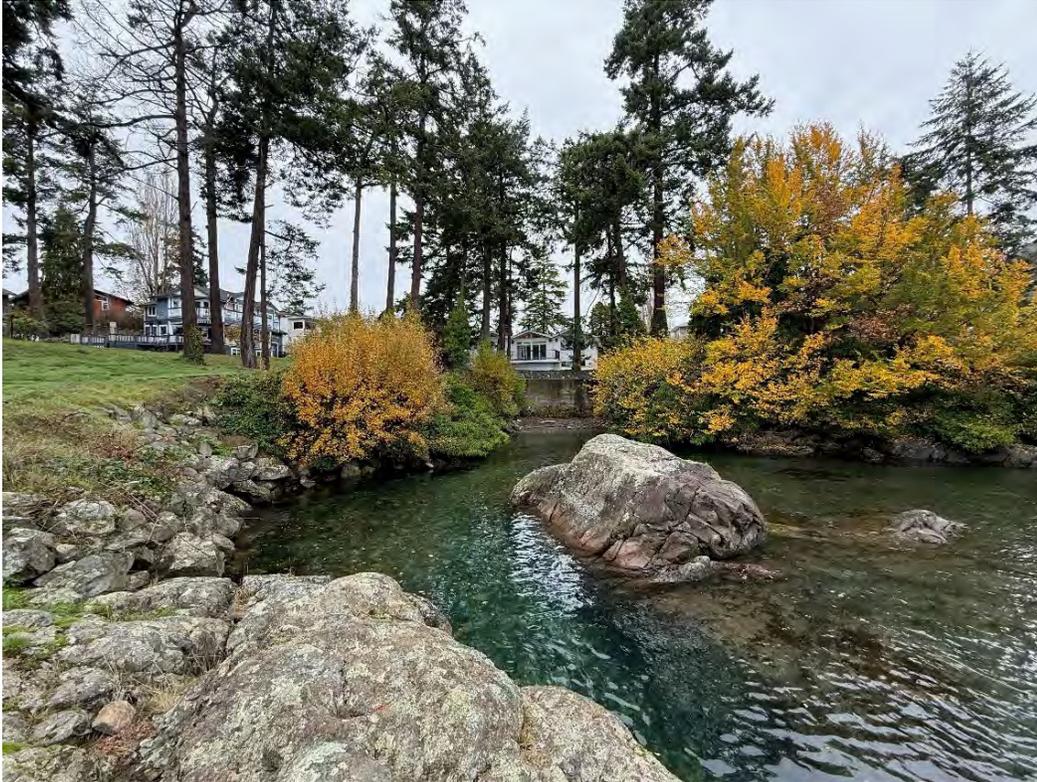
The shoreline area associated with the Property is located along the marine shoreline of the Juan de Fuca Strait and is characterized by a predominantly rocky outcrop foreshore interspersed with cobble substrate and shrubby overhanging vegetation. A small cove is present on the property. The upper shoreline and immediate riparian transition zone support mature native shrubby vegetation, which is well established atop rock features and contributes to shoreline stability, erosion resistance, and nearshore habitat complexity. This vegetation provides shading and organic input to the intertidal environment and supports ecological functions such as foraging and refuge opportunities for marine and terrestrial species. The absence of extensive fine sediments along the shoreline reduces susceptibility to erosion, and the existing natural shoreline configuration remains largely intact, consistent with the ecological objectives of DPA No. 1.

Photo 1. View north of aquatic environment and shoreline area of the Property on November 18, 2026.

delineated using high visibility fencing prior to the start of work. Equipment, materials, and hazardous substances must not be stored within the riparian area. Landscaping adjacent to the shoreline should utilize native, deep-rooted species that enhance bank stability and provide natural shading, rather than hardscaping or non-native ornamental plantings. In accordance with DPA No. 1, exterior lighting should be designed to minimize light spillage into aquatic environments to reduce anthropogenic disturbances.

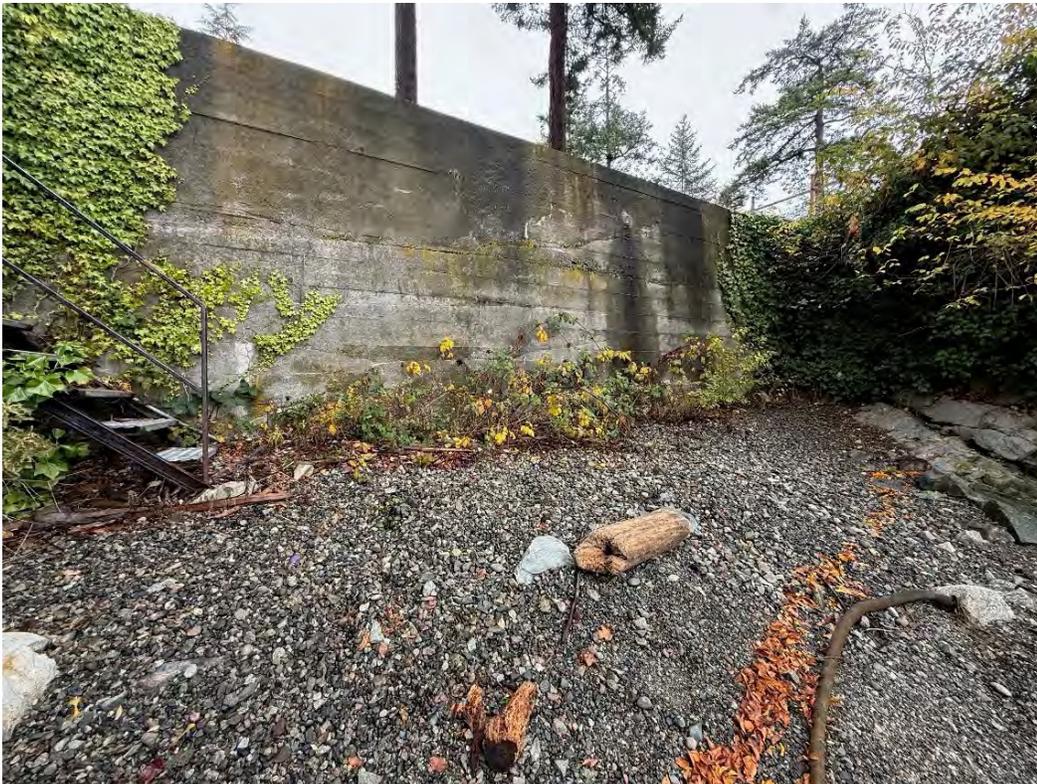
The Property is 0.21 ha in area and is currently zoned for Single Family Waterfront Residential (RS-3) within the ToE. There is an existing vacant single-family residence on the Property, which is located approximately 17 m away from the closest point of the PNB. The Property contains a series of terraced retaining walls to establish plateaued areas downslope towards the rocky shoreline. A small beach is separated from the Property by a concrete retaining wall.

Photo 2. Existing concrete retaining wall on the Property.

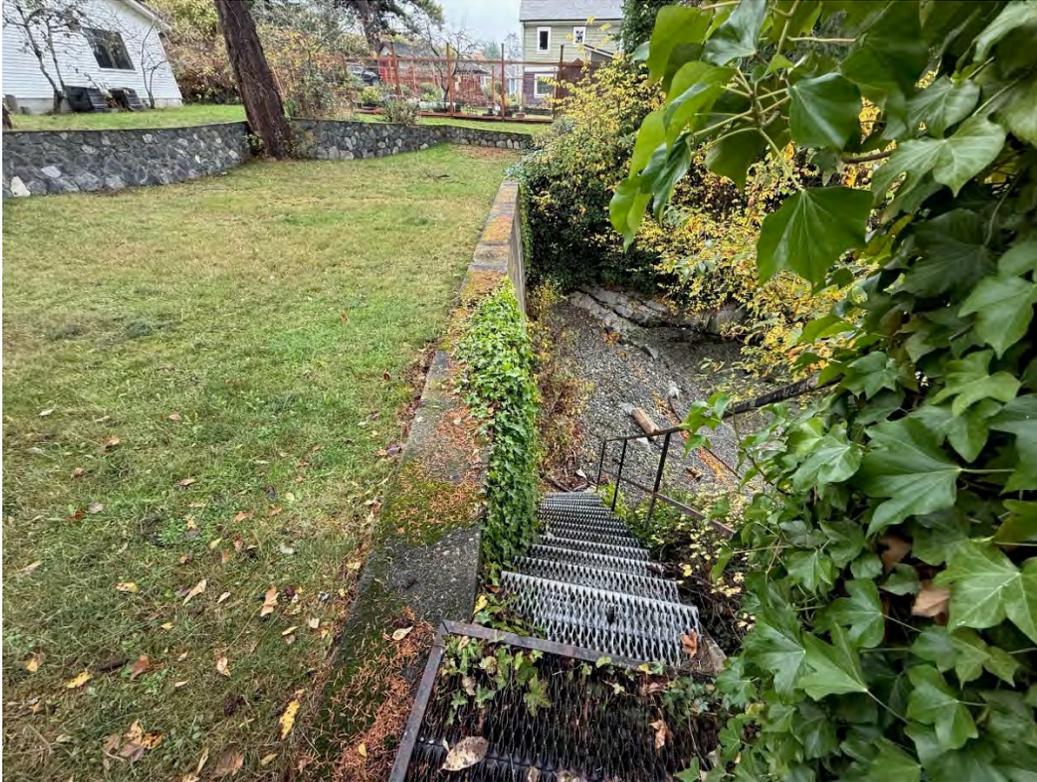
extending from the northern boundary toward the southern shoreline. The Property has been historically modified through the construction of retaining walls to manage the natural slope and maintain usable plateau areas. A substantial retaining wall is located at the seaward extent of the lawn area, marking the transition between the upland portion of the Property and the marine foreshore. The shoreline itself consists mostly of exposed bedrock outcrops with one small cove featuring a beach with cobble substrate.

Photo 3. Shoreline access on the Property, view of existing terraces and retaining walls.

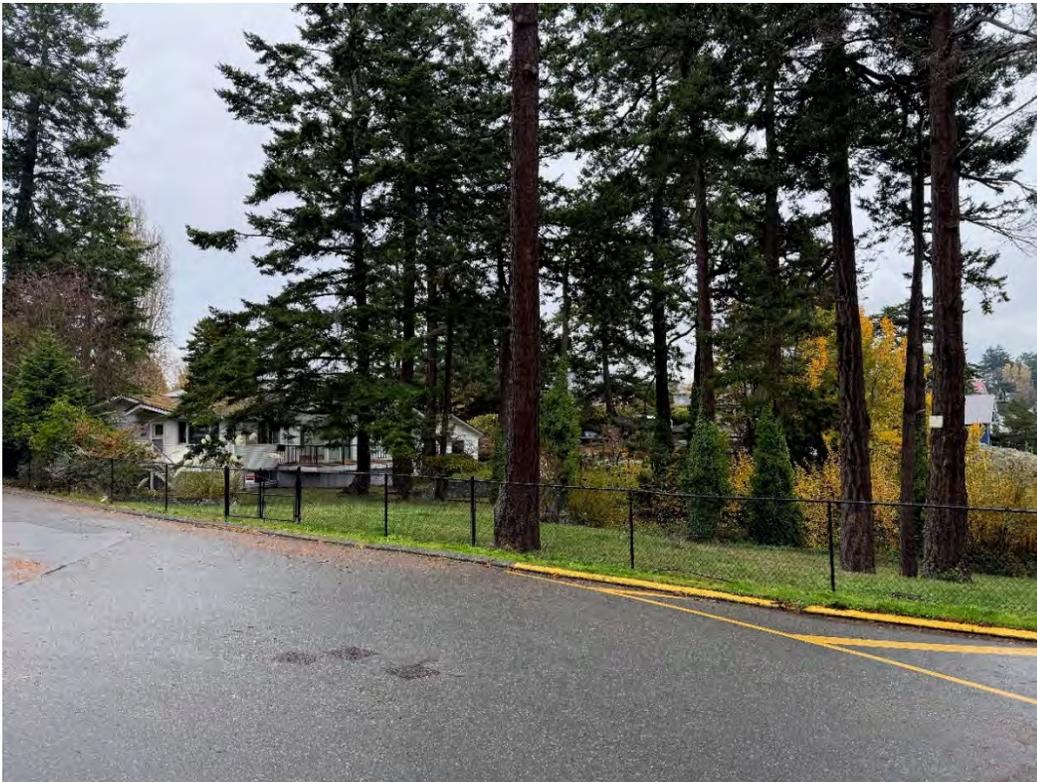
Vegetation composition across the Property is variable and reflects historical landscaping and ongoing maintenance. The overstory canopy is discontinuous and consists of individual stands of mature Douglas-fir (*Pseudotsuga menziesii*) and western redcedar (*Thuja plicata*). The native shrub layer is dominated by oceanspray (*Holodiscus discolor*), with limited species diversity in upland areas. Large portions of the Property consist of maintained lawn and turf grasses within previously cleared areas. Localized, dense patches of the invasive species English ivy (*Hedera helix*) are present at the base of mature trees in the upper portions of the Property. Shoreline vegetation is characterized by native shrub cover, including oceanspray and willow species (*Salix spp.*), which contribute to bank stability and nearshore habitat function. No plant species listed under provincial or federal species at risk legislation were observed during the field survey.

Photo 4. Existing mature trees and vegetation on the Property.

To ensure tree root protection of existing mature tree stands on the Property, underground pipes and infrastructure should be placed within paved areas or previously disturbed areas to avoid tree root damage. If damage is unavoidable, infrastructure should be placed greater than 0.6 m below the soil surface to minimize root damage, as described in DPA No. 1.
