Stage 1

Preliminary Site Investigation

900 Esquimalt Rd., Esquimalt, BC

Submitted to:
GMC PROPERTIES INC.

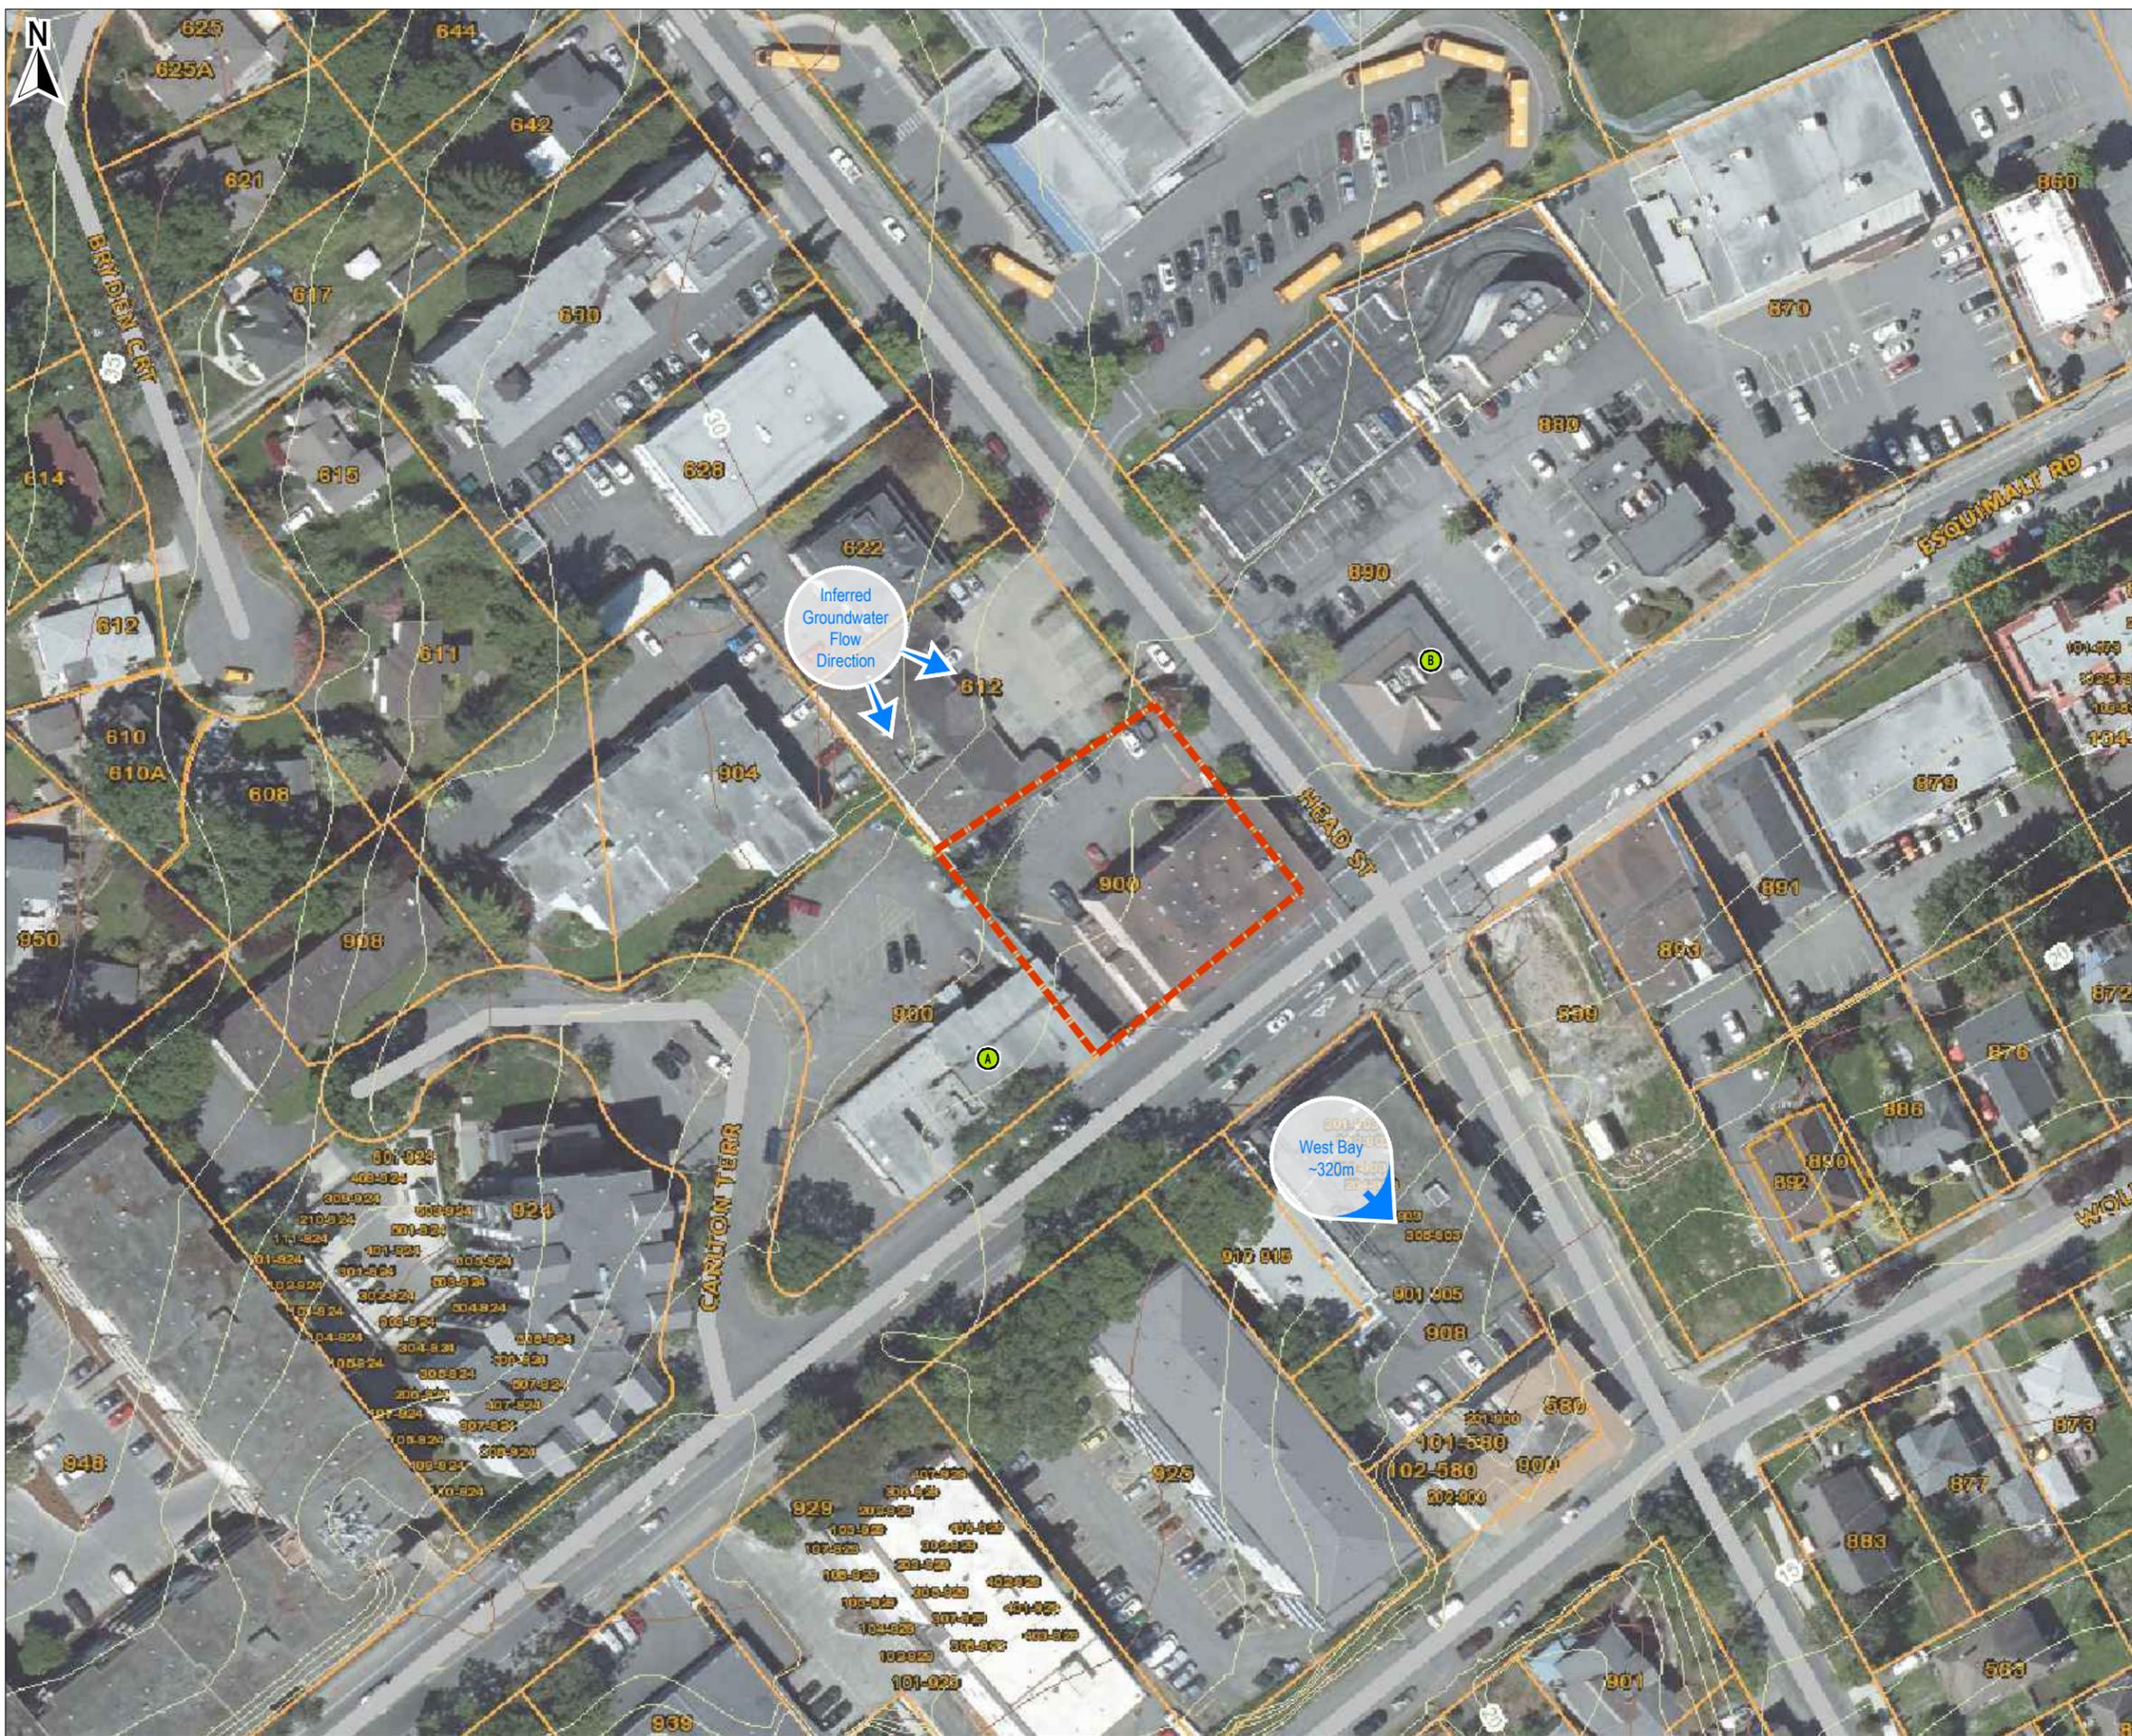
Client: GMC Properties Inc.			
Project: Stage 1 Preliminary Site Investigation 900 Esquamalt Rd, Esquamalt, BC			
Consultant: MW	Drawn by: PZ Drawn date: March 11, 2022	Checked by: AH Checked date: March 11, 2022	Project No: GMC020501
Site Plan			DWG: GMC020501-001.dwg Figure: 01

Item A (Low Risk): 910 Esquimalt Rd *Adjacent to the southwest Site boundary and inferred cross-gradient.*
Former Laundromat (c. 1969)

Item B (Low Risk): 890d Esquimalt Road *~30m northeast of the Site and inferred cross-gradient*
Former Laundromat (c. 1999)

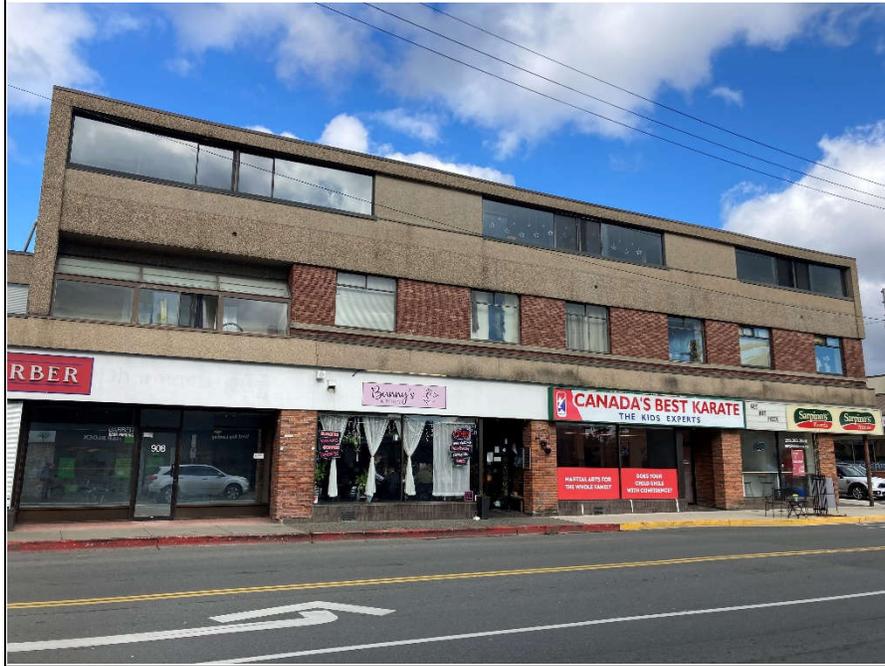
Photograph 1

A frontal view of the Site. Photo taken from the southeastern side of Esquimalt Road facing northwest.

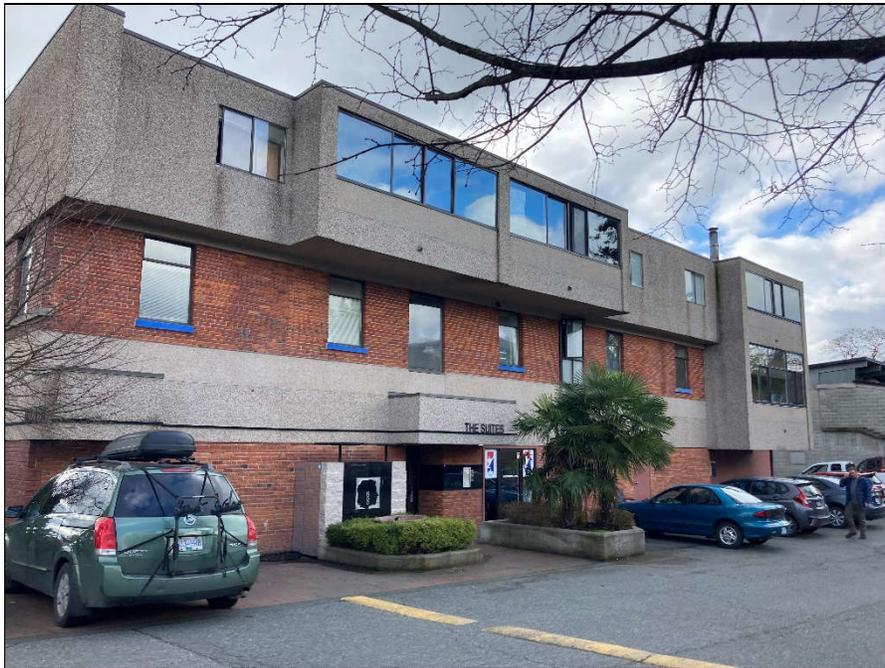
Photograph 2

A rear view of the Site. Photo taken from the northeastern portion of the Site facing southwest.

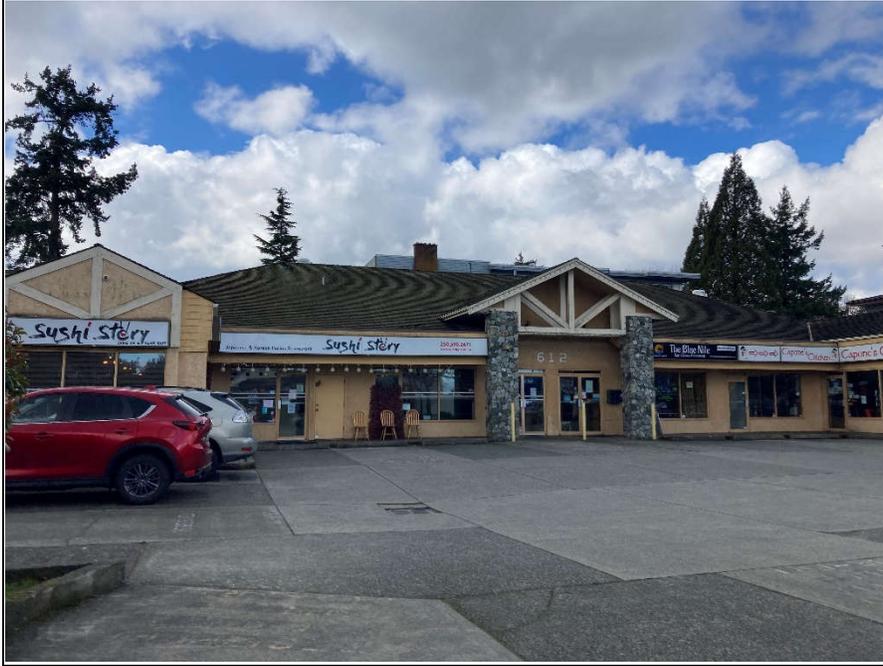
Photograph 3

A view of the property located directly northwest of the Site. Photo taken from the western side of Head Street facing west.

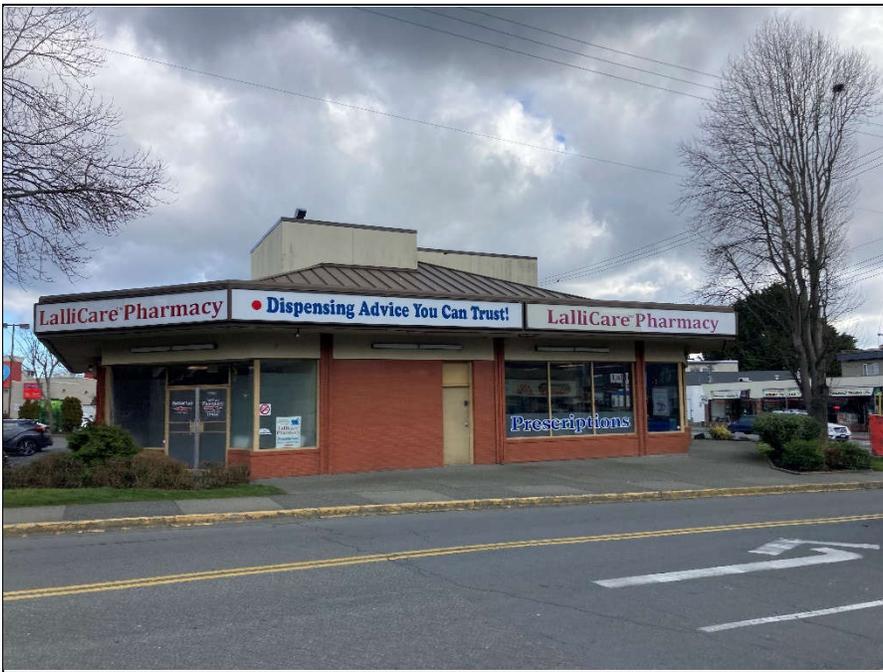
Photograph 4

A view of the commercial property to the northeast of the Site. Photo taken from the western side of Head Street facing northeast.

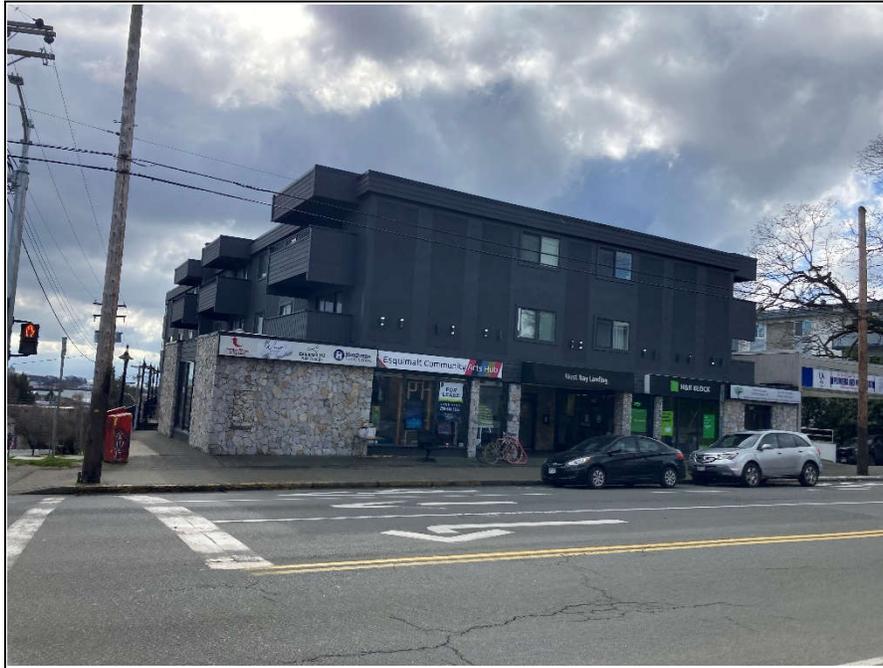
Photograph 5

A view of the property located to the southeast of the Site. Photo taken from the northwestern side of Esquimalt Road facing southeast.

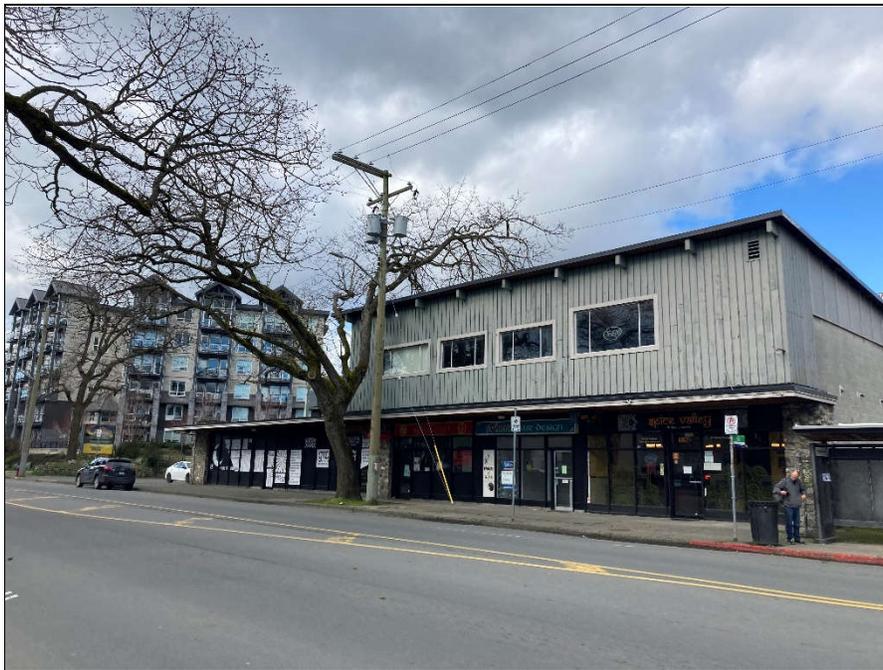
Photograph 6

A view of the property located to the southwest of the Site. Photo taken from the southeastern side of Esquimalt Road facing northwest.
