## Capital Tree Service Inc.

Arborist Report

903 Admirals Rd,

\*Revised November 3, 2025\*

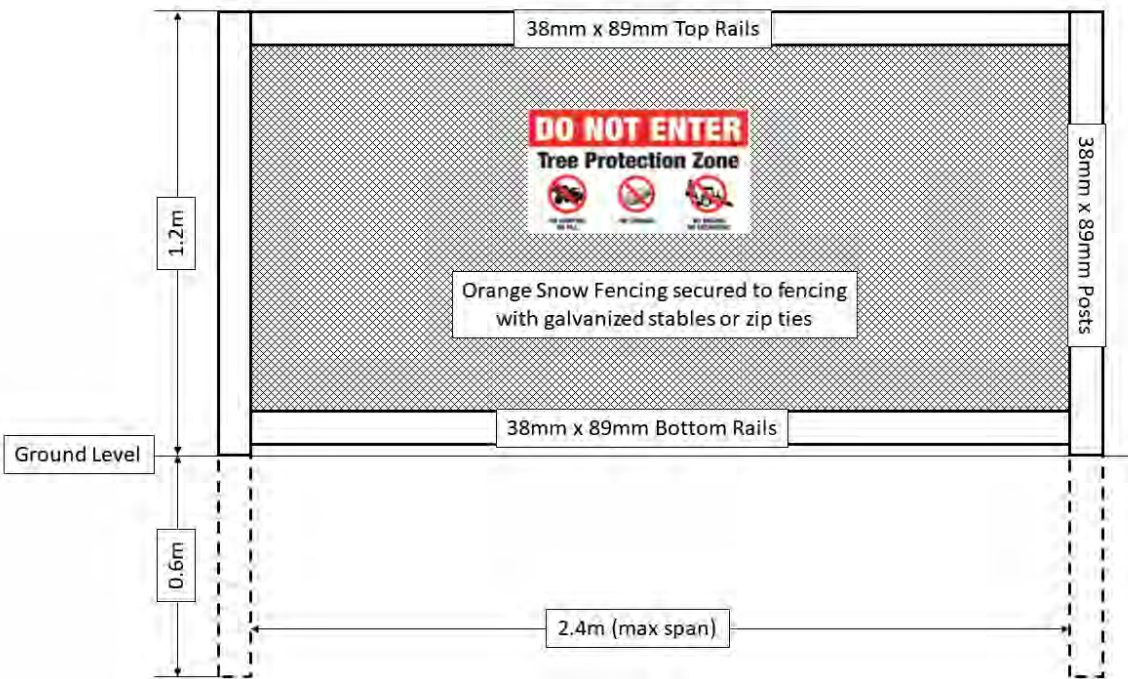
**Figure 1. Tree Protection Fencing.** In rocky areas, metal (t-posts or rebar) drilled into rock will be accepted instead of wooden posts.

Attach a sign with a minimum size of 407mm x 610mm (16"x24") with the following wording:

- a) DO NOT ENTER – Tree Protection Zone (for retained trees) or;
- b) DO NOT ENTER – Future Tree Planting Zone (for tree planting sites).

These signs must be affixed on every fence face or at least every 10 linear meters.
