Capital Tree Service Inc.

Arborist Report

903 Admirals Rd,

September 9, 2025

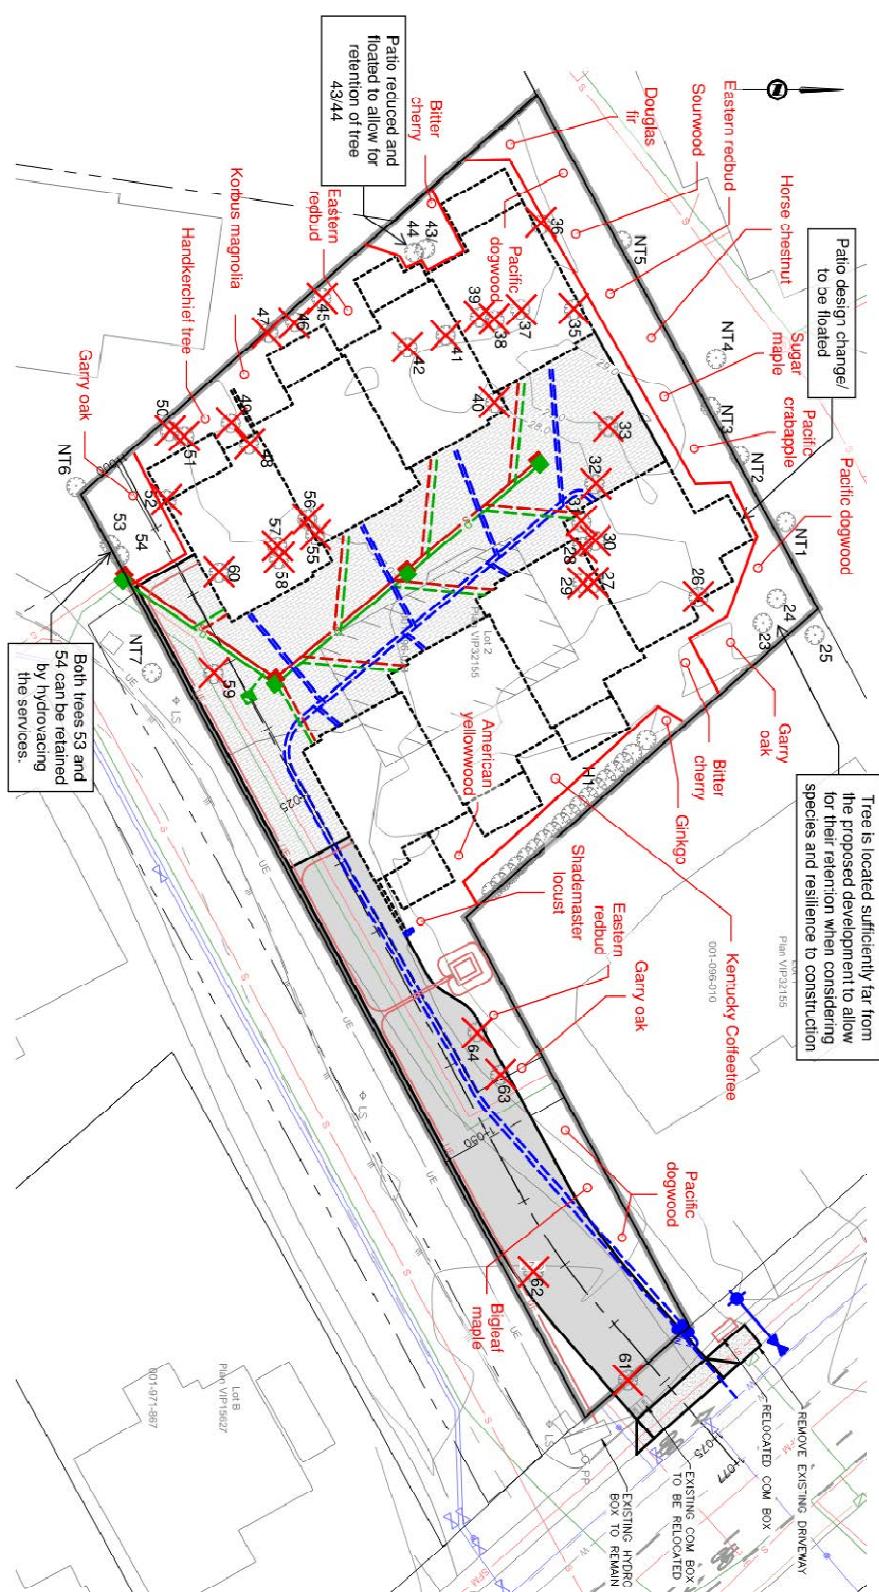
Figure 1. Site Plan. Red lines indicate Tree Protection Fencing. See Appendix C for Tree Protection Fencing specifications. Hatched brown indicated anti-compaction required.
