## **880 Fleming Street, Esquimalt**

### **Construction Impact Assessment & Tree Preservation Plan**

Date of Issuance: January 21, 2021

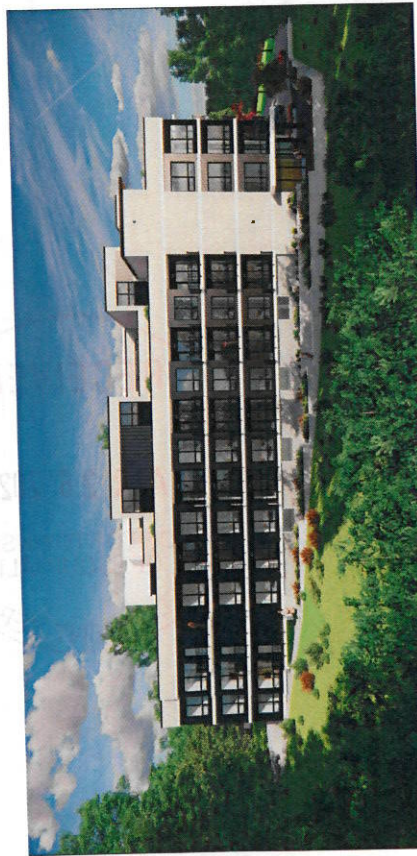
WEST EXTERIOR ELEVATION

PREFINISHED ALUMINUM RAILING - GLAZED PANELS
