**GEOPACIFIC**  
VANCOUVER KAMLOOPS CALGARY

September 5, 2017  
File: 15265

**Re: Geotechnical Investigation Report - Proposed Mixed Use Development  
899 Esquimalt Road and 896 Wollaston Street, Victoria, B.C.**

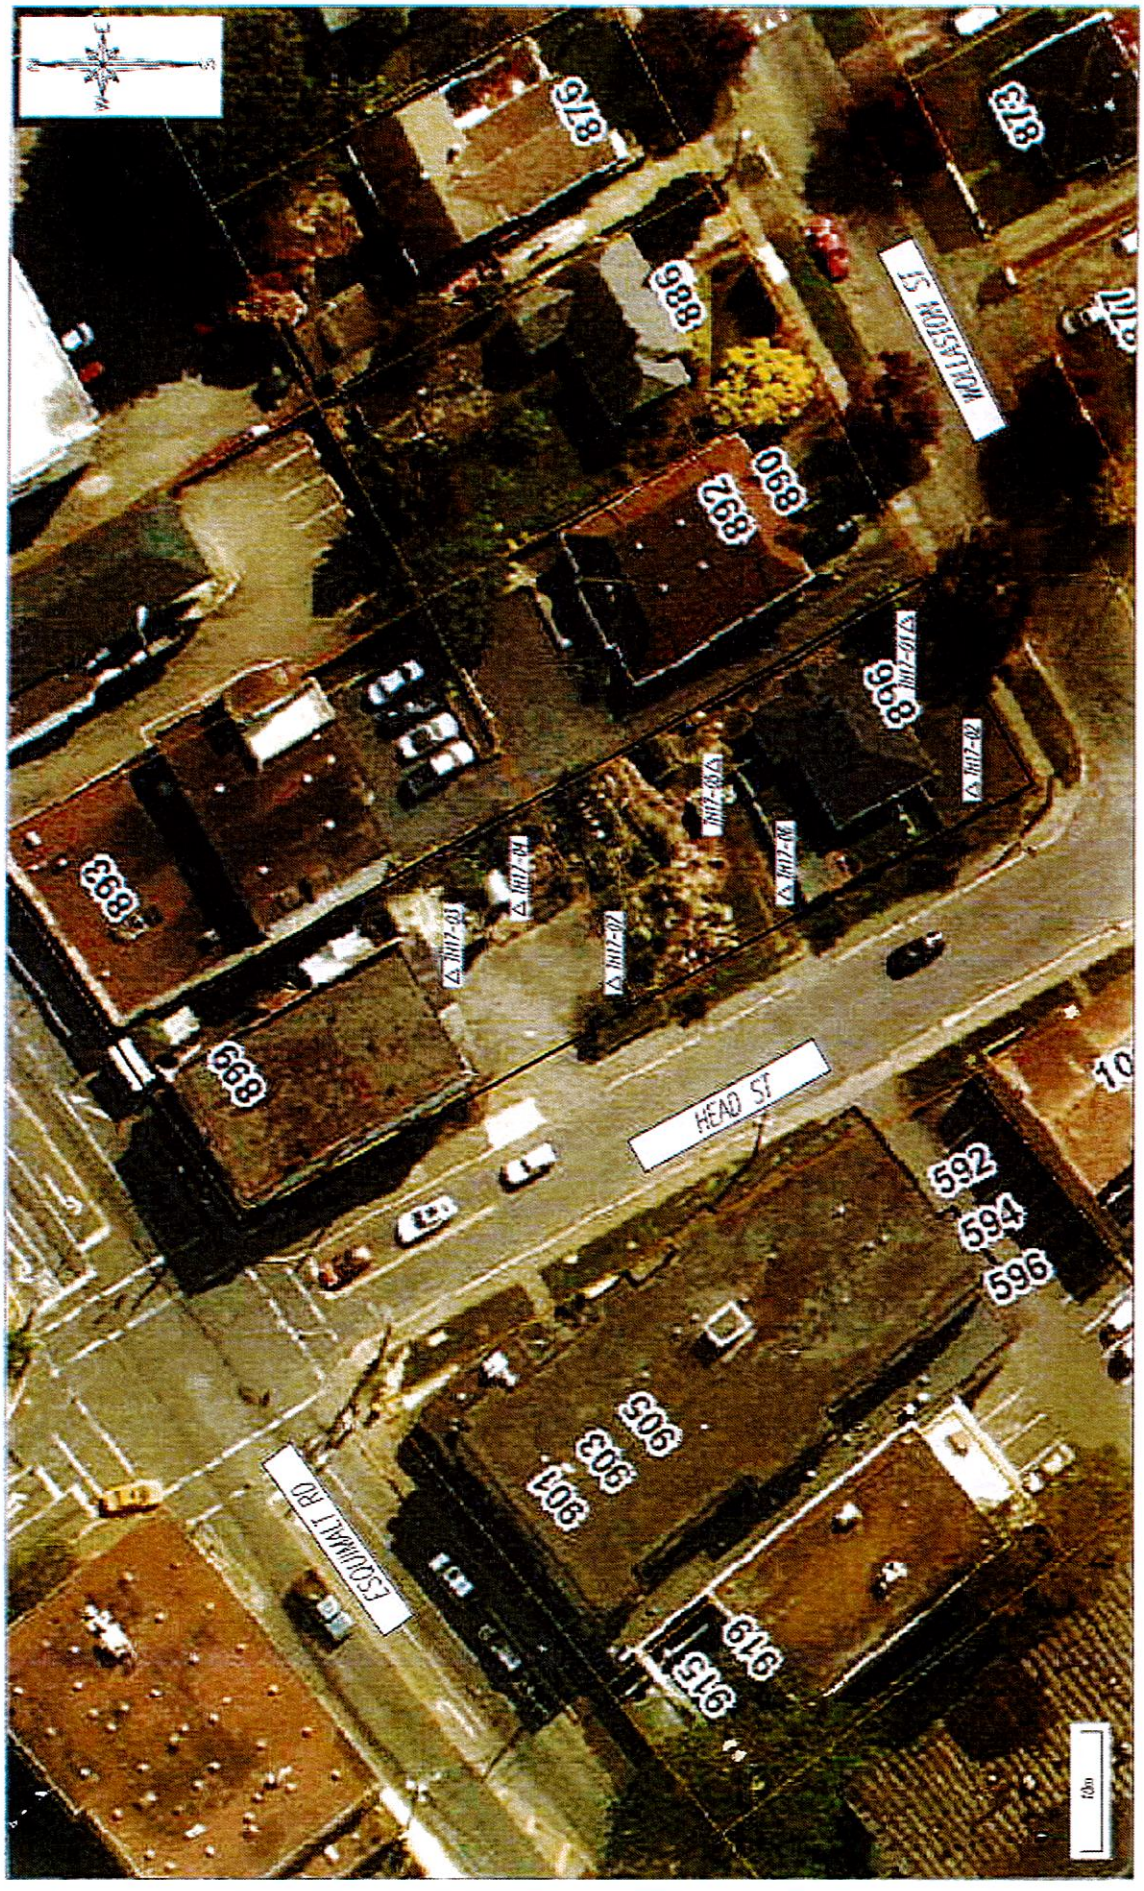
△ THH-1 - TEST HOLE (TH) LOCATION

The site location relative to the surrounding developments is shown on our Drawing No. 15265-01, following the text of this report.

The approximate locations of our test holes are shown on our Drawing No. 15265-01, following the text of this report.
